CLARK COUNTY LAW ENFORCEMENT CENTER

FEASIBILITY STUDY | August 2016

Existing Building Facility Assessment Overview

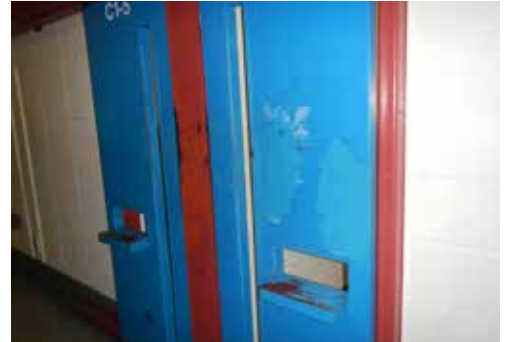
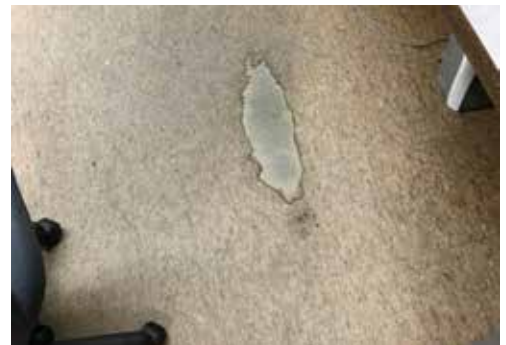
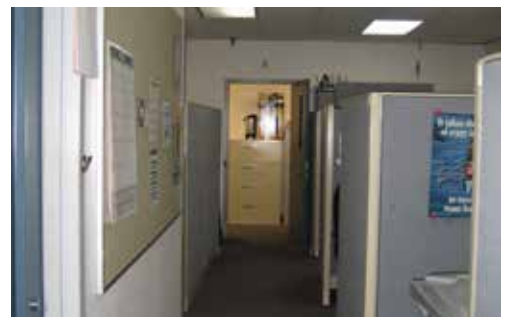
- Worn and at End of Life
- High Effort: Repaint detention area walls
- High Effort: Upgrade shower and wet area systems/finishes
- Detention Doors/Hardware: End of life

- Detention Furnishings: Worn
- Public Furnishings: Worn

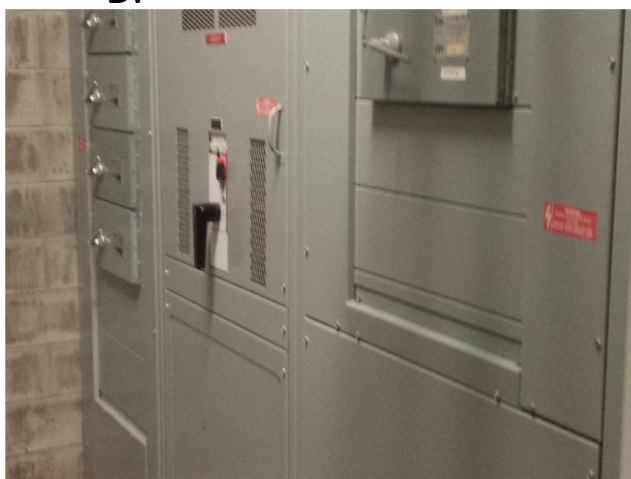
- A. Existing Distribution panelboards
- B. Close up of panelboard showing breakers, Normal and GFI (red)
- C. Receptacle showing burn marks from pencil lead shorting/cigarette lighting method
- D. VFD no longer in use.

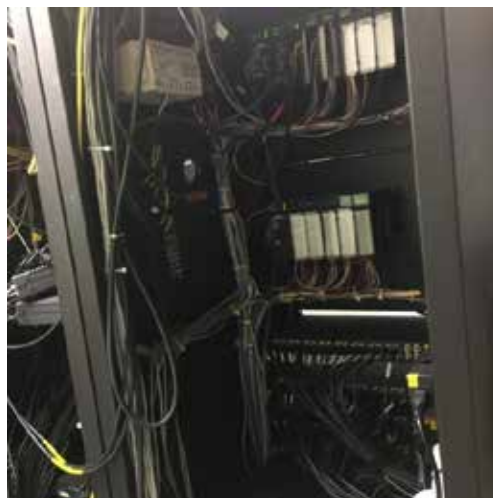
The PLC system is the heart and brains of the entire security electronics system and was manufactured by General Electric. GE is still a viable manufacture of PLC equipment but the series of PLCs being used (Fanuc) is no longer being manufactured for general use. GE does however continue to provide support and replacement parts for this equipment.

Recommendation: HK recommends that this system be replaced with a new system. Also, consideration should be given to having the new system have redundant PLC processors and power supplies to lessen the likelihood of a catastrophic system-wide failure.

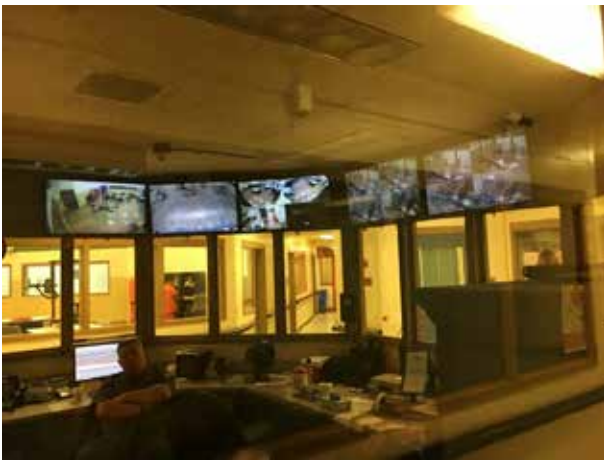
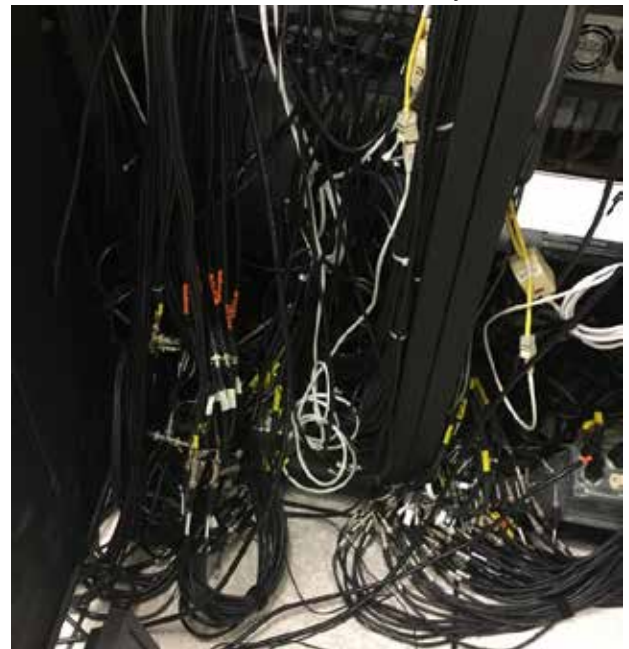
The video switcher is connected through an RS-232C interface to the touchscreen system server to facilitate automatic switching upon door selection from a touch screen computers. The IP cameras have not been equipped with decoders to allow them to be interfaced to either the video switcher or touch screen systems.

The video monitors are a mix of CRT and LCD units. The Central Control Room monitors are primarily CRT based.

Recommendations: HK Recommends that the entire system be replaced with a new IP based system. This will eliminate the potential for a catastrophic system failure due to the video switcher failing and provide approximately 4 to 8 times better resolution. Several of the monitors can be retained, and the cabling can be reused.

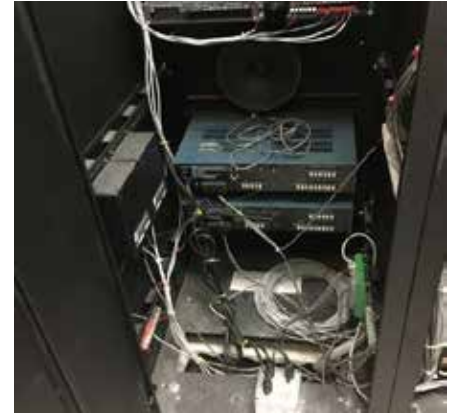
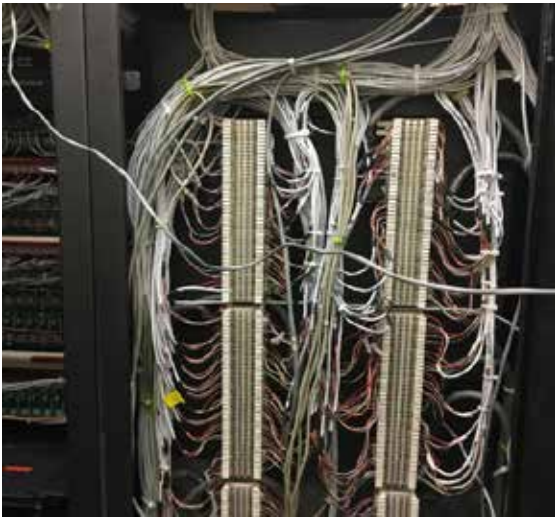
The remote master stations are still available and the audio quality is good. Numerous master stations have been wall mounted for use as door stations. We noted that contrary to the IBC (UBC during original construction) no call request stations have been provided in the cells. HK feels that this puts the County at risk relative to both allowing a person who is in a lock-down condition to call for help, and with respect to the PREA guidelines.

Recommendations: HK Recommends that the entire Master intercom system and the Local intercom system be replaced with a new PBX based system capable of both functions. This will eliminate the potential for a catastrophic system failure due to the existing PBX that is no longer being supported by the manufacturer. Existing field cabling can be reused. Also, by combining both the Master and Local intercom systems and interfacing them with the PLC system, the master stations could still be used to call remote (Local) intercom stations through the use of the keypad thereby facilitating a level of redundancy if either the PLC or touch screen systems were to fail.
