# ADA Compliance Program

## Tri-Mountain Golf Course – Accessibility Survey 1701 NW 299<sup>th</sup> Street - Ridgefield, WA

Date of Survey: July 7, 2008  
 Conducted by: Trenton Hanson, Wayne Yarnall, Bud Van Cleve, Dave Maret, Tim McVicker

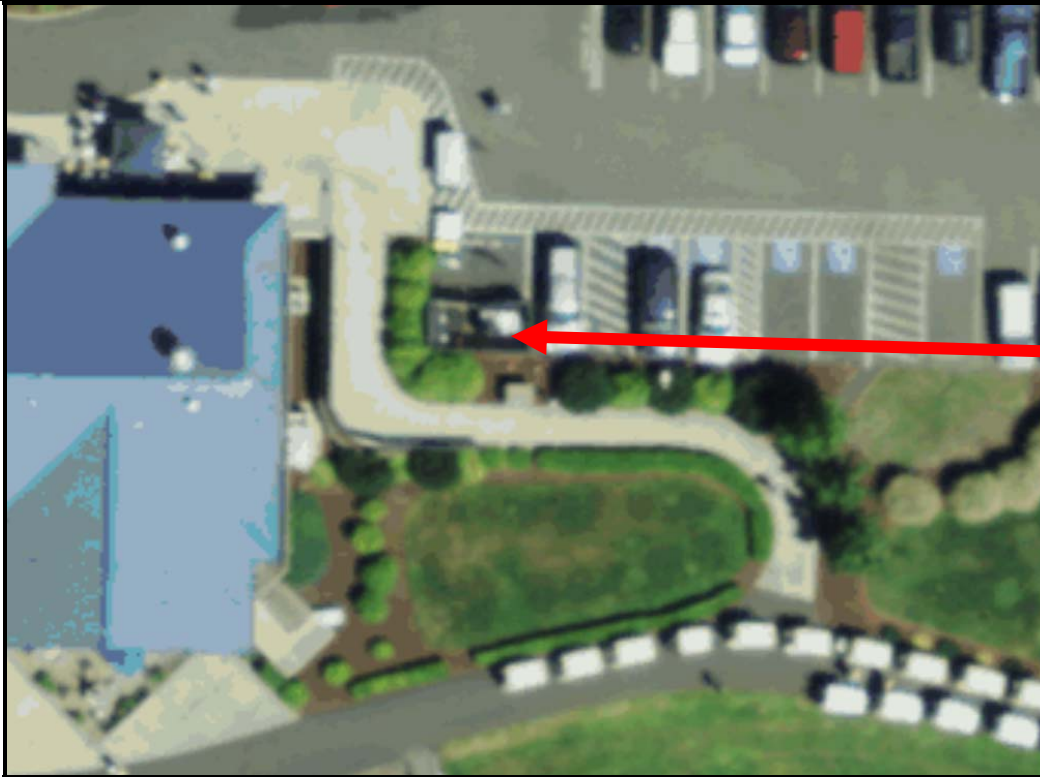
Several items need to be addressed regarding accessible parking:

- Dumpster Location
- Height of accessible parking signs
- Missing accessible parking signs
- Missing van accessible parking signs
- Width of access aisles
- Location of access aisles that overlap vehicular way
- Curb cuts
- Passenger loading zone in front of main or north entrance to clubhouse

Red line in photo displays recommended access pathway to club house from parking lot.

**Note:** It is recommended the access aisle which is currently located behind or north of the disabled parking stalls be moved in front of or south of the disabled parking stalls. Wheel stops should be placed in the parking stall to prevent vehicles infringing into the access aisle. The garbage dumpsters should be moved and the access aisle extended west to the pathway located on the east end of the club house. This will require removal of some shrubbery and construction of curb cuts. Truncated domes should also be positioned at the head of the new access aisle as it enters the parking lot.

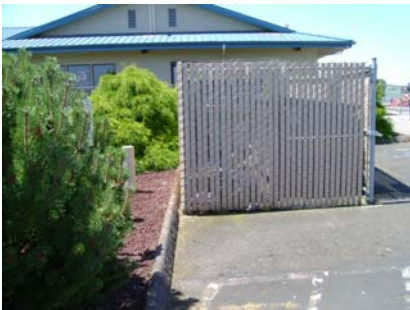
Item # 1  
Issue: Dumpster Location and Accessible Parking  
Issue: Northeast Side of Club House  
Location:  
Code: IBC 1106.6 Location: Accessible parking spaces shall be located on the shortest accessible route of travel from adjacent parking to an accessible building entrance.  
Notes: Dumpster should be re-located and space used for accessible parking

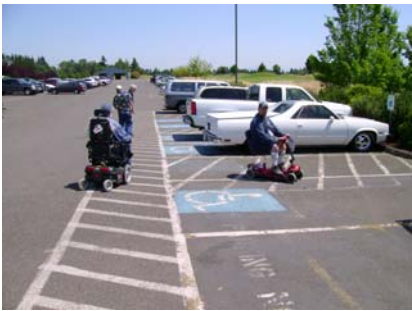
<p>Item # 2</p> <p>Issue: Access Aisle in Parking Lot Adjacent to Vehicular Way</p> <p>Issue:</p> <p>Location: North Parking Lot</p> <p>Code: ANSI 503.3.1 Location. Access aisles shall adjoin an accessible route. <u>Access aisles shall not overlap the vehicular way</u></p> <p>Notes: Relocate access pathway in front of parked vehicles. See notations above.</p>

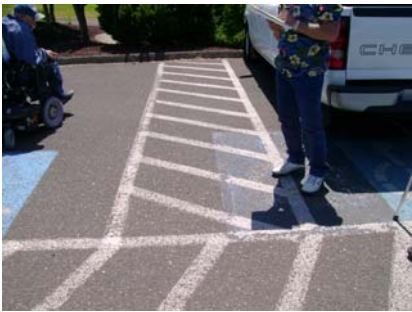
<p>Item # 3</p> <p>Issue: Width and Length of Access Aisle</p> <p>Issue:</p> <p>Location: North Parking Lot</p> <p>Code: ANSI 503.3.2 Width. Access aisles serving car and van parking spaces shall be 60 inches (1525 mm) minimum in width. ANSI 502.4.3 Length. Access aisles shall extend the full length of the parking spaces they serve.</p> <p>Notes: Access aisle in photo is only 48 inches wide</p>

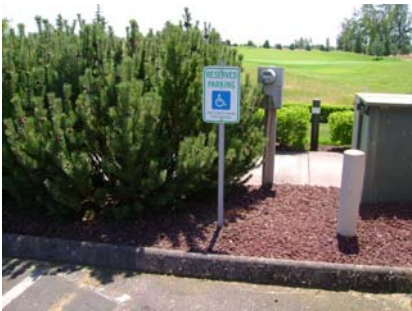
<p>Item # 4</p> <p>Issue: Sign Height; Missing Signs; Van Accessible Signage</p> <p>Issue:</p> <p>Location: North Parking Lot</p> <p>Code: ANSI 502.7 Identification: Where accessible parking spaces are required to be identified by signs, the signs shall include the International Symbol of Accessibility complying with Section 703.6.3.1.</p> <p>Signs identifying van parking spaces shall contain the designation "van accessible." Such signs shall be 60 inches (1525 mm) minimum above the floor of the parking space, measured to the bottom of the sign.</p> <p>Notes: There are only 2 signs designating parking for the</p>

disabled.  
Field house disabled parking sign is only 41" above surface.

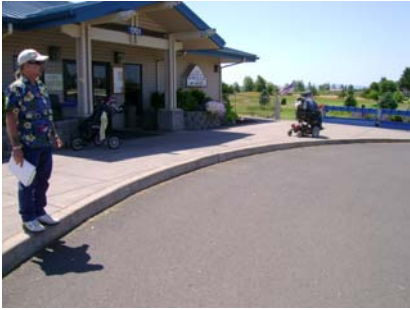
Item # 5  
Issue: Passenger Loading Zone Access Aisle and Curb Cut  
Issue:  
Location: North side of Club House  
Code: ANSI 503.2 Vehicle Pull-up Space Size. Passenger loading zones shall provide a vehicular pull-up space 96 inches (2440 mm) minimum in width and 20 feet (6100 mm) minimum in length. – See diagram below.

Notes: The main entrance to the club house has what appears to be a pull-up area for passenger loading and unloading. If this is the purpose of the pull-up it must meet the accessible standards listed in this section of the survey. Additionally, a curb cut, with truncated domes, will be required from the

<p>drop-off area to the front or north door of the club house. <u><i>If this is not a drop-off zone, it should be signed as such.</i></u></p>
<p>No Photo</p>	<p>Item # 6</p> <p>Issue: Existing Accessible Curb Cut (Ramp) No Detectible Warning Lip Exceeds ½ inch Maximum Height</p> <p>Issue: Front of Club House</p> <p>Location:</p> <p>Code: ANSI 303.2 Vertical - Changes in level of ¼ inch (6.4 mm) maximum in height shall be permitted to be vertical. ANSI 303.3 Beveled - Changes in level greater than ¼ inch (6.4 mm) in height and not more than ½ inch (13 mm) maximum in height shall be beveled with a slope not steeper than 1:2. IBC- Section 1102 Definitions – Detectable Warnings – A standardized surface feature built in or applied to walking surfaces or other elements to warn visually impaired persons of hazards on a circulation path. ANSI Code: 705.2 Standardization – Detectable warning surfaces shall be standard within a building, facility, site or complex of buildings ANSI 705.5 Truncated Domes – Detectable warning surfaces shall have truncated domes complying with Section 705.5 (See preceding photo and comments)</p> <p>Notes:</p>

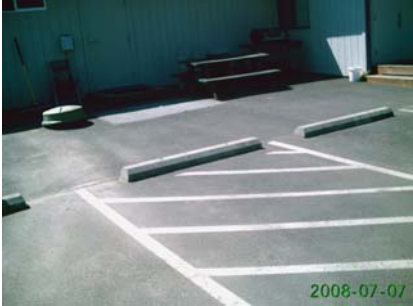
<p>Item # 7</p> <p>Issue: Accessible Access Aisle – Field House Parking – Wheel Stop Obstructs Access.</p> <p>Issue:</p> <p>Location: Parking Lot – Field House</p> <p>Code: Remove wheel stop and install truncated domes on west end of access aisle.</p> <p>Notes: Wheel stop prevents access to restroom</p>

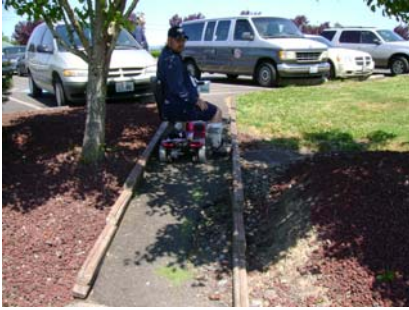
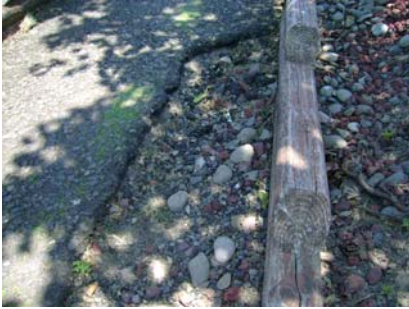
Item # 8

Issue: Gravel Path from Accessible Parking Area – Excessive Grade - Surface

Location: Path from North Parking Lot to Course

Code: WAC (ICC A117.1 Section 403.5) Clear width of accessible route. Clear width of an accessible route shall comply with ICC A117.1 Table 403.5. For exterior routes of travel, the minimum clear width shall be 44 inches (1118 mm).

ANSI 302.1 General. Floor surfaces shall be stable, firm, and slip resistant, and shall comply with Section 302. Note: Path is in need of repair. It is a trip and fall hazard.

<p>ANSI 405.7.1 Slope. Landings shall have a slope not steeper than 1:48 and shall comply with Section 302.</p> <p>ANSI 405.7.2 Width. Clear width of landings shall be at least as wide as the widest ramp run leading to the landing.</p> <p>ANSI 405.7.3 Length. Landings shall have a clear length of 60 inches (1525 mm) minimum.</p> <p>ANSI 405.7.4 Change in Direction. Ramps that change direction at ramp landings shall be sized to provide a turning space complying with Section 304.3.</p> <p>ANSI 405.8 Handrails. Ramp runs with a rise greater than 6 inches (150 mm) shall have handrails complying with Section 505.</p> <p>ANSI 405.9 Edge Protection. Edge protection complying with Section 405.9.1 or 405.9.2 shall be provided on each side of ramp runs and at each side of ramp landings.</p> <p>Notes: Width of existing path is 36" (minimum width is 44") Surface is broken and uneven. Slope of path is 7% on the north end and 15% on the south end. Slope cannot exceed 8%. If slope exceeds a 1:20 grade, handrails on both sides of the ramp are required. This path was not designed to be an accessible route. It is recommended that it be signed as inaccessible with directions to an accessible route – See Recommendations in "Golf Cart Parking Area"</p>

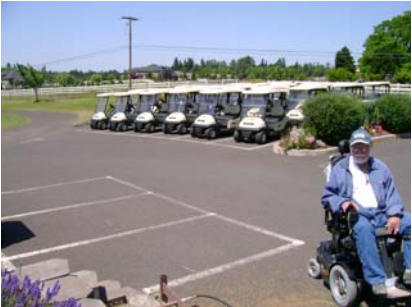
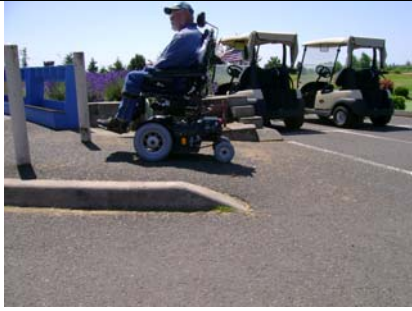
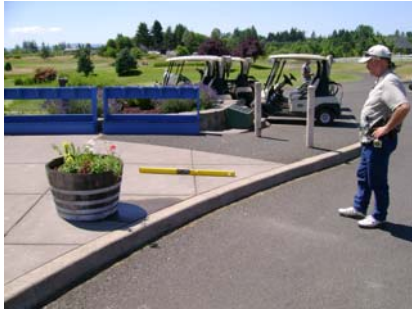
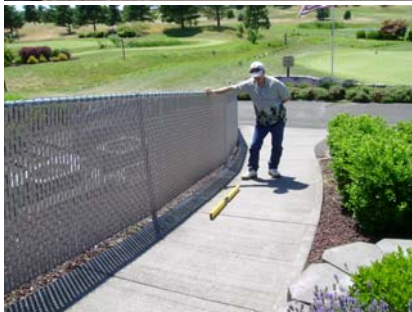
<p>Item # 9</p> <p>Issue: Golf Cart Parking Area (Inaccessible)</p> <p>Issue:</p> <p>Location: NW Area of Parking Lot</p> <p>Code: ANSI 405 Ramps</p> <p>ANSI 405.2 Slope. Ramp runs shall have a running slope not steeper than 1:12.</p> <p>EXCEPTION: In existing buildings or facilities, ramps shall be permitted to have slopes steeper than 1:12</p>

Cross slope measurements of parking area and ramps leading to parking area: (Running slopes cannot exceed 8%; cross slopes cannot exceed 2%)

Cross Slope - West parking lot area: 4.2%

Cross Slope- North parking lot area: 2.2%

Cross Slope - East parking lot area: 3.5%

Running Slope - Small paved ramp to parking area: 13.4%;

Cross Slope – Ramp: 2.9%

Cross Slope - Sidewalk approaching above listed ramp: 3.8%

Running Slope - Paved ramp west of clubhouse north of cyclone fence: 19.3%

Recommendations: The west side golf cart area is inaccessible. An alternate location needs to be identified where:

Accessible gold carts can be acquired and parked

Pathway to golf course meets accessibility guidelines

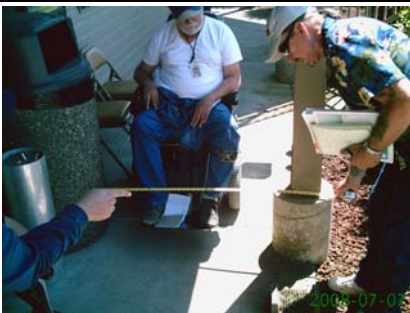
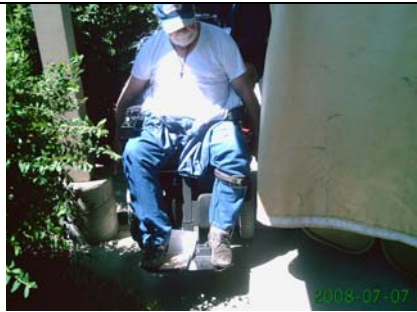
Item #	10
Issue:	Accessible Routes must be Cleared of Obstructions
Issue:	
Location:	Exterior Lower Level of Club House
Code:	WAC 1101.2.2 (ICC A117.1 Section 403.5) Clear width of accessible route. Clear width of an accessible route shall comply with ICC A117.1 Table 403.5. For exterior routes of travel, the minimum clear width shall be 44 inches (1118 mm).
Notes:	Garbage receptacle obstructs accessible route on

<p>lower level west side near entrance to restrooms. The width of the accessible route must be 44". Currently, the width is 36".</p> <p>Accessible routes must not be used for temporary or permanent storage of materials.</p>
---	---

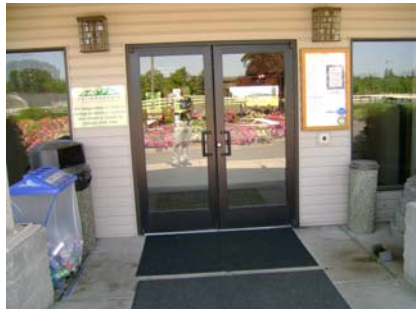
<p>Item # 12</p> <p>Issue: Door Opening Force</p> <p>Issue:</p> <p>Location: Main Entrance to Clubhouse</p> <p>Code: WAC1101.2.3 (ICC A117.1 Section 404.2.8) Door-Opening Force. Fire doors shall have the minimum opening force allowable by the appropriate administrative authority. The force for pushing or pulling open doors other than fire</p>
---	--

<p>doors shall be as follows:</p> <ol style="list-style-type: none"> <li>1. Interior hinged door: 5.0 pounds (22.2 N) maximum</li> <li>2. Interior sliding or folding doors: 5.0 pounds (22.2 N) maximum</li> <li>3. Exterior hinged, sliding or folding door: 10 pounds (44.4 N) max</li> </ol> <p>Exception: Interior or exterior automatic doors complying with Section 404.3 of ICC A117.1.</p> <p>These forces do not apply to the force required to retract latch bolts or disengage other devices that hold the door in a closed position.</p> <p>Notes: Recommendation: The following doors should be checked for opening force: (Current foot/lbs are listed)</p> <ul style="list-style-type: none"> <li>• Main Entrance/North Side: East Door 12 lbs; West Door 22 lbs.</li> <li>• Gold Shop Door – West Side: 25 lbs.</li> <li>• South Deck Doors Upper Level: Both Doors 15 lbs.</li> </ul> <p>Restroom Doors – Lower Level - West Side: Both Doors 26 lbs.  Men's restroom Upper Level: 10 lbs.  Women's restroom Upper Level: 9 lbs</p>

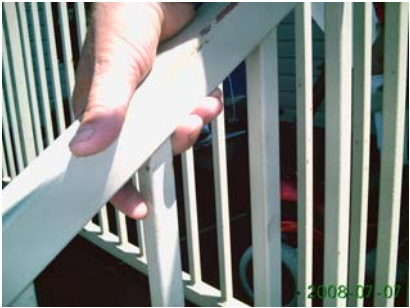
<p>Item # 14</p> <p>Issue: Handrail Gripping Surface – Clubhouse</p> <p>Issue:</p> <p>Location: West Side of Clubhouse</p> <p>Code: ANSI 505.2 Location - Handrails shall be provided on both sides of stairs and ramps. ANSI 505.6 Gripping Surface. Gripping surfaces shall be continuous, without interruption by newel posts, other construction elements, or obstructions.</p> <p>Notes:</p>

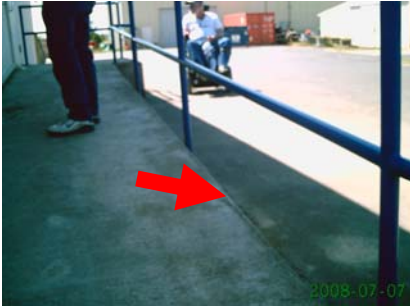
<p>Item # 15</p> <p>Issue: Ramp - No Edge Protection</p> <p>Issue:</p> <p>Location: Guardrail at Maintenance Building</p> <p>Code: ANSI 405.9 Edge Protection - Edge protection complying with Section 405.9.1 or 405.9.2 shall be provided on each side of ramp runs and at each side of ramp landings.</p> <p>Notes:</p>

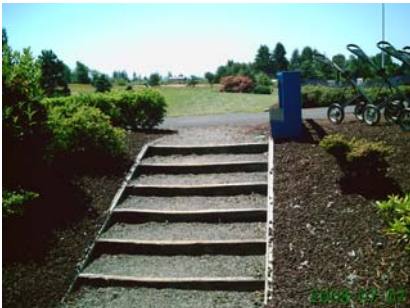
<p>Item # 16</p> <p>Issue: Stairs – No Handrails</p> <p>Issue:</p> <p>Location: West side of Clubhouse</p> <p>Code: ANSI 505 Handrails ANSI 505.1 General - Handrails required by Section 405.8 for ramps, or Section 504.6 for stairs, shall comply with Section 505. ANSI 505.2 Location - Handrails shall be provided on both sides of stairs and ramps.</p> <p>Notes:</p>

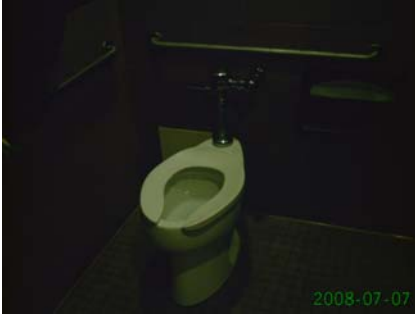
Item # 17

Issue: Flush Controls

Issue: Vertical Grab Bars

Men's Restroom – Upper Level of Clubhouse

Men's Restroom – Lower Level of Clubhouse

Men's Restroom – Field House

Code: ANSI 604.10.6 Flush Controls - Flush controls shall be hand operated or automatic. Hand operated flush controls shall comply with Sections 309.2 and 309.4 and shall be installed 36 inches (915 mm) maximum above the floor. Flush controls shall be located on the open side of the water closet.

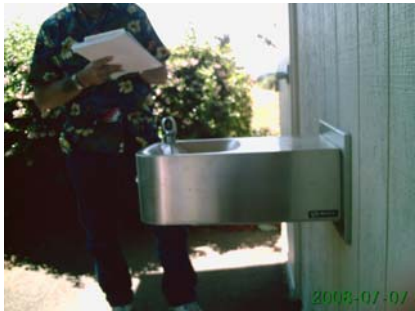
<p>Item # 18</p> <p>Issue: Field House Drinking Fountain - Protrusion</p> <p>Issue:</p> <p>Location: Field House - exterior</p> <p>Code: ANSI 307.2 Protrusion Limits. Objects with leading edges more than 27 inches (685 mm) and not more than 80 inches (2030 mm) above the floor shall protrude 4 inches (100 mm) maximum horizontally into the circulation path.</p> <p>Notes: Drinking fountain is 29.5" high and protrudes 18.5" from wall</p>
<p>No Photos</p>	<p>Item # 19</p> <p>Issue: Access to Operable Parts</p> <p>Issue:</p> <p>Location: Locations where items need to be adjusted:</p> <ul style="list-style-type: none"> <li>• Men's Restroom – Upper Level of Clubhouse</li> <li>• Hand towel dispenser electric eye is 52" above floor and towel dispensing point is 49" above the floor</li> <li>• Women's Restroom – Upper Level of Clubhouse</li> <li>• Towel dispenser electric eye is 57.25" above the floor and towel dispensing point is 54.5" above the floor.</li> <li>• Women's Restroom – Lower Level of Clubhouse</li> <li>• Towel dispenser electric eye is 54" above the floor and towel dispensing point is 51" above the floor.</li> <li>• Men's Restroom – Field House</li> <li>• Coat hook is 65" above the floor</li> <li>• Control knob for wall mounted heater is 58" above the floor</li> <li>• Women's Restroom – Field House</li> <li>• Coat hook is 65" above the floor</li> <li>• Control knob for wall mounted heater is 58" above the floor</li> </ul> <p>Code: ANSI 308.2 Forward Reach ANSI 308.2.1 Unobstructed - Where a forward reach is unobstructed, the high forward reach shall be 48 inches (1220 mm) maximum and the low forward</p>

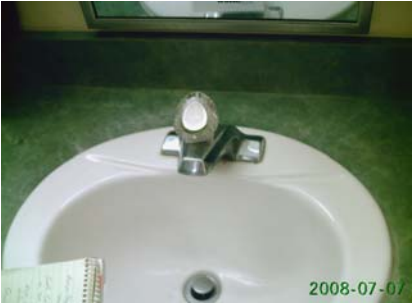
<p>Item # 20</p> <p>Issue: Faucet Handles – Operable Parts</p> <p>Issue:</p> <p>Location: Most Restrooms</p> <p>Code: ANSI 309.4 Operation - Operable parts shall be operable with one hand and shall not require tight grasping, pinching, or twisting of the wrist. The force required to activate operable parts shall be 5.0 pounds (22.2 N) maximum.</p> <p>Notes: Faucet handles in most restrooms should be replaced with lever handles that can be operated with a closed fist. (Faucets in men's restroom on main level are satisfactory.)</p>

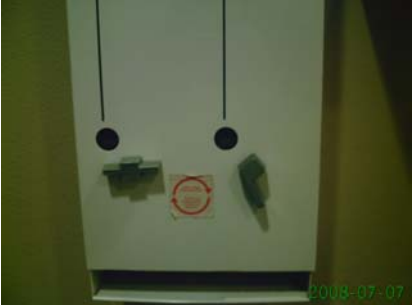
<p>Item # 21</p> <p>Issue: Sanitary Napkin Dispensers – Reach Range</p> <p>Issue:</p> <p>Location: Women's restrooms - Both floors</p> <p>Code: ANSI 309.4 Operation - Operable parts shall be operable with one hand and shall not require tight grasping, pinching, or twisting of the wrist. The force required to activate operable parts shall be 5.0 pounds (22.2 N) maximum.</p> <p>Notes: Sanitary napkin dispenser handles must be such that they can be operated with a closed fist.</p>

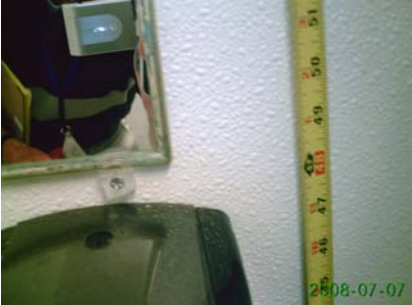
<p>Item # 22</p> <p>Issue: Restroom Mirror Height</p> <p>Issue:</p> <p>Location: Location where items need to be adjusted: Men's Restroom – Field House – Currently 48" Women's Restroom – Field House – Currently 48"</p> <p>Code: ANSI 603.3 Mirrors - Mirrors located above lavatories, sinks or counters shall be mounted with the bottom edge of the reflecting surface 40 inches (1015 mm) maximum above the floor. Mirrors not</p>

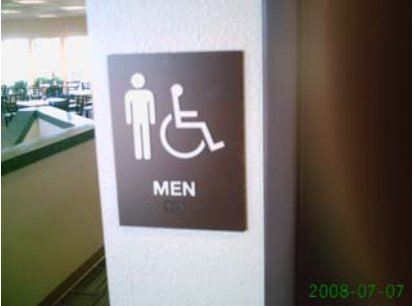
<p>Item # 23</p> <p>Issue: Signage Color</p> <p>Issue:</p> <p>Location: All Restrooms and ADA Signage</p> <p>Code: WAC 1101.2.9 (ICC A117.1 Section 703.6.3.1) International symbol of accessibility. Where the International Symbol of Accessibility is required, it shall be proportioned complying with ICC A117.1 Figure 703.6.3.1. All interior and exterior signs depicting the International Symbol of Accessibility shall be white on a blue background.</p> <p>Notes:</p>
<p>No photo</p>	<p>Item # 24</p> <p>Issue: Stall Handles – Operable Parts</p> <p>Issue:</p> <p>Location: All Restrooms</p> <p>Code: ANSI 309.4 Operation - Operable parts shall be operable with one hand and shall not require tight grasping, pinching, or twisting of the wrist. The force required to activate operable parts shall be 5.0 pounds (22.2 N) maximum.</p> <p>ANSI 404.2.6 Door Hardware. Handles, pulls, latches, locks, and other operable parts on accessible doors shall have a shape that is easy to grasp with one hand and does not require tight grasping, pinching, or twisting of the wrist to operate. Operable parts of such hardware shall be 34 inches (865 mm) minimum and 48 inches (1220 mm) maximum above the floor.</p> <p>Notes:</p>

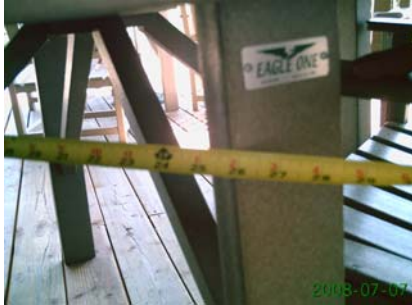
- Item # 25
- Issue: Table Accessibility – (Clear Width Under Table)
- Issue:
- Location: South Club House Patio
- Code:
- ANSI 902.1 General. Accessible dining surfaces and work surfaces shall comply with Section 902.

<p>Notes: Width for knee clearance under deck tables was only 25". Clearance should be 30". An adequate number of tables should be acquired for each deck section that meets code as listed below.</p> <p>ANSI 902 Dining Surfaces and Work Surfaces</p>
--	--

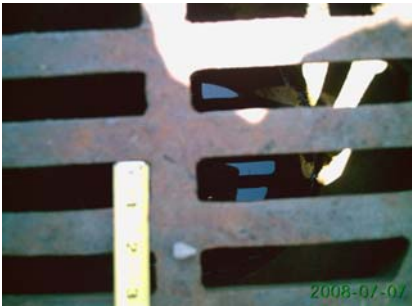
<p>Item # 26</p> <p>Issue: Floor Openings – Drain Grates</p> <p>Issue:</p> <p>Location: Drain grate on lower level west side of clubhouse.</p> <p>Code: ANSI 302.3 Openings. Openings in floor surfaces shall be of a size that does not permit the passage of a ½ inch (13 mm) diameter sphere, except as allowed in Sections 407.4.3, 408.4.3, 409.4.3, 410.4, and 805.10. Elongated openings shall be placed so that the long dimension is perpendicular to the dominant direction of travel.</p> <p>Notes: Width of drain grate is 1". Maximum allowable is ½"</p>
---	--

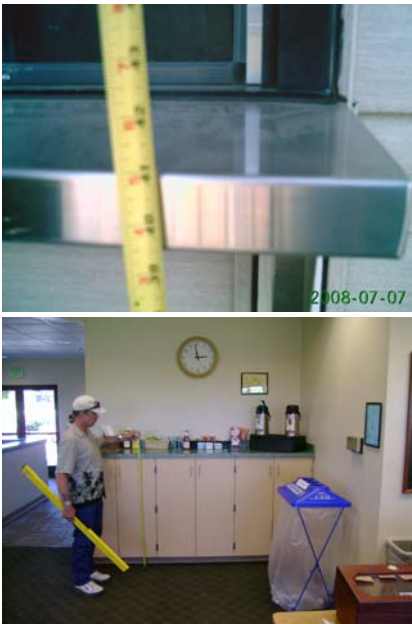
<p>Item # 27</p> <p>Issue: Service Counter Height</p> <p>Issue:</p> <p>Location: Exterior east side service counter (41")  Restaurant service counters on west (46")  Restaurant service counter on east end (47.5")  Golf sales counter exceeds 36 inches. (Portion of counter shall be 36 inches in height and 36 inches in length)</p> <p>Code: 904.5 Food Service Lines. Counters in food service lines shall comply with Section 904.5.  904.5.1 Self-Service Shelves and Dispensing Devices. Self-service shelves and dispensing devices for tableware, dishware, condiments, food and beverages shall comply with Section 308.  308.3 Side Reach.  308.3.1 Unobstructed. Where a clear floor space allows a parallel approach to an element and the side reach is unobstructed, the high side reach shall</p>
--	--

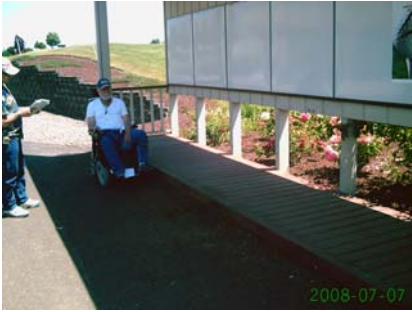
<p>Item #      28</p> <p>Issue:      No Ramp Access to Score Board Platform</p> <p>Issue:</p> <p>Location:    Score Board South of Clubhouse</p> <p>Code:      ANSI 401.1 Scope. Accessible routes required by the scoping provisions adopted by the administrative authority shall comply with the applicable provisions of Chapter 4.</p> <p>              ANSI 402 Accessible Routes</p> <p>              ANSI 402.1 General. Accessible routes shall comply with Section 402.</p> <p>              ANSI 402.2 Components. Accessible routes shall consist of one or more of the following components:</p>
---	---

<p>Walking surfaces with a slope not steeper than 1:20, doors and doorways, ramps, curb ramps excluding the flared sides, elevators, and platform lifts. All components of an accessible route shall comply with the applicable portions of this standard.</p> <p>Notes: The score board is a program available at the golf course that needs to be accessible. Currently there is no ramp to the scoreboard platform. Ramps must be constructed on both ends as the platform is only 48" wide and does not provide the required space to turn a wheelchair around. Also, the ramp on the east end of the platform should be constructed to pass over the drain as the grates in the drain exceed the ½" width requirement. (Currently, drain grates are 1" wide.)</p>
--	--

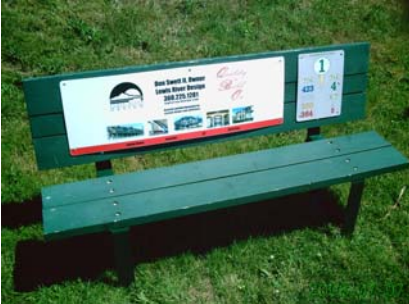
<p>Item # 30</p> <p>Issue: Accessible Benches</p> <p>Issue:</p> <p>Location: Throughout Course</p> <p>Code: ANSI 903.1 General. Accessible benches shall comply with Section 903.</p> <p>ANBSI 903.2 Clear Floor Space. A clear floor space complying with Section 305, positioned for parallel approach to an end of the bench seat, shall be</p>
---	--

<p>provided.</p> <p>ANSI 903.3 Size. Benches shall have seats 42 inches (1065 mm) minimum in length, and 20 inches (510 mm) minimum and 24 inches (610 mm) maximum in depth.</p> <p>ANSI 903.4 Back Support. The bench shall provide for back support or shall be affixed to a wall. Back support shall be 42 inches (1065 mm) minimum in length and shall extend from a point 2 inches (51mm) maximum above the seat surface to a point 18 inches (455 mm) minimum above the seat surface. Back support shall be 21/2 inches (64 mm) maximum from the rear edge of the seat measured horizontally.</p> <p>ANSI 903.5 Height. The top of the bench seat shall be 17 inches (430 mm) minimum and 19 inches (485 mm) maximum above the floor, measured to the top of the seat.</p> <p>ANSI 903.6 Structural Strength. Allowable stresses shall not be exceeded for materials used where a vertical or horizontal force of 250 pounds (1112 N) is applied at any point on the seat, fastener mounting device, or supporting structure.</p> <p>ANSI 903.7 Wet Locations. Where provided in wet locations the surface of the seat shall be slip resistant and shall not accumulate water.</p> <p>Notes: All benches within the complex should be examined for accessibility</p>

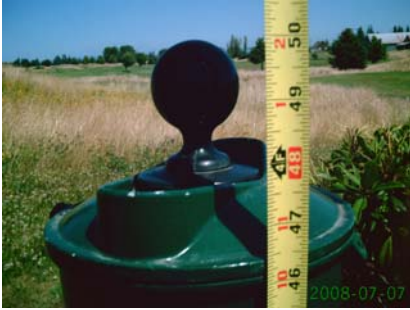
Item # 31  
Issue: Ball Washer Height and Accessibility  
Issue:  
Location: Throughout Course  
Code: ANSI 308.2.1 Unobstructed - Where a forward reach is unobstructed, the high forward reach shall be 48 inches (1220 mm) maximum and the low forward reach shall be 15 inches minimum above the floor.  
Notes: All ball washers should be checked for height accessibility.  
Grasping surface shall be no higher than 48 inches.  
Ball washers should be acquired that do not require grasping of the handle to operate the device or an alternate means of providing this service should be researched

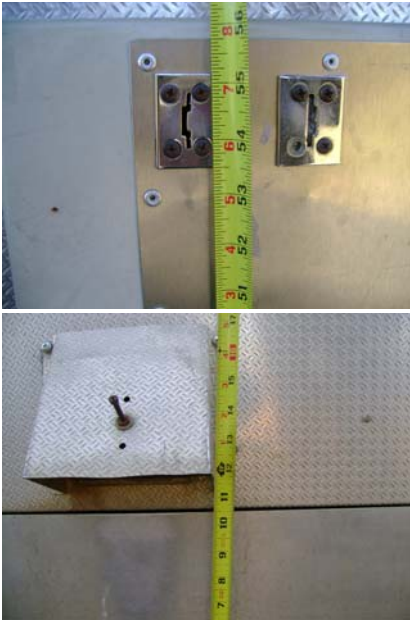
Item # 32  
Issue: Range Ball Servant  
Issue:  
Location: Driving Range  
Code: 308.3.1 Unobstructed. Where a clear floor space allows a parallel approach to an element and the side reach is unobstructed, the high side reach shall be 48 inches (1220 mm) maximum and the low side reach shall be 15 inches (380 mm) minimum above the floor.  
EXCEPTION: Existing elements shall be permitted at 54 inches (1370 mm) maximum above the floor.  
Notes:

- Coin deposit is 54" high.
- Golf ball dispenser is 11.5" above ground surface

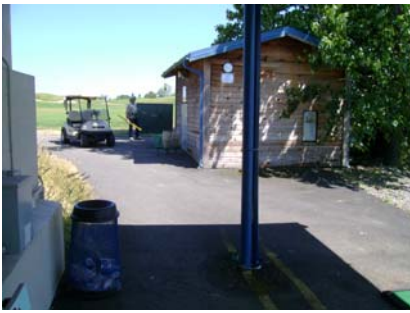
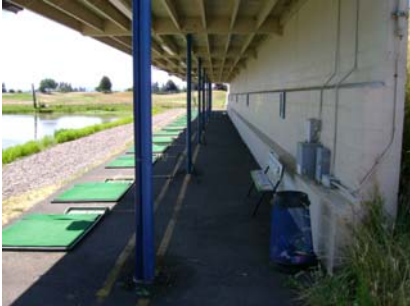
Item # 33

Issue: Driving Range Accessibly

Notes: The following observations were made regarding lack of accessibility to the golf range. Recommendations for improvements are offered. Golf cart access and parking needs to be provided. It is recommended the area east of the golf ball service building be leveled and paved to provide room to park two accessible golf carts. Also, the area should be of sufficient size to permit cart maneuverability. At least two tees on the east end of the range should be altered to provide access to accessible golf carts whereupon the disabled individual can access the tee while seated in the golf cart. This may necessitate paving the area in front of the tees to provide sufficient room to drive the cart out of the range area and back to the pathway. This alteration may result in the loss of a tee station.
