ADA Compliance Program

Clark County Facilities Transition Plan Public Works Operations Center

Date of Survey: November 5, 2007 and December 6, 2007

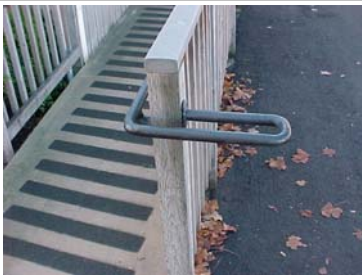
<p>Item # 5</p> <p>Issue: Handrail Extension</p> <p>Issue:</p> <p>Location: Conference center North side ramp</p> <p>Code: ANSI 505.10 Handrail Extensions – Handrails shall extend beyond and in the same direction of stair flights and ramp runs in accordance with Section 505.10. Exception – In alterations, full extensions of handrails shall not be required where such extensions would be hazardous due to plan configurations.</p> <p>Notes: Construct handrail to extend beyond and in same direction of ramp run. (Minimum - One side of ramp)</p>

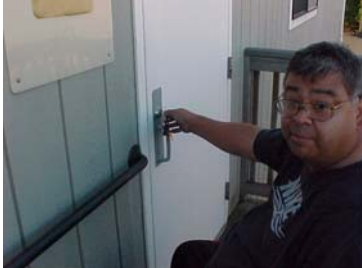
<p>Item # 6</p> <p>Issue: Inability to open door with a closed fist</p> <p>Issue:</p> <p>Location: Public entrance (North side) Conference Center</p> <p>Code: ANSI 309 Operable Parts; 309.4 Operation – Operable parts shall be operable with one hand and shall not require tight grasping, pinching, or twisting of the wrist. The force required to activate operable parts shall be 5.0 pounds (22.2 N) maximum.</p> <p>Notes: Also, this door requires the operator to simultaneously push the locking device while pulling the door to open. Replace existing handle with lever action handle.</p>

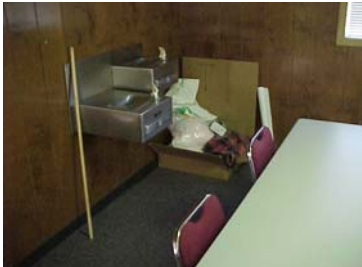
<p>Item # 7</p> <p>Issue: Clear floor space- Drinking Fountain</p> <p>Issue:</p> <p>Location: Conference Center</p> <p>Code: ANSI section 602 Drinking Fountains – ANSI 602.2 Clear Floor Space – A clear floor space complying with Section 305, positioned for a forward approach to the drinking fountain, shall be provided. ANSI Section 305 Clear Floor Space – Section 305.3 Size - The clear floor space shall be 48 inches minimum in length and 30 inches minimum in width.</p> <p>Notes: There is only 30" clearance (length) between table and drinking fountain. Move table as needed to provide necessary space for accessibility to drinking fountain.</p>

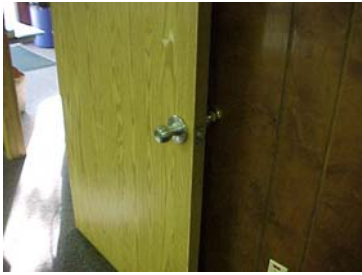
<p>Item # 8</p> <p>Issue: Inability to open door with a closed fist</p> <p>Issue:</p> <p>Location: Interior conference center door</p> <p>Code: ANSI 309 Operable Parts; 309.4 Operation – Operable parts shall be operable with one hand and shall not require tight grasping, pinching, or twisting of the wrist. The force required to activate operable parts shall be 5.0 pounds (22.2 N) maximum.</p> <p>Notes: Replace existing handle with lever action handle.</p>

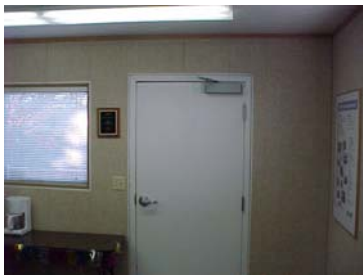
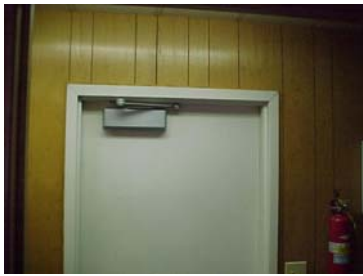
Item # 13
Issue: Signage - No exit signs
Issue:
Location: Two interior exit doors from small conference room
Code:
Notes: ANSI 1011.3 Tactile Exit Signs – A tactile exit sign stating EXIT and complying with ICC A117.1 shall be provided adjacent to each door to an egress stairway, an exit passageway and the exit discharge.
