# Americans with Disabilities Office General Services Department

## Accessibility Survey

**Date: July 2, 2010**

**Location: 13<sup>th</sup> Street between Courthouse and Public Service Center**

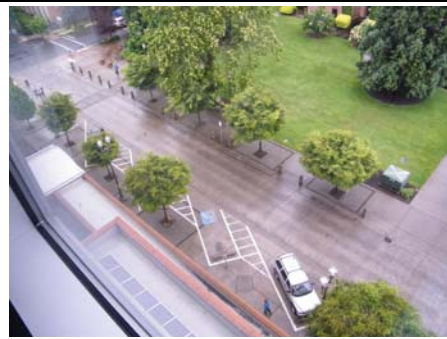
### Item 1

Issue: Accessible Route – Not clearly identified

Code IBC 1104.1 Site arrival points – Accessible routes within the site shall be provided from public transportation stops, accessible parking and accessible passenger loading zones and public street or sidewalks to accessible building entrance.

Code IBC 1104.3 Connected Spaces – when a building, or portion of a building, is required to be accessible, an accessible route shall be provided to each portion of the building, to accessible building entrances connecting accessible pedestrian walkways and the public way.

Code IBC 1104.5 Location – Accessible routes shall coincide with or be located in the same area as a general circulation path.

Recommendation: See Item 2

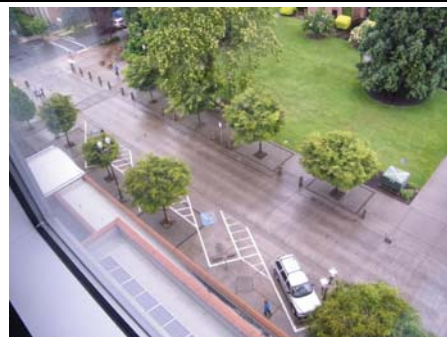
### Item 2

Issue: No demarcation between sidewalk and street. No curbs. Sidewalk is flush with street.

Code: IBC 1102

Accessible Route – a continuous, unobstructed path that complies with Chapter 11

Circulation Path – An exterior or interior way of passage from one place to another for pedestrians

Detectable Warning – a standardized surface feature built in or applied to walking surfaces or other elements to warn visually impaired persons of hazards on a circulation path.

Recommendation:

Install barriers between bollards to prevent crossing of street at non-designated areas. Install additional bollards and barriers where required.

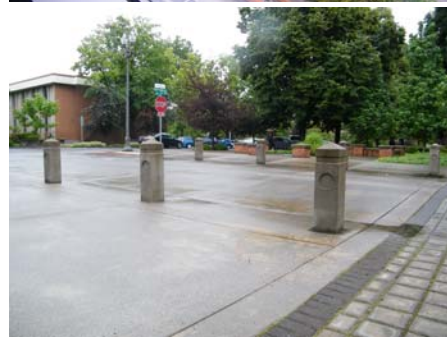
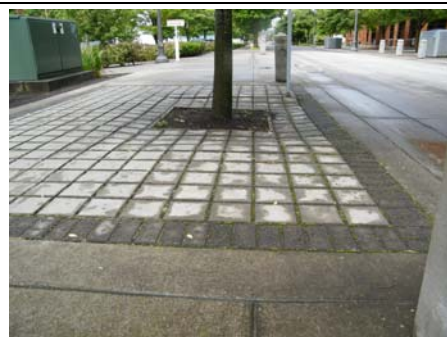
### Item 3

Issue: Pavers – Trip Hazard

Pavers sink and rise due to settling or movement by tree roots and become trip hazards.

Code: ANSI 302.1 Floor Surfaces – Floor surfaces shall be stable, firm and slip resistant, and shall comply with Section 302.

<p>Recommendation:</p> <p>Remove pavers and replace with solid floor (concrete) paved surface.</p>

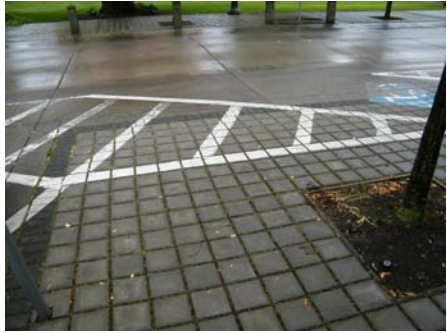
<p><b>Item 4</b></p> <p>Issue: No detectible warnings at head of parking access aisles.</p> <p>Code: IBC- Section 1102 – Detectable Warnings – A standardized surface feature built in or applied to walking surfaces or other elements to warn visually impaired persons of hazards on a circulation path.</p> <p>Recommendation:</p> <p>Install detectible warnings where required</p>

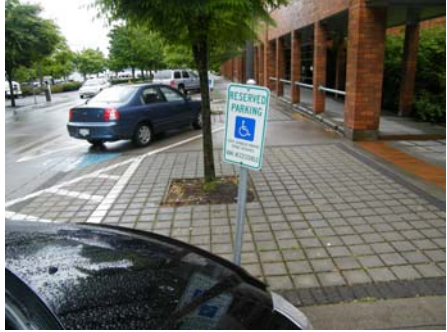
<p><b>Item 5</b></p> <p>Issue: Sign height</p> <p>Code: ANSI 502.7 Identification: Where accessible parking spaces are required to be identified by signs, the signs shall include the International Symbol of Accessibility complying with Section 703.6.3.1.</p> <p>Signs identifying van parking spaces shall contain the designation "van accessible." Such signs shall be 60 inches (1525 mm) minimum above the floor of the parking space, measured to the bottom of the sign.</p> <p>Recommendations: Correct sign height as required</p>

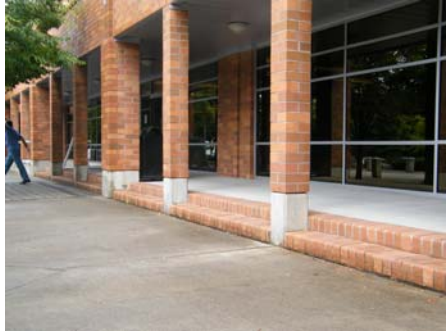
<p><b>Item 6</b></p> <p>Issue: No hand rails on steps – South side of the Public Service Center</p> <p>Code: ANSI 505.2 Location - Handrails shall be provided on both sides of stairs and ramps.</p> <p>Code: ANSI 505.6 Gripping Surface. Gripping surfaces shall be continuous, without interruption by newel posts, other construction elements, or obstructions.</p> <p>Recommendations: Install handrails as required</p>

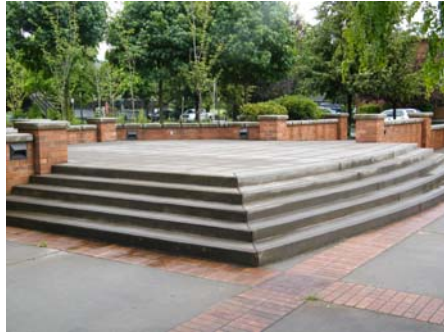
### **Item 7**

Issue: No hand rails on steps to stage - East side of the Public Service Center

Code: ANSI 505.2 Location - Handrails shall be provided on both sides of stairs and ramps.

Code: ANSI 505.6 Gripping Surface. Gripping surfaces shall be continuous, without interruption by newel posts, other construction elements, or obstructions.

Recommendations: Install handrails as required

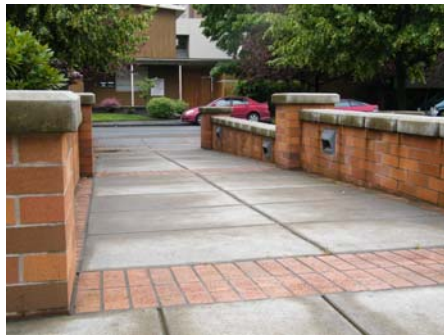
### **Item 8**

Issue: No hand rails on ramp to stage - East side of the Public Service Center

Code: ANSI 505.2 Location - Handrails shall be provided on both sides of stairs and ramps.

Code: ANSI 505.6 Gripping Surface. Gripping surfaces shall be continuous, without interruption by newel posts, other construction elements, or obstructions.

Recommendations: Install handrails on both sides of ramp as required
