S8.C.3 Effectiveness Monitoring

Final Report

Prepared by
Clark County Department of Public Works
Clean Water Division
December 2017

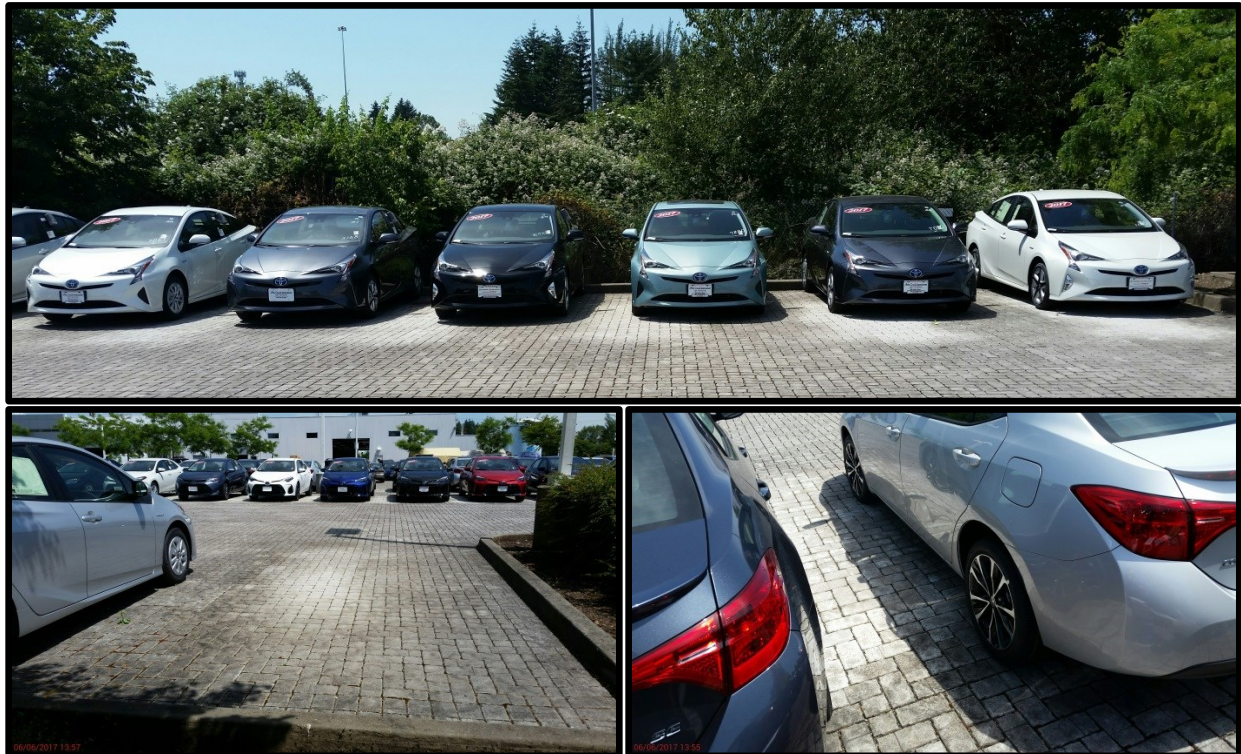
Two conditions noted by field staff could indicate unanticipated effects from the maintenance practices:

- New and used vehicles are frequently moved to rearrange the stock of vehicles for sale. However, replacement vehicles are often parked in or near the previously occupied parking spaces. The relatively continuous, near-complete shading under the vehicles may help to deter moss growth between the pavers in some areas.
- Distinct patterns of lighter-colored pavers with little inter-paver moss are apparent in several parking areas used for vehicle sales (Figure 13). While the cause is unknown, the condition may be due to the pavement surface being unintentionally exposed to pressure-washing as the vehicles are cleaned.

Figure 13. Examples of white appearance on pavers near new vehicles

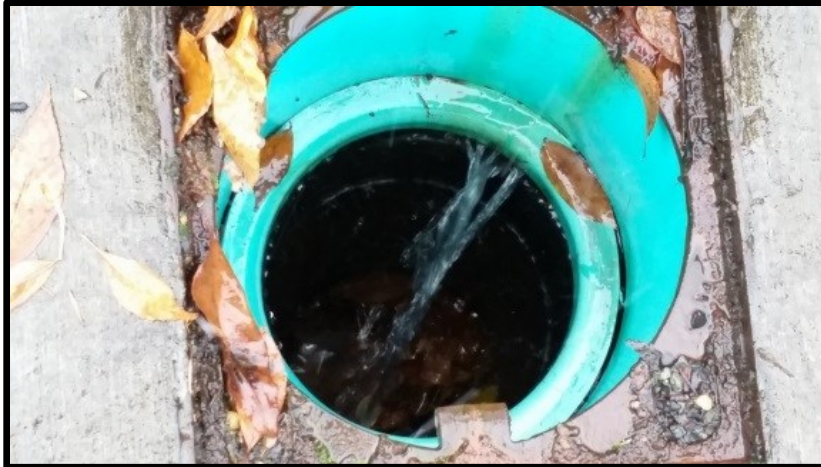
No surface runoff left the parking lot via the field inlets over the course of the study. In a few cases, a small amount of infiltrated water stored in the subbase appears to have seeped into the conveyance pipes and drained to the monitoring vault. Figure 15 shows infiltrated water seeping into the conveyance system during one of these times. Figure 16 depicts the minimal overall seepage into the field inlet conveyance system and the unusual December 2015 peak.

Figure 15. Close-up image of subsurface seepage under a south curb inlet between green reducer and black vertical pipe (taken during heavy rain event on 10/22/2014)

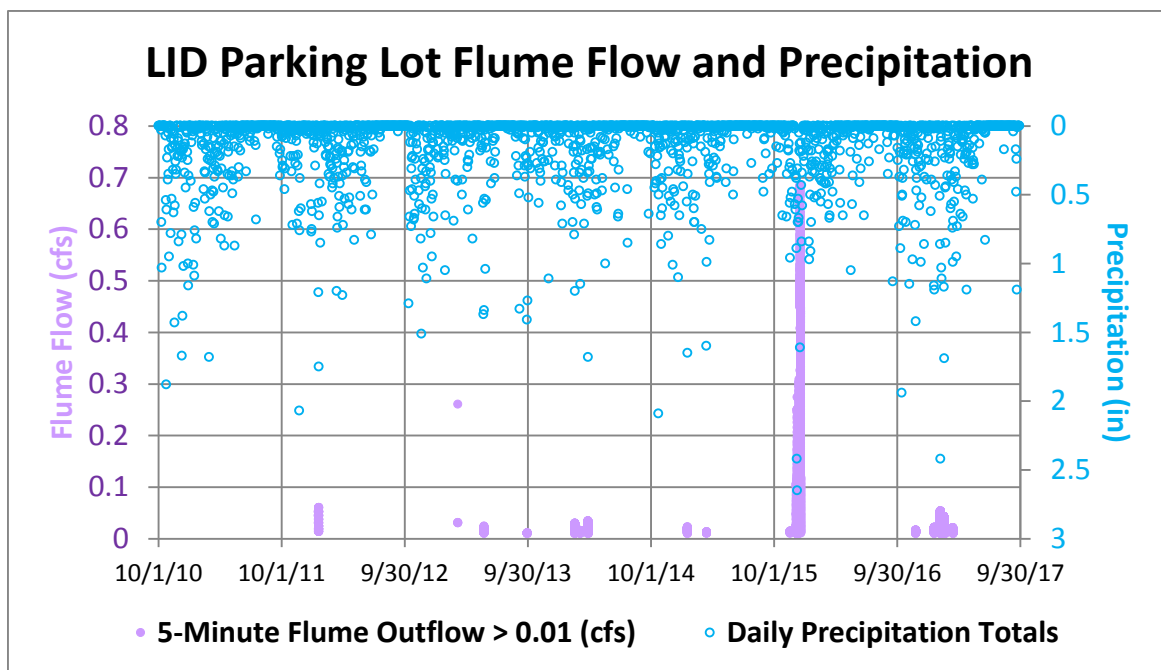
Figure 16. Monitoring vault flume 5-minute interval outflow and daily total precipitation WY2011-2017

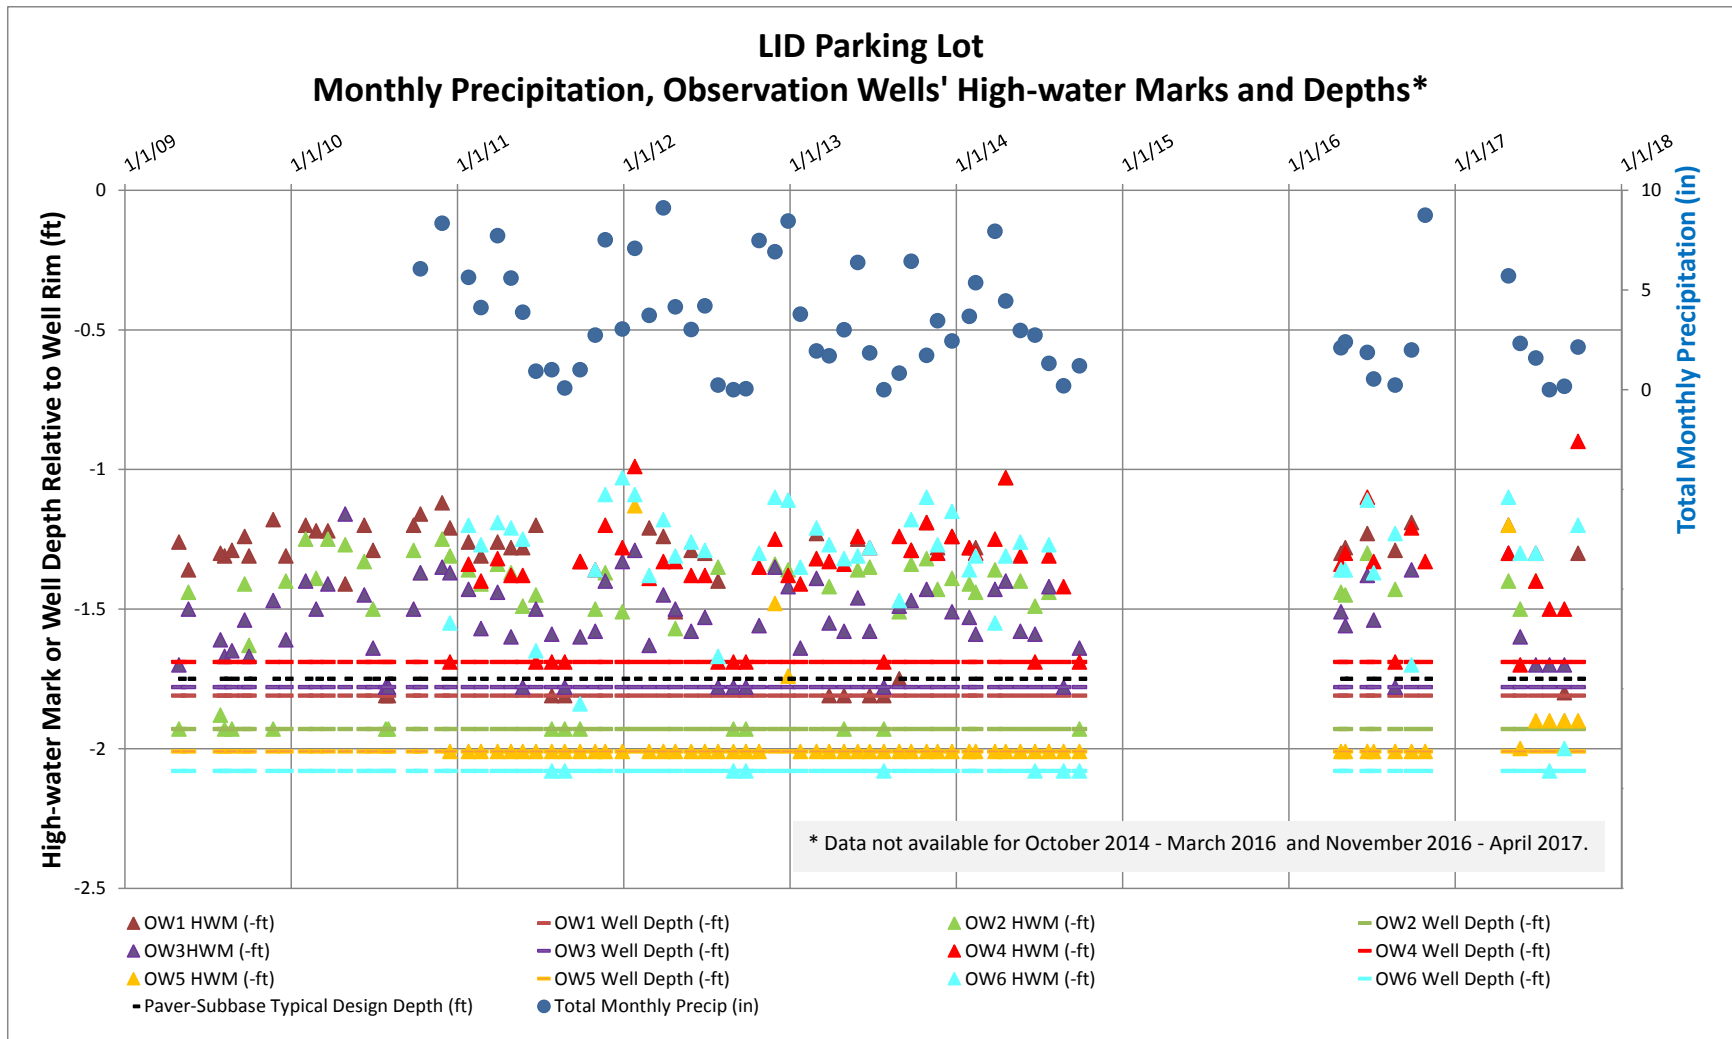
Observation well high-water marks generally paralleled the seasonal precipitation pattern but remained well below the pavers. As expected, peak high-water marks occurred during the winter with much lower marks measured during the summer, often at the bottom of a well. Figure 17 shows observation well depths, measured subsurface water heights, and monthly rainfall during the study. Across all six observation wells, the high-water marks always remained at least one foot below the paver surface except for a single measurement slightly less than one foot in well #4. These measurements indicate that the stone filled subbase performed as designed.

Figure 17. Monthly precipitation, observation well high-water marks (e.g., OW#1-6HWM) and well depths

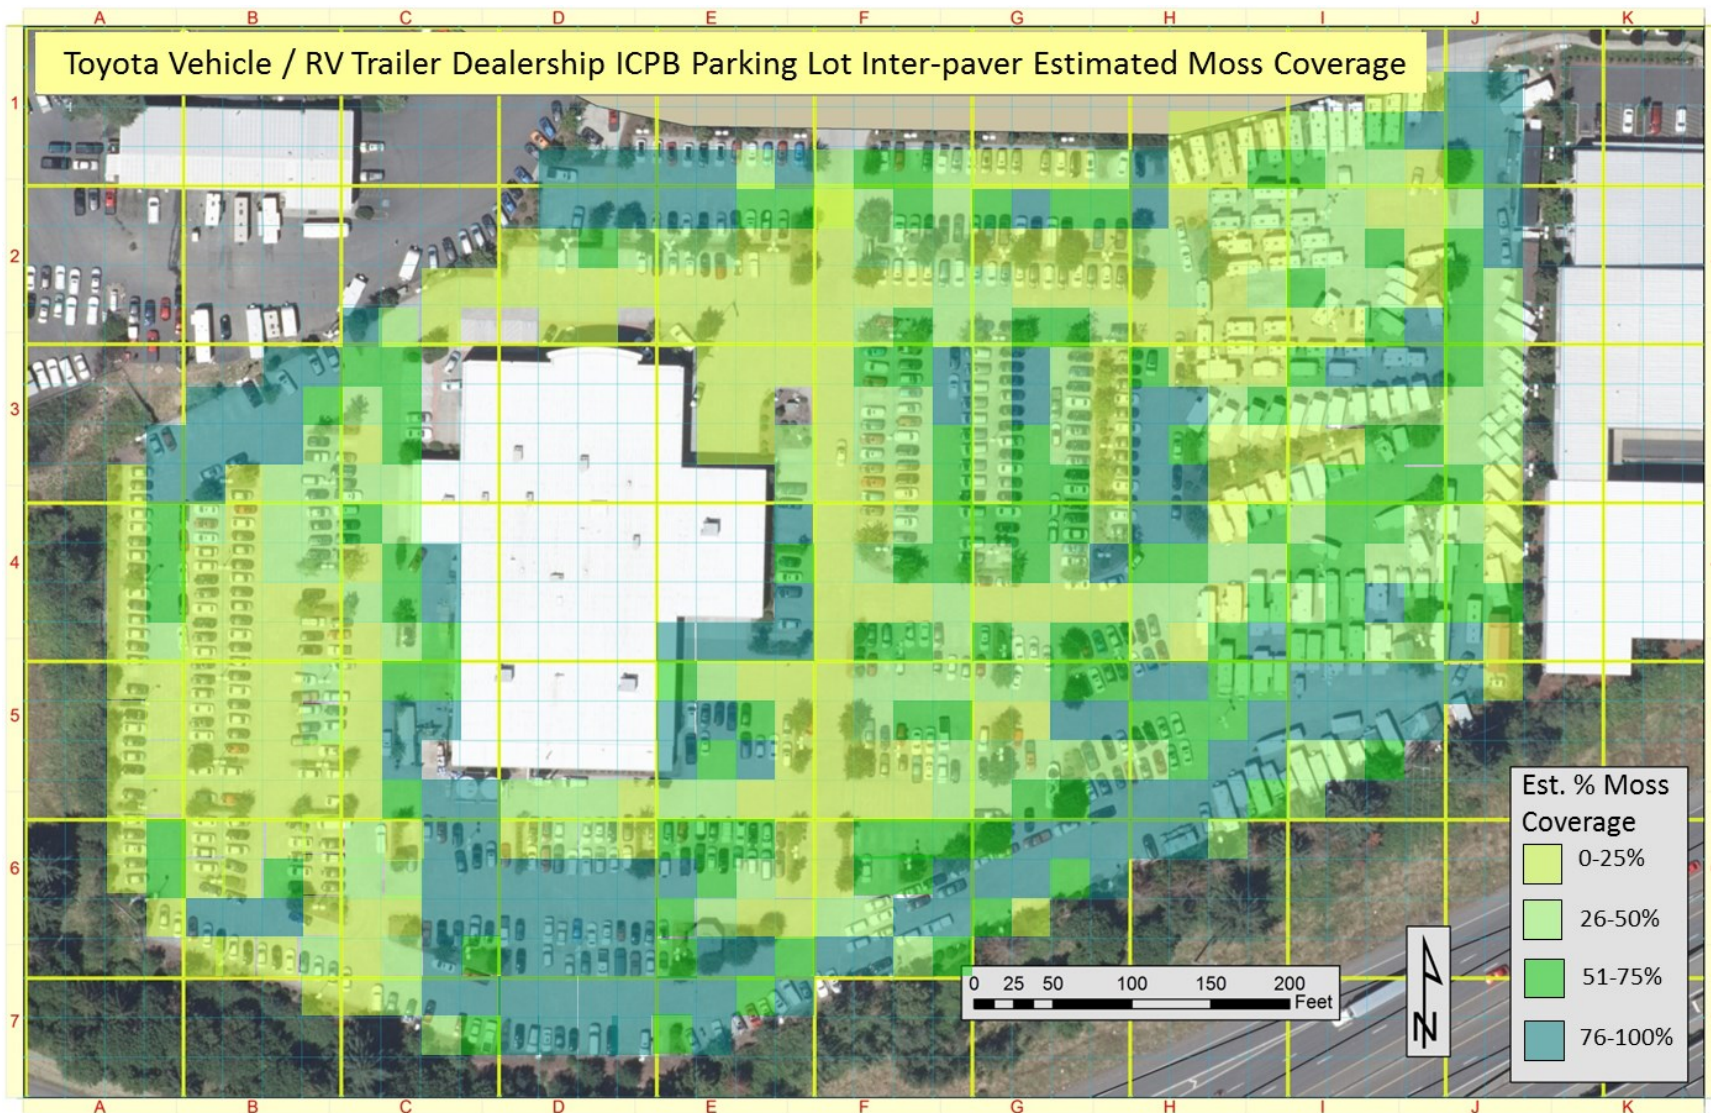
Visual estimates of inter-paver moss coverage varied considerably across the site. Figure 18 shows the spatial distribution of estimated inter-paver moss cover by quartiles. Larger areas of contiguous high moss coverage tended to occur along or near the southern boundary and to a lesser extent along the northwestern and northern boundaries. The trailer parking area in the eastern third of the lot also tended to have more inter-paver moss coverage. Low moss coverage areas were most prevalent in the western new vehicle parking area where frequent vehicle cleaning occurs and in the more heavily traveled primary traffic flow areas. The site's moss coverage pattern may be due to relative amounts of traffic, shading, prolonged damp conditions, and organic input from nearby trees. Overall, since the earlier study, moss growth in much of the newer Phase 2 area appears to have caught up with the Phase 1 area.

Figure 18. LID parking lot's estimated average inter-paver percent moss coverage within 25-foot grid areas

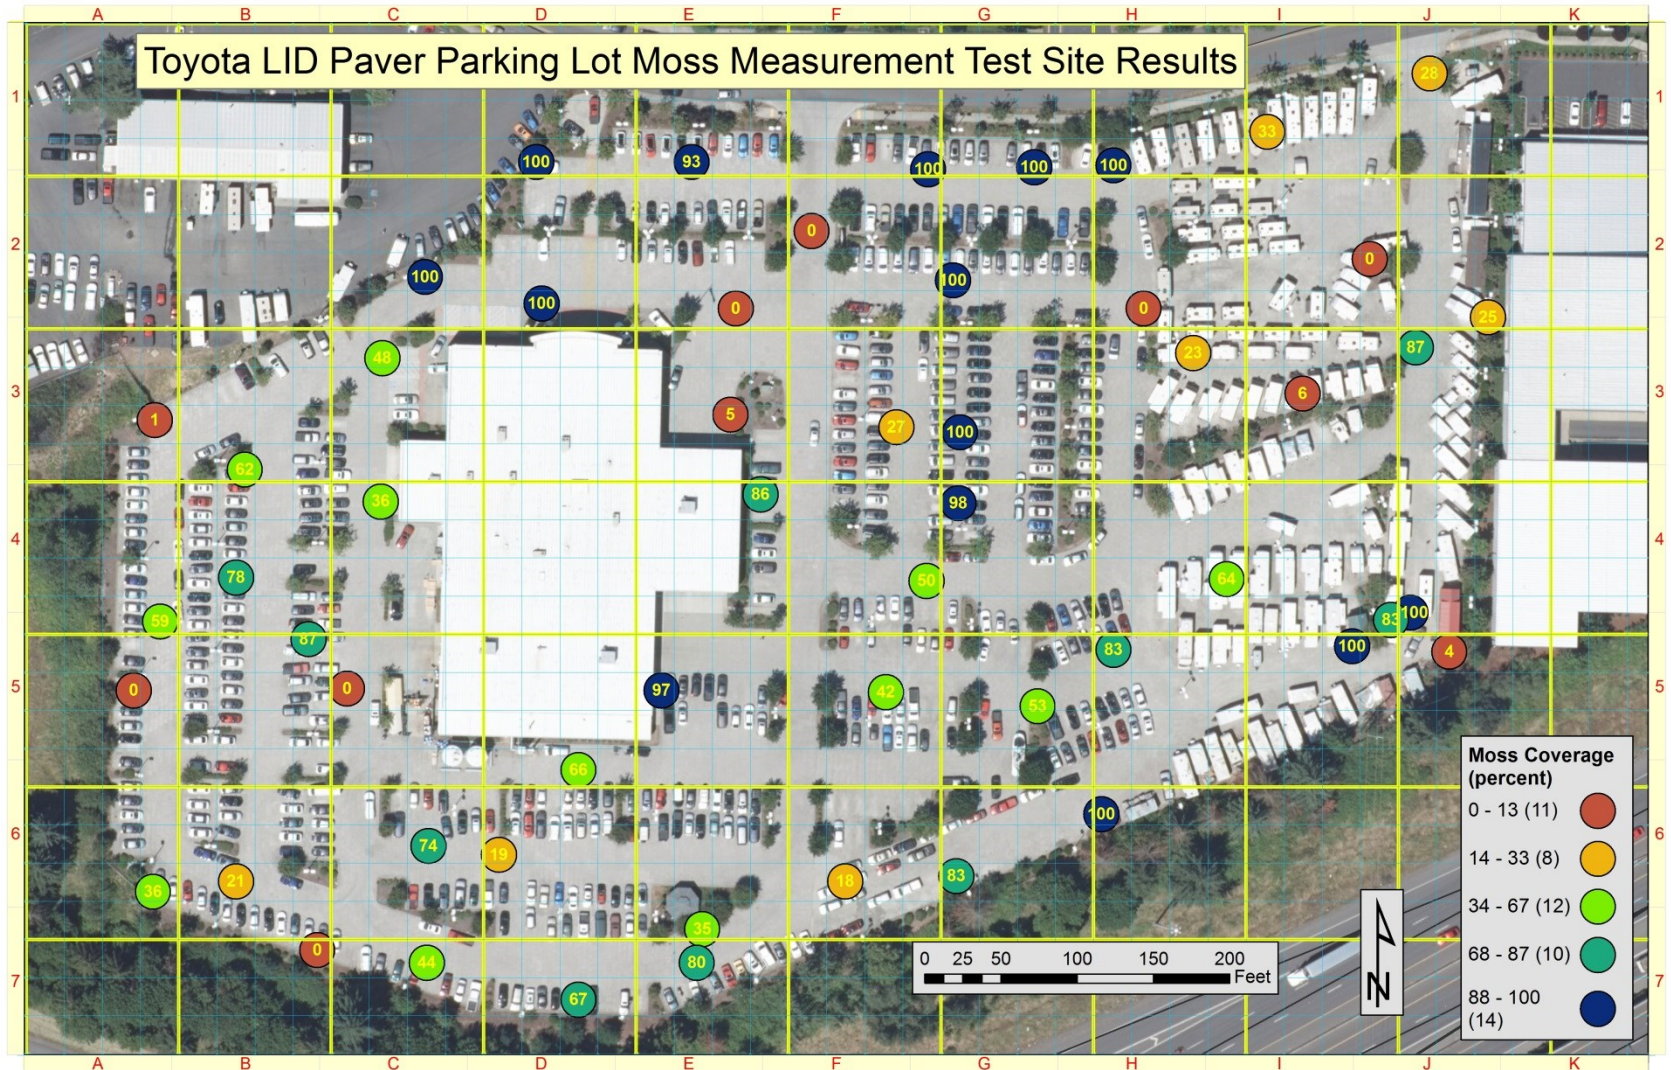
Figure 19 shows the measured percentages of inter-paver moss coverage. Measured moss coverage across the parking lot was highly variable but generally tended to be the lowest in isolated spots along the southwestern border, the heavy traffic areas between the entrance and vehicle service bay entrance (northeast of building), and the northern part of the recreational vehicle trailer area. Conversely, the highest moss coverages were measured in the northern half of the new vehicle parking area with slightly lower moss coverages closer to the southern tree border. This overall pattern for the measured moss is generally consistent with that of the visually estimated moss coverage.

Figure 19. Inter-paver moss measurement results

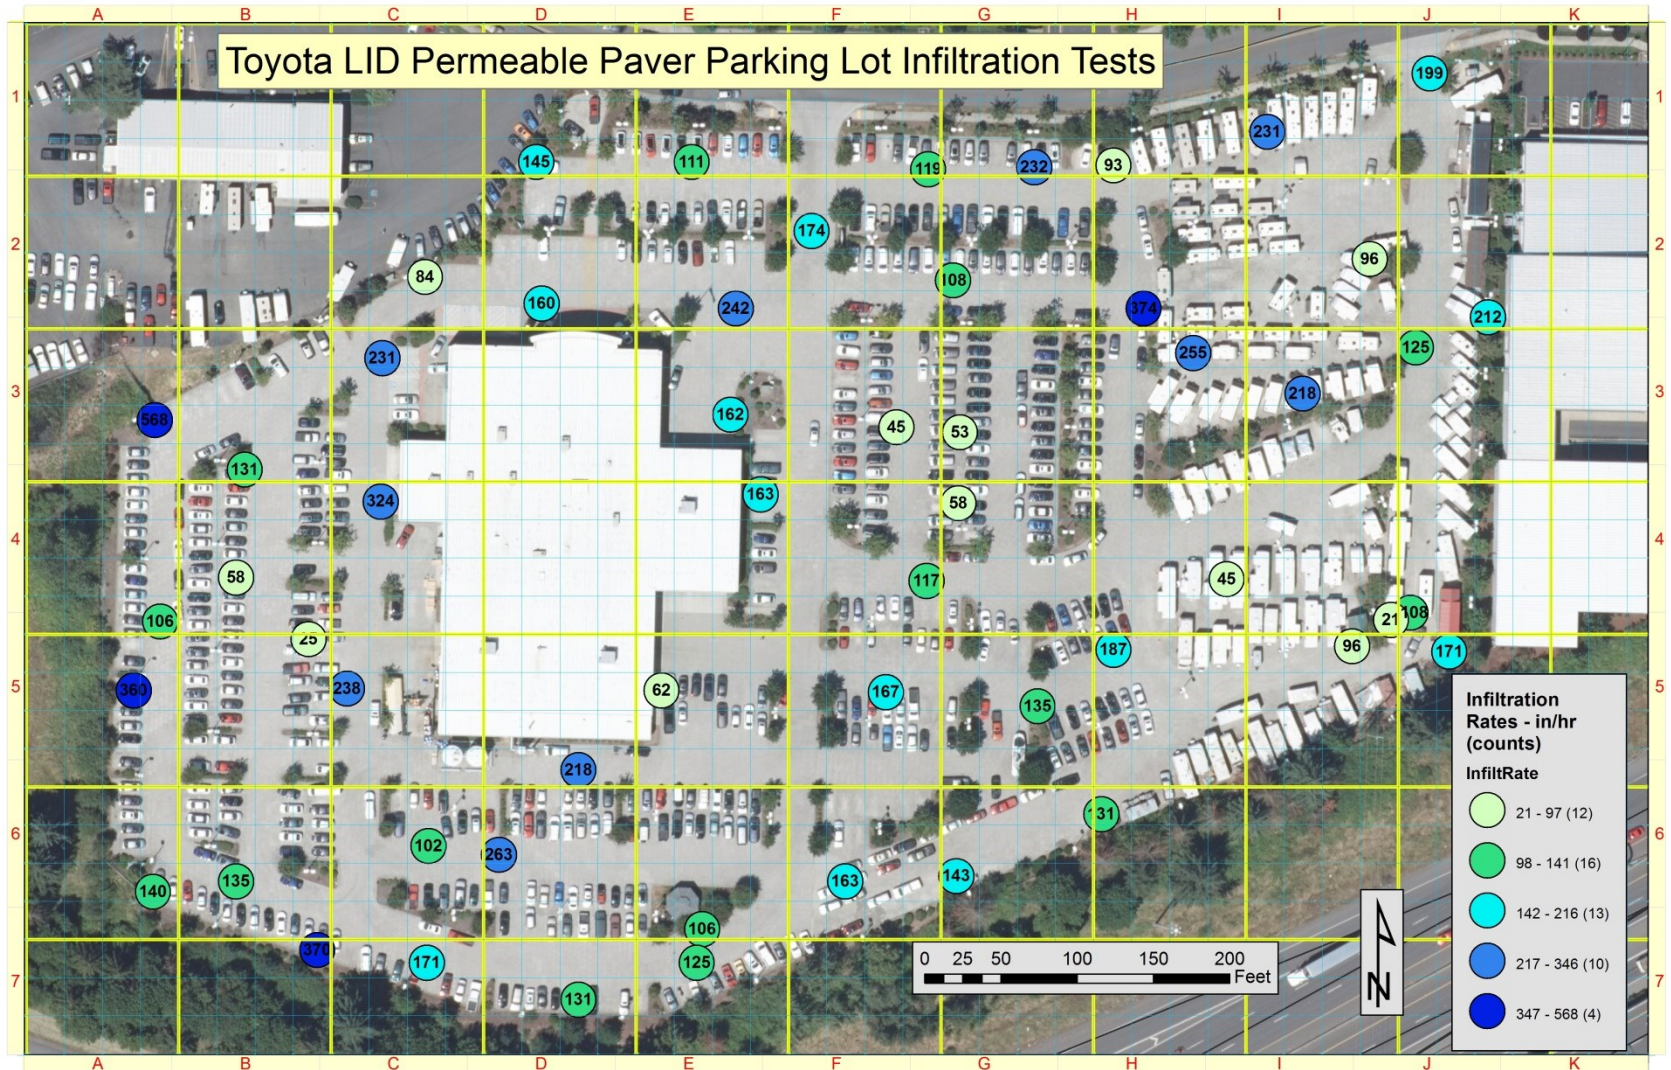
Figure 20 shows the measured infiltration rates for the same fifty-five sites. The overall infiltration rate pattern tends to mirror the pattern of measured inter-paver moss coverage. Many of the highest infiltration rates along the southwest border, northeastern trailer, and to a lesser extent the north central high traffic areas coincide with the lowest measured moss coverages. Conversely, many of the lowest measured infiltration rates coincide with the highest measured moss coverages in the center of the eastern new / used vehicle and southeast trailer parking areas.

Figure 20. Infiltration test results

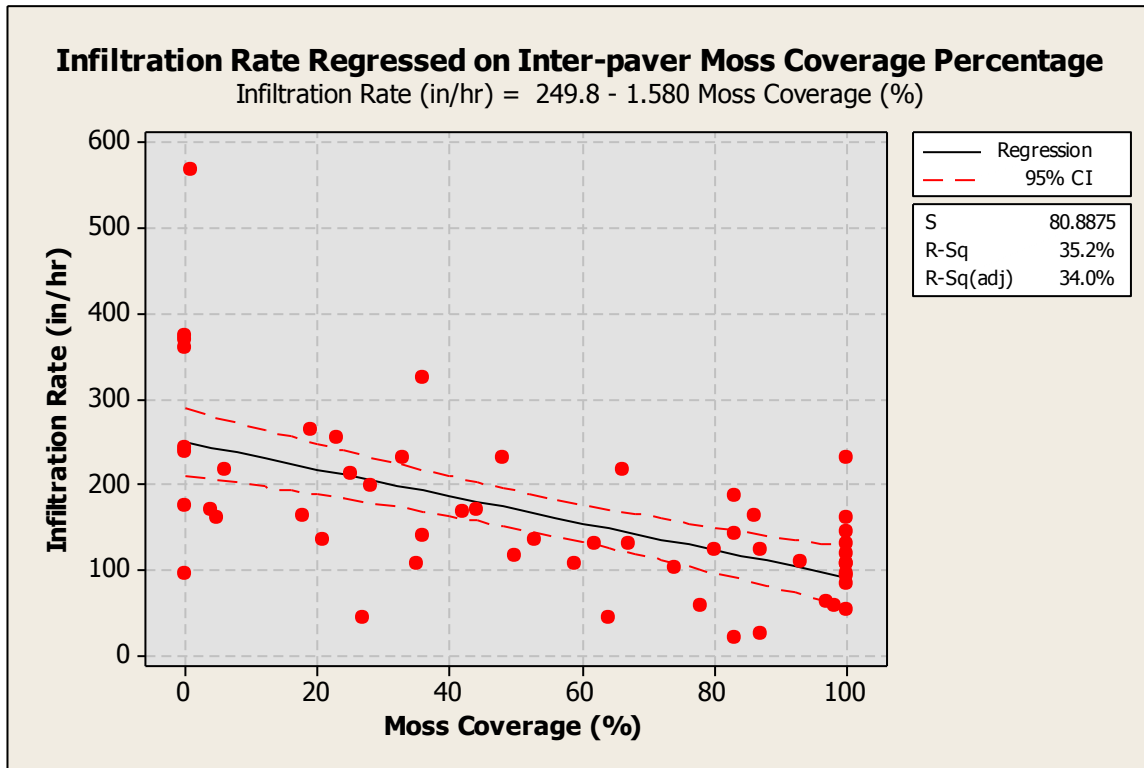
Figure 21 depicts the significant inverse linear relationship (negative slope of 1.58 and p-value of 0.00) found between pairs of measured infiltration and inter-paver moss coverage. The R-Sq (R^2 or coefficient of determination) of 35.2% suggests this model fits the data moderately well and that 35 percent of the variation in infiltration rate is explained by the measured percent of moss coverage. Other tested variables, such as moss height and distance to larger trees bordering the parking lot, were found not to be significant explanatory variables for infiltration rates.

Figure 21. Measured infiltration rates regressed on inter-paver moss coverage

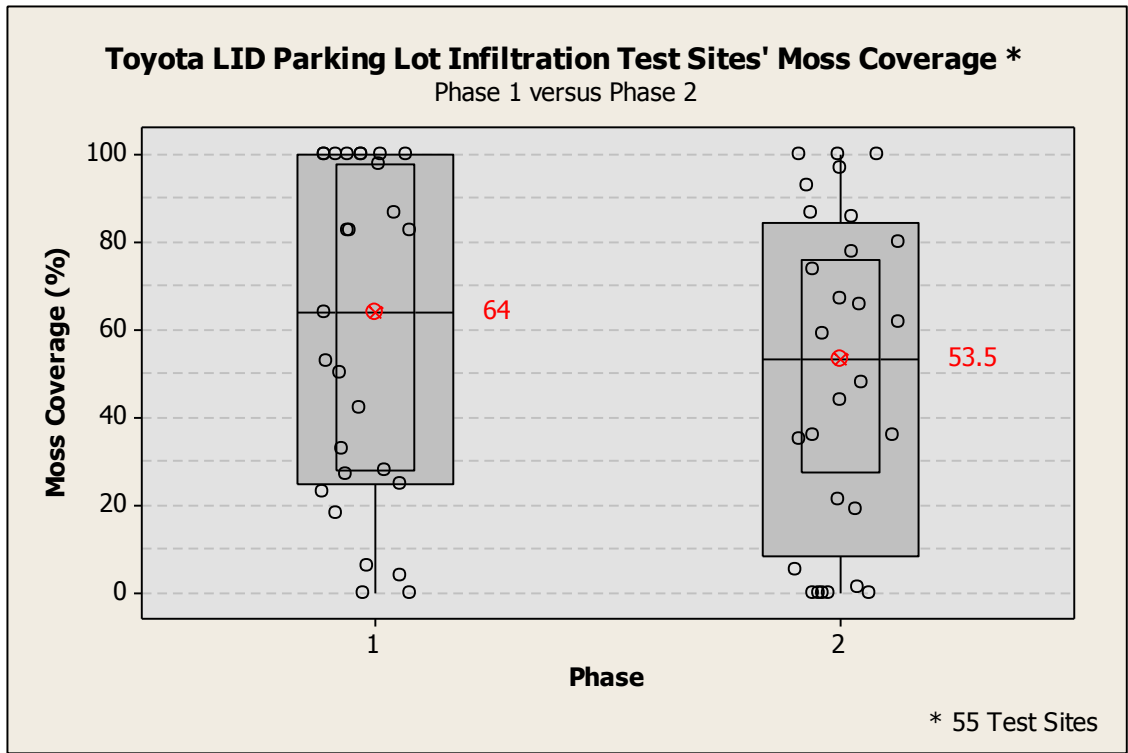
Boxplots in Figure 22 and Figure 23 compare values of moss coverage percentages and infiltration rates for phase 1 and phase 2 installations based on the fifty-five measured sites. The red values and inner boxes indicate, respectively, the median values and 95% confidence limits around the medians for each phase.

Median values for moss coverage and infiltration rates were not statistically different between the phases. However, the general pattern in the boxplots suggests moss may have affected infiltration rates to an increased extent in the older area.

Figure 22 LID parking lot phases 1 and 2 measured inter-paver moss coverage

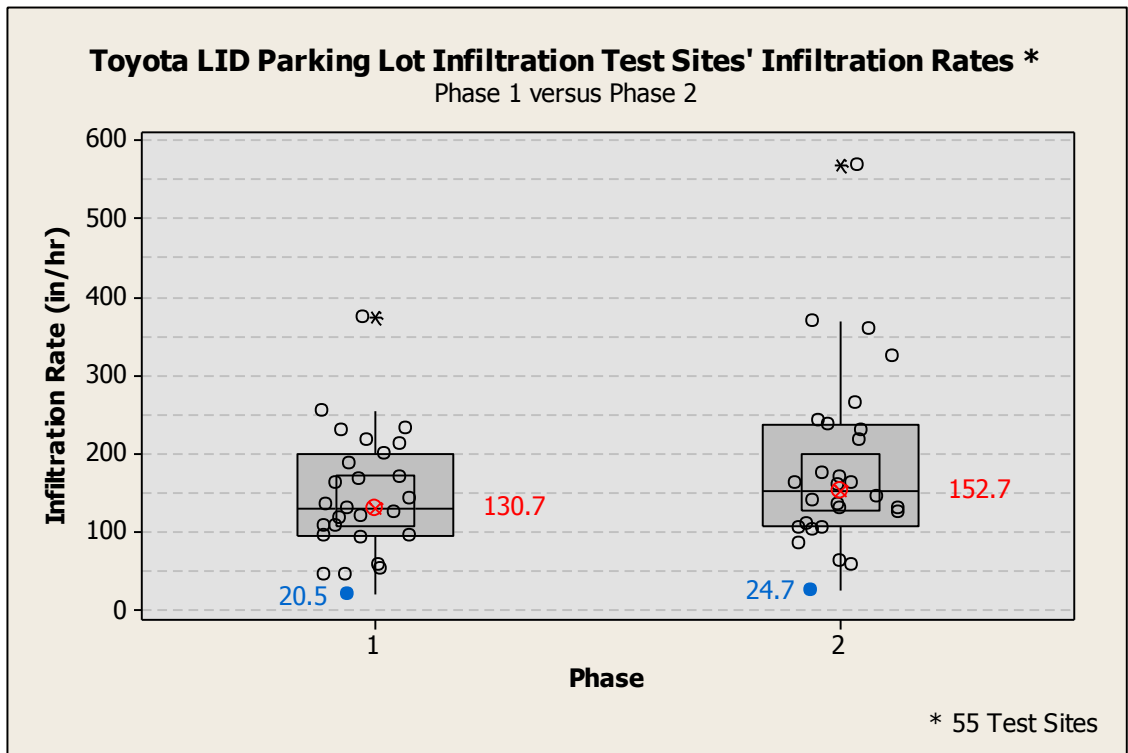
Figure 23 LID parking lot phase 1 and 2 measured inter-paver infiltration rates

Regardless of measured inter-paver moss coverage, even after seven to eight years of site operation, the minimum measured infiltration rates of 20.5 for phase 1 and 24.7 for phase 2 (blue dots in Figure 23) remain substantially higher than Ecology's Guidance maintenance standard action criterion of 10 inches per hour for ICPB. This was an unexpected result given the minimum of 4" per hour measured in the initial study. A more significant overall reduction in observed infiltration rates was anticipated as the facility matured. Due to the high rates of measured infiltration, we are not able to effectively evaluate the appropriateness of Ecology's 10 inches per hour guidance for corrective maintenance.

While median infiltration rates are not statistically different between the newer phase 2 and older phase 1, the difference in medians of 22 inches per hour (152.7 minus 130.7) does suggest decreasing infiltration over time based on the 18 month difference in their completion dates (April 2009 and October 2010).
