**CLARK COUNTY  
STAFF REPORT**

**REQUEST:** Accept and Approve the 2013 Annual Bridge Report.

# 2013 Annual Bridge Report

Prepared by the Clark County Public Works Engineering and Construction Division  
Submitted May 2014

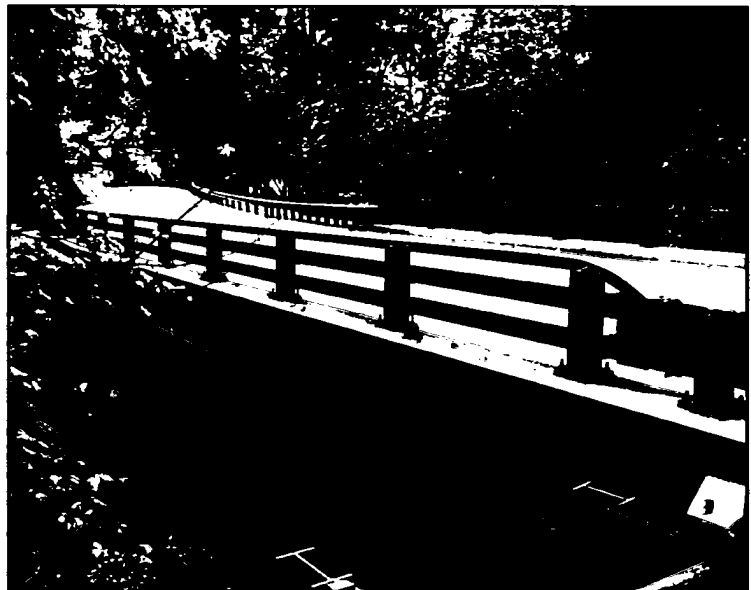
Cougar Creek Bridge No. 1409 completed in 2012.
