# **PROVIDENCE ACADEMY**

ADA AND DECK REPAIRS - 2020

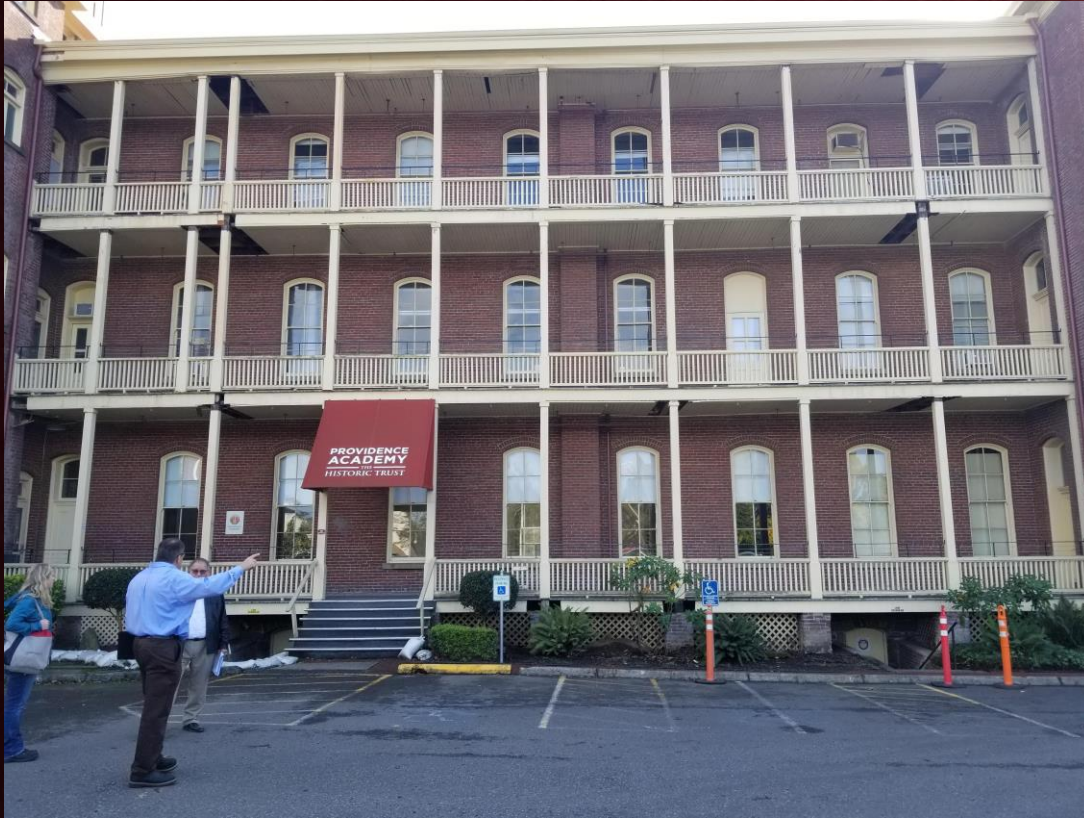
- MOST JOISTS CAN BE RETAINED (ROUGHLY 10% NEEDS REPLACED), BUT RETAINED JOISTS WILL BE STRENGTHEND AND CONNECTIONS IMPROVED.
- COLUMNS ARE IN VARYING STATES OF REPAIR. MOST WILL REQUIRE SOME REPAIR/REPLACEMENT.
- DECKING AND SOFFITS NEEDS TO BE REPLACED.
- SOME BRICK REPAIR.
- REPLACE RUBBLE FOOTINGS WITH STRUCTURALLY SOUND FOOTINGS.
  - FACE NEW FOOTINGS WITH SALVAGED BRICK, SIMILAR TO THE SOUTH BUILDING PROJECT.

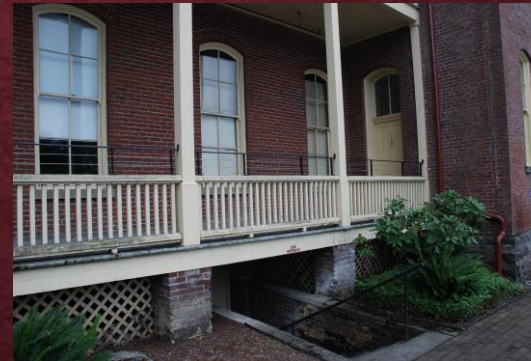
RETAINING WALL NEXT TO FOOTINGS WILL NEED TO BE REMOVED AND REPLACED.

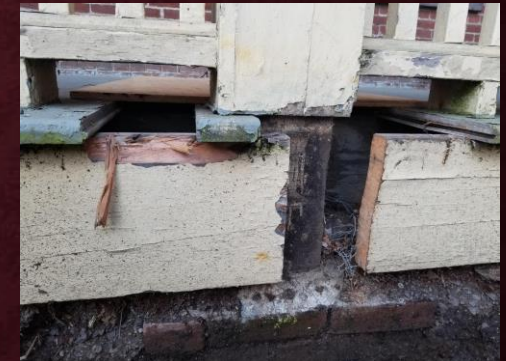
COLUMNS SIT ON DECKING AND ARE NOT INTERCONNECTED FLOOR-TO-FLOOR

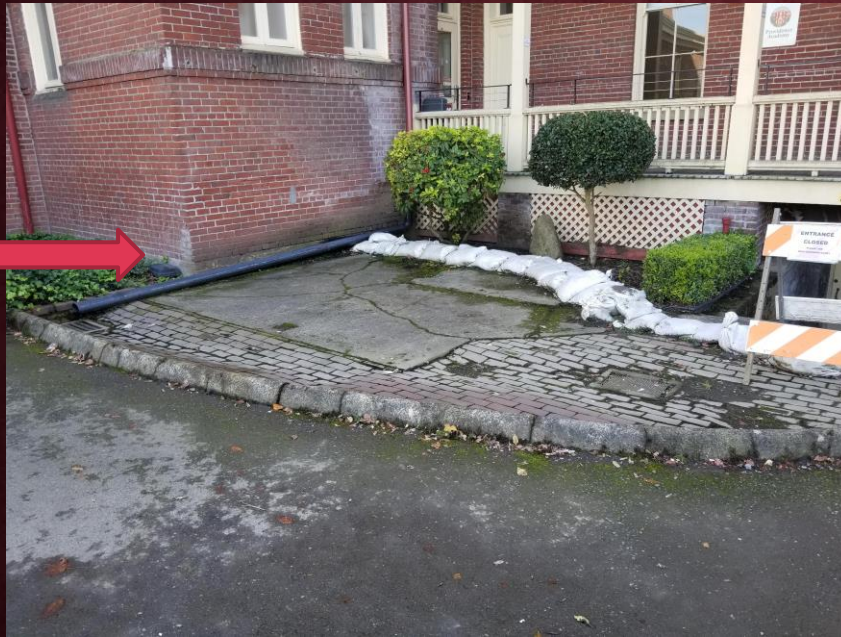
PROPOSED LOCATION OF NEW ADA RAMP

- COORDINATE RAMP WITH MASTER PLAN LAYOUT OF THE SITE.
- PROVIDE A NEW STEEL RAMP WITH CONC. TOPPING
- SIZED FOR ACCESSIBILITY AND SERVICE ACCESS.

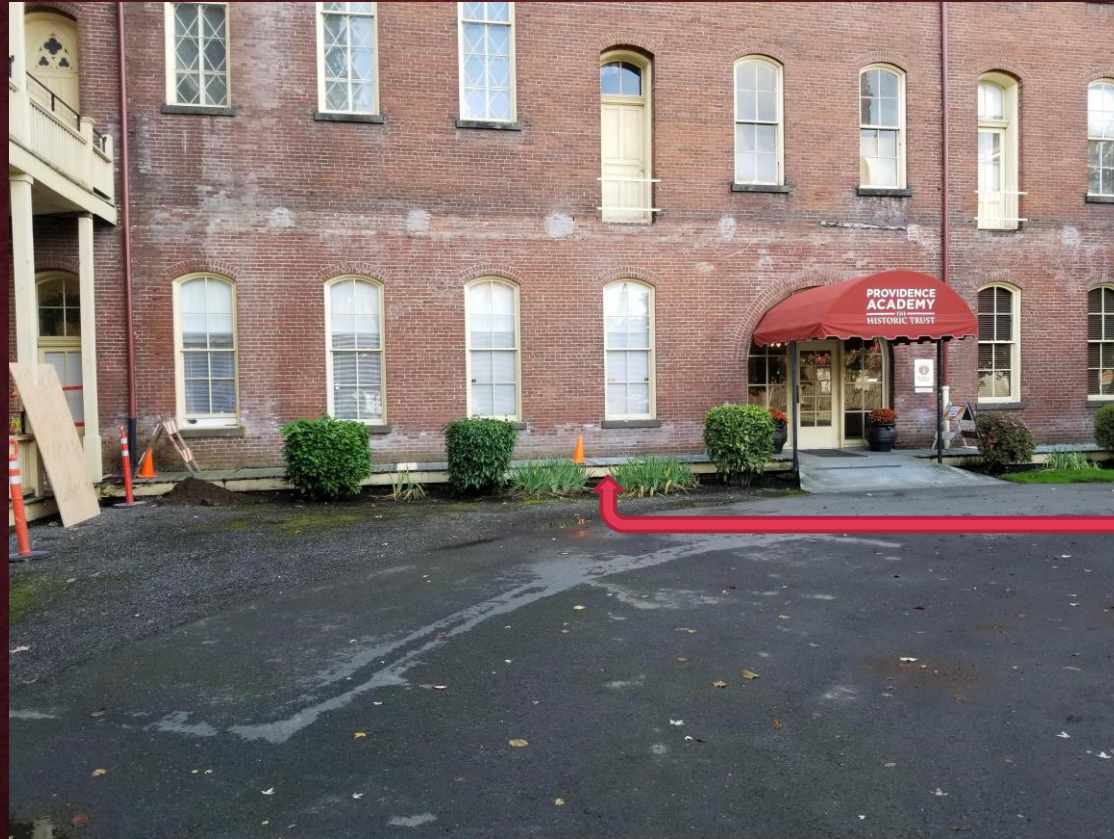
REMOVE DECK. ADD ADA RAMP BESIDE BUILDING

- COORDINATE WITH MASTER PLAN FOR THIS AREA SO RAMP INTEGRATES WITH PEDESTRIAN CIRCULATION AREAS.
- NEW STEEL RAMP WITH CONCRTE TOPPING.

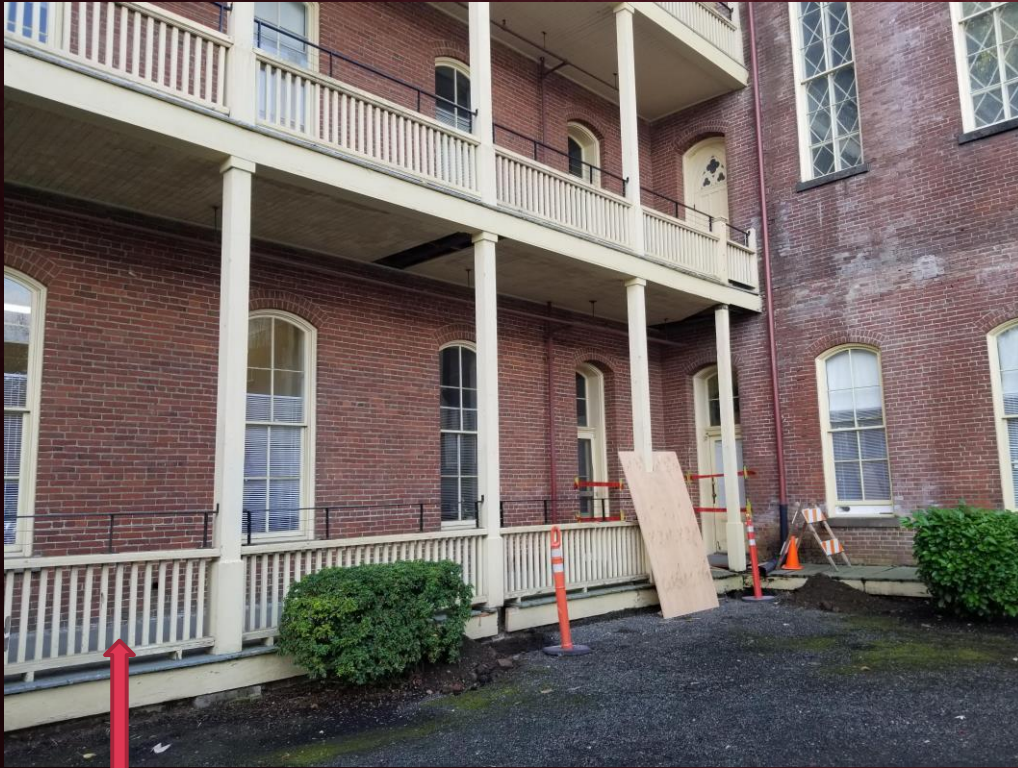
3-STORY PORCH SIMILAR TO WEST PORCH

1. DECK REPAIRS SIMILAR TO SCOPE 1A.
  - a) COLUMN CONNECTIONS WILL NEED TO BE IMPROVED.
  - b) PORTIONS OF LOWER DECK FRAMING TO BE REPLACED.
2. BRICK SKIRT TO BE REMOVED AND REPLACED WITH SALVAGED BRICKS.

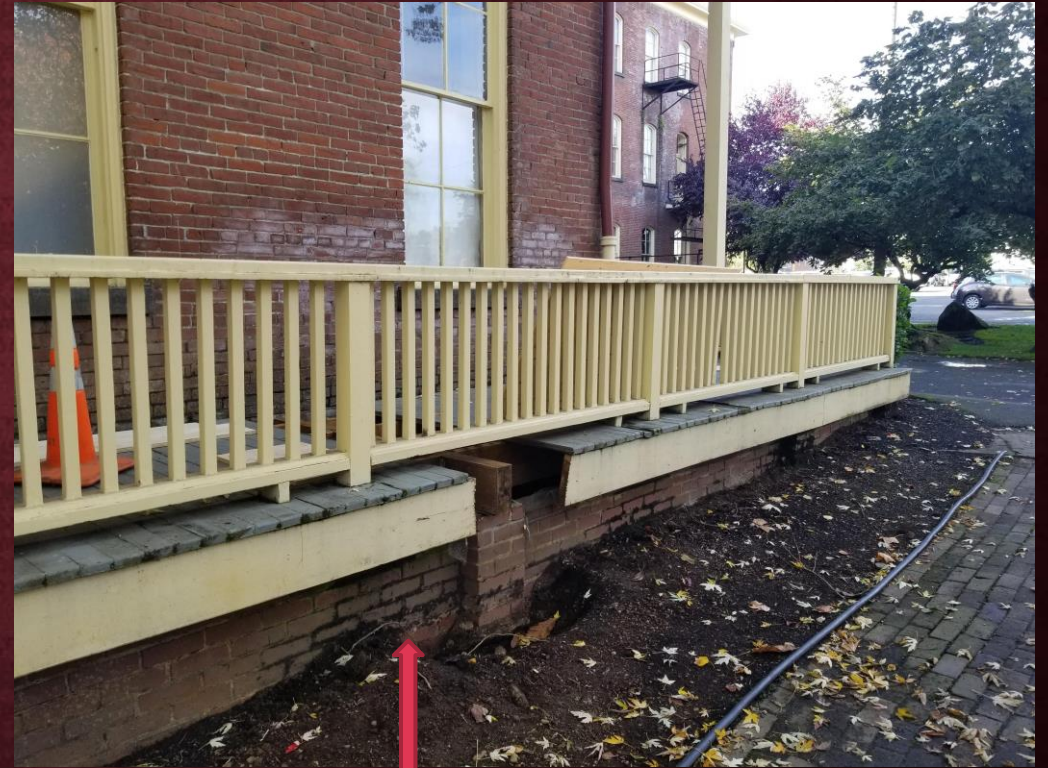
WRAP AROUND SINGLE LEVEL PORCH - BRICK SKIRT.

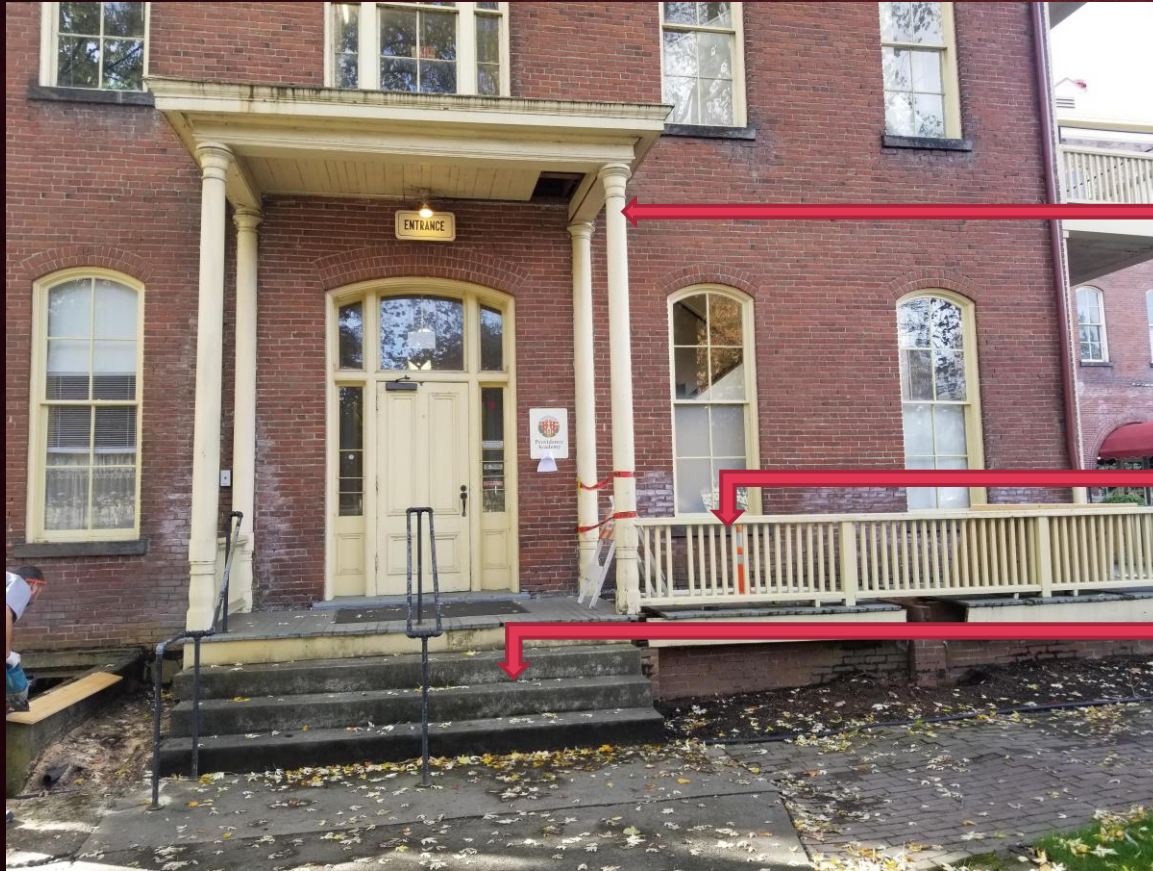
UNIQUE ENTRY  
FRAMING

WATERPROOF  
TRANSITION?

OCCUPIED BASEMENT  
BELOW

- ROOF FRAMING IS UNIQUE WITH MANY DEFICIENCIES. REPAIR IS IMPRACTICAL. CANOPY WILL BE REMOVED AND REPLACED.
- OCCUPIED SPACE BELOW DECK WILL REQUIRE A WATERPROOF SOLUTION AT DECK LEVEL.
- REPAIR SOLUTIONS WILL IMPACT ALL THE WAY DOWN TO THE RETAINING WALLS BELOW GRADE.
