Unfit Building Demolition Request Laundry Building and Boiler Building

The Applicant requests that the Laundry and Boiler Buildings on the Providence Academy site at 400 East Evergreen Boulevard (the "Structures") be declared "unfit" buildings in accordance with VMC 17.32.040. These unreinforced masonry buildings were acquired by The Historic Trust in 2015. They have seen decades of structural and general dilapidation that has rendered the Structures unsafe in any capacity.

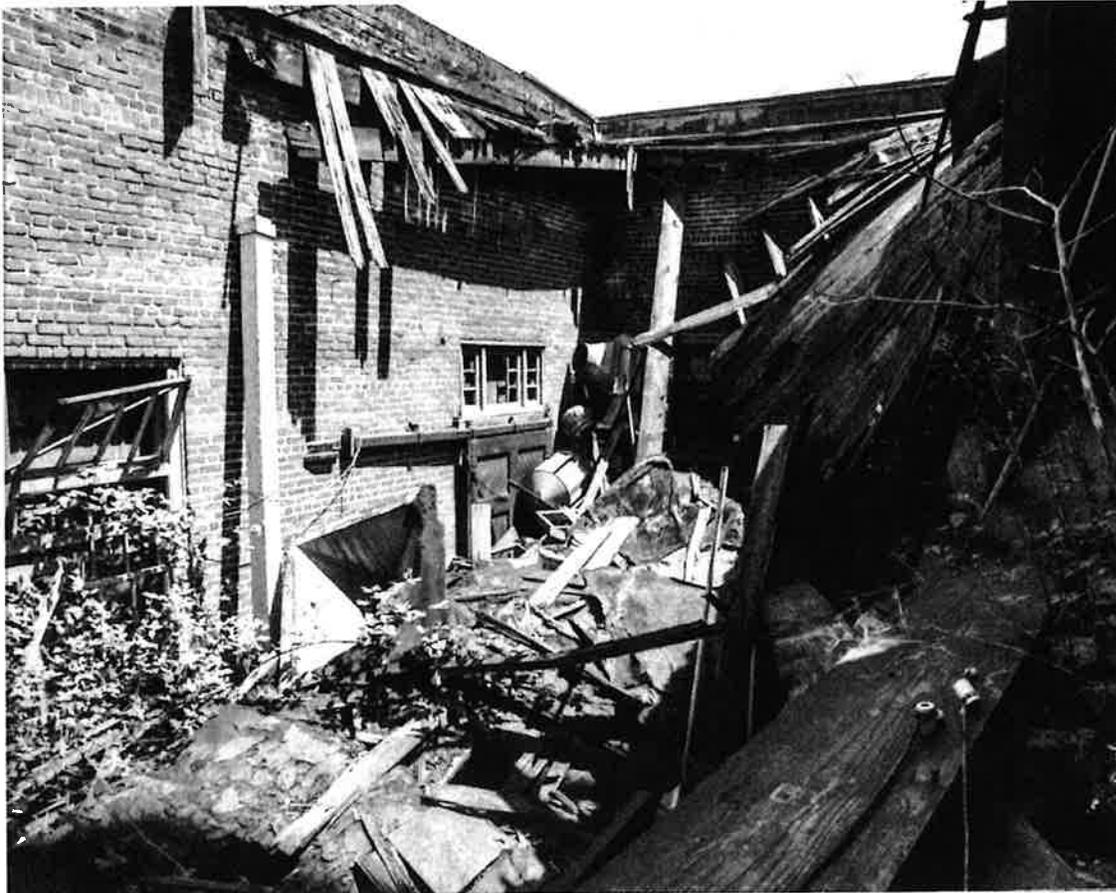
Laundry Building – Because the building is not stable and presents significant danger of the second floor collapsing, all of the exterior doors are locked with padlocks and the first-floor windows and some second floor ones are barricaded to discourage entry. When people force an entry, all other exits are blocked. An interior staircase has many broken treads, is unstable and impassable.

Boiler Building – Because the structure was mostly destroyed in a fire, the interior is not usable, the exterior doors are locked with padlocks and in some cases barricaded, and the windows are barricaded to discourage entry. When people force an entry, all other exits are blocked.

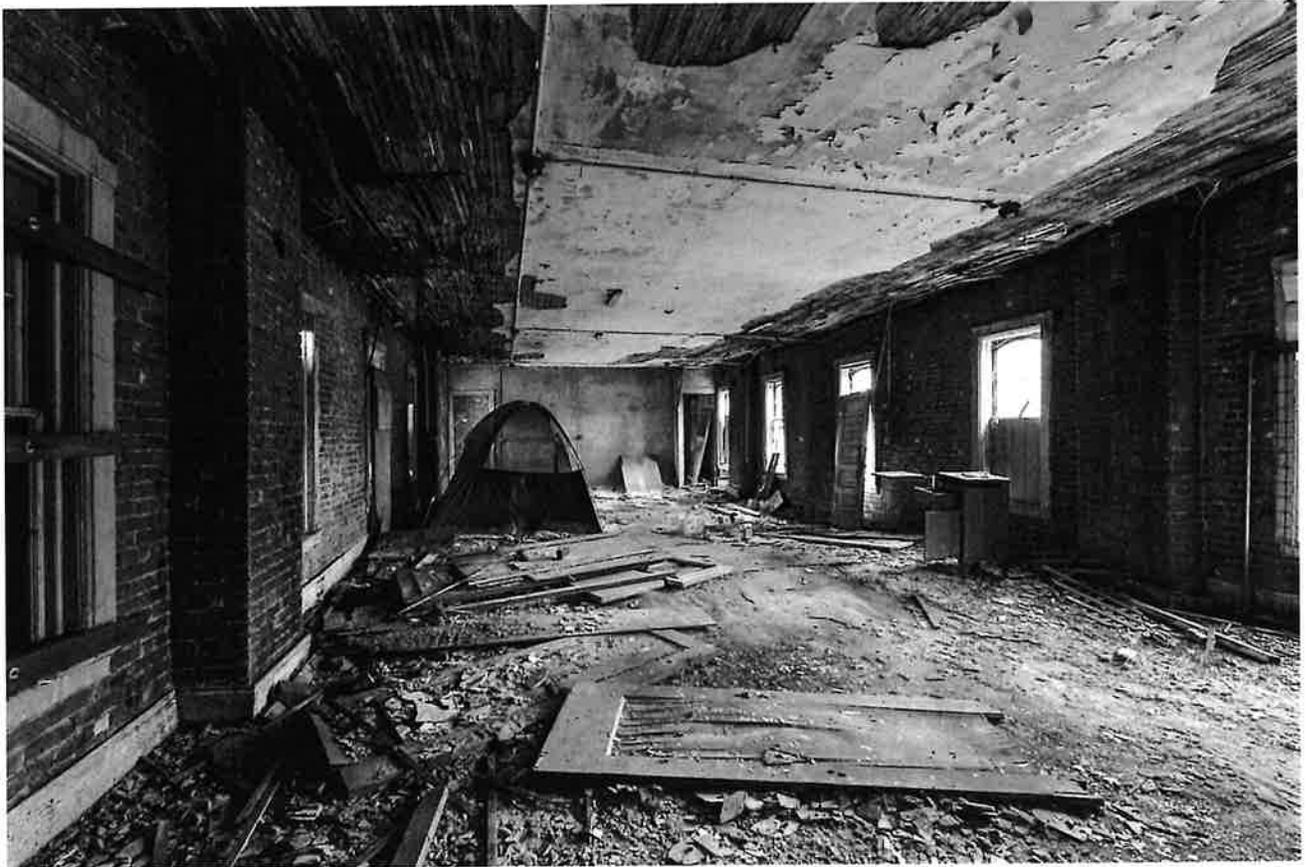
Laundry Building – Many portions of the interior ceilings and walls have fallen down due to

general age and the incursion of moisture, and more are cracked and liable to fall at any time.

The exterior brick at the southeast corner of the building has experienced much loss of mortar and is failing and will continue to fail.

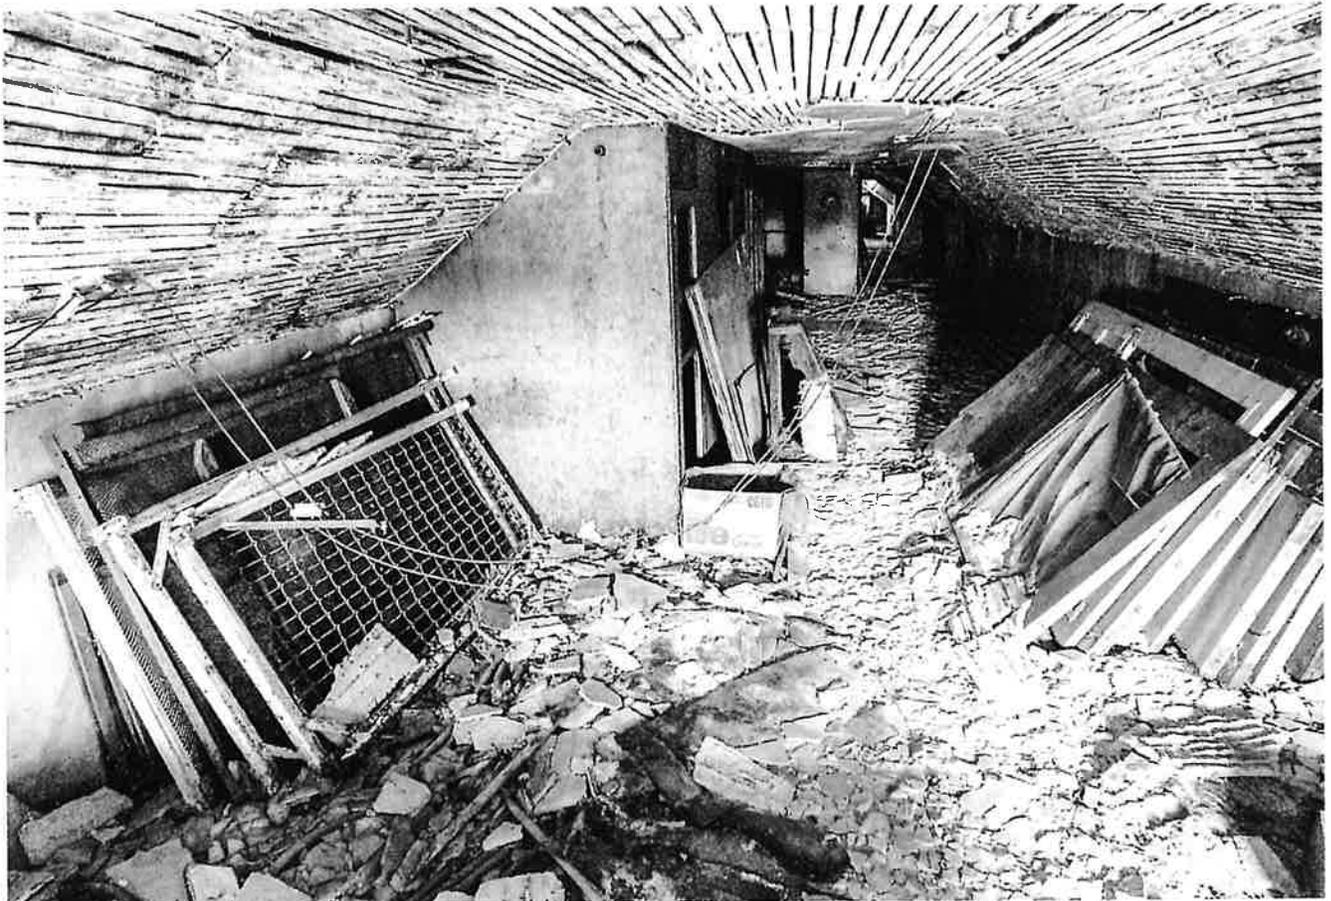
Laundry Building – The entire building is dilapidated and deteriorated and has attracted

numerous instances of trespass during Historic Trust ownership, despite stringent efforts to prevent entry.

Boiler Building – The entire structure is dilapidated and deteriorated and has attracted numerous instances of trespass during Historic Trust ownership, despite stringent efforts to prevent entry.
