August 28th, 2019

RE: Action required to address structural condition of Laundry and Boiler Buildings, and the Smokestack.

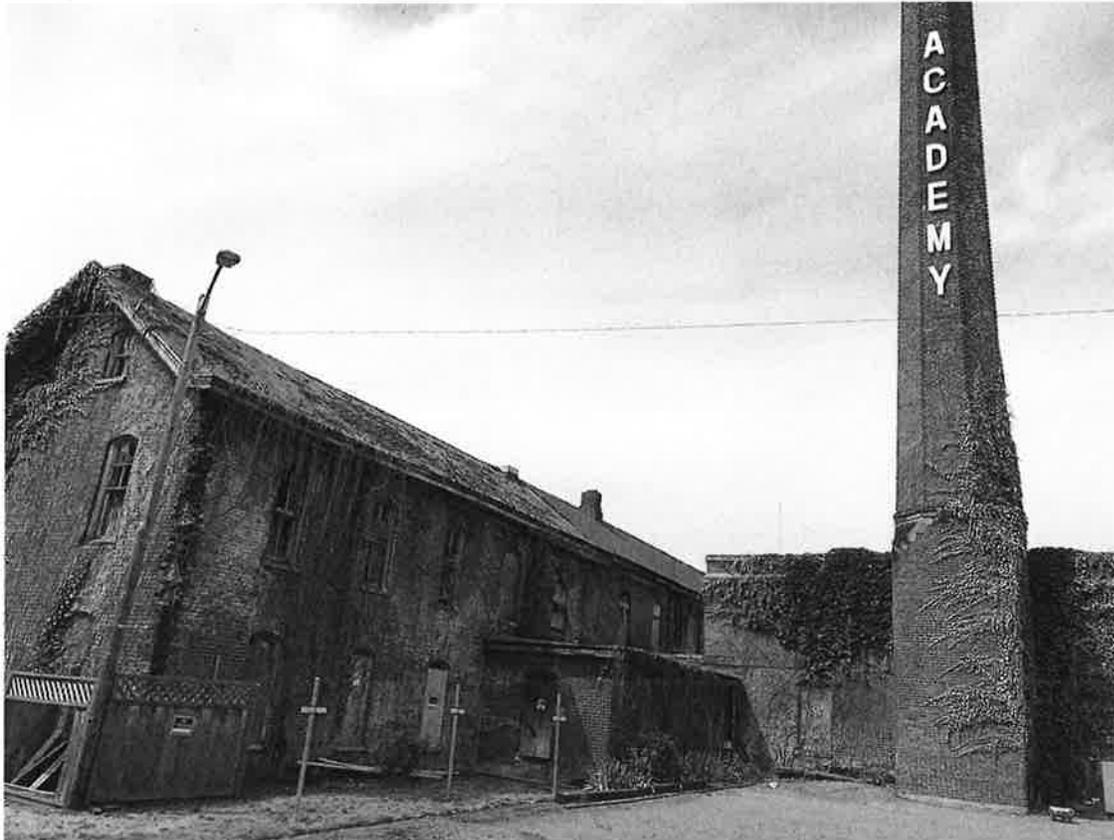
Laundry Building: This is a two-story structure with masonry exterior walls. With holes in the roof and openings in the building exterior, the building's interior has been exposed to the elements for many years. Roof and floor assemblies have deteriorated to the extent that significant portions of floor and roof have collapsed. Portions of the exterior masonry walls show signs of severe deterioration. An area at southeast section of the building has been cordoned due to loose bricks from the building falling to the ground.

Boiler Building: It is a one-and-one-half story structure with masonry exterior walls. Similar to the Laundry building, the Boiler building is in severe disrepair. The roof assembly is nonexistent and the masonry shell is showing signs of severe structural deterioration.

Smokestack: The structure is approximately 80' tall and is located on the south wall of the Boiler building. The structural connection between the Boiler building and the Smokestack shows signs of severe deterioration and failure. Furthermore, lack of roof structure over the Boiler building limits

its capacity to function as a buttress for the Smokestack. Test reports indicate various degrees of deterioration of the masonry work. The geometry of the structure and its deteriorated condition makes the Smokestack highly susceptible to collapse during a moderate seismic event.

Pictures taken on 8/14/2019, Above: Shows the three primary structures (Laundry building to the left, the Smokestack and Boiler building behind the stack), smaller connecting structures are also seen in the picture. Below: Shows falling bricks at southeast corner of Laundry building

- By March 1st, 2020, submit building permit application and plans for repair of the three aforementioned structures or obtain demolition permits. The option to repair or demolish applies separately for the Laundry and Boiler Buildings, and the Smokestack.
- By March 1st, 2022, complete required repairs or demolition work.
