CLARK COUNTY STAFF REPORT

REQUESTED ACTION: Accept and Approve the 2014 Annual Bridge Report.

2014 Annual Bridge Report

Prepared by David Dolan, P.E. Clark County Public Works Engineering and Construction Division Submitted June 2015

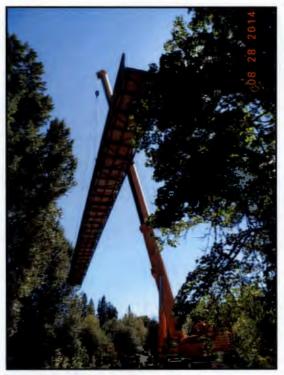
Pleasant Valley Pedestrian Bridge (2014).

The County also completed the Pleasant Valley Pedestrian Bridge over Salmon Creek in 2014. This bridge will connect the trails within the Pleasant Valley

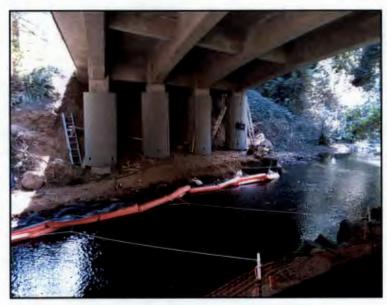
One bridge project was completed in 2014, the Blair Zeek Bridge No. 252 Seismic Retrofit. In addition, design and permitting work continued on the Cedar Creek Bridge No. 65 Bridge Replacement Project, the 10th Avenue Bridge and the Brush Prairie Creek No. 201 Seismic Retrofit and Scour Mitigation Project. Five projects are scheduled for construction in in 2015.

Blair Zeek seismic retrofit completed in 2014.
