CLARK COUNTY LAW ENFORCEMENT CENTER

FEASIBILITY STUDY | August 2016

Existing Building Facility Assessment Overview

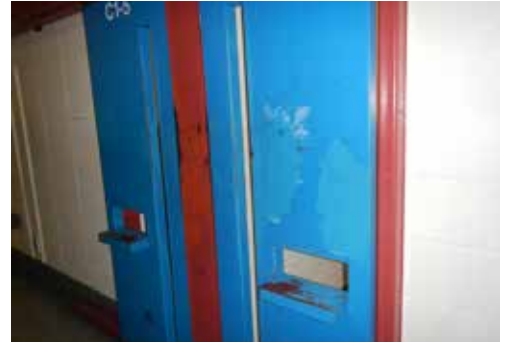
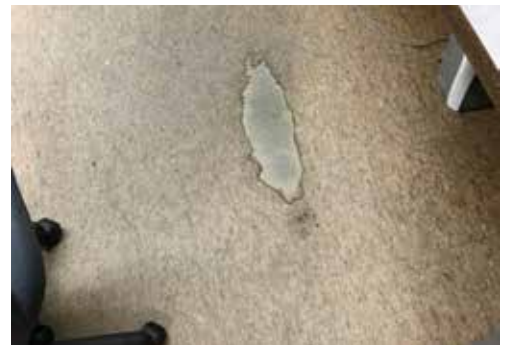
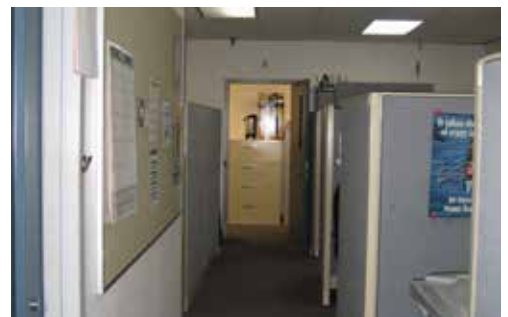
- Detention Furnishings: Worn
- Public Furnishings: Worn

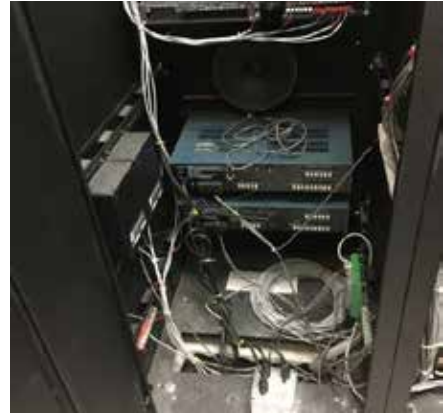
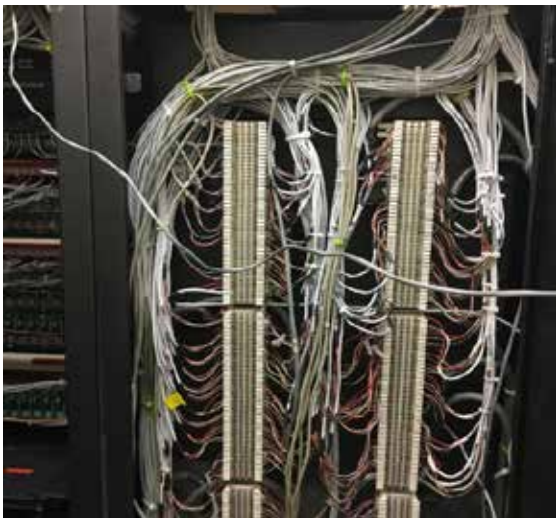
The remote master stations are still available and the audio quality is good. Numerous master stations have been wall mounted for use as door stations. We noted that contrary to the IBC (UBC during original construction) no call request stations have been provided in the cells. HK feels that this puts the County at risk relative to both allowing a person who is in a lock-down condition to call for help, and with respect to the PREA guidelines.

Recommendations: HK Recommends that the entire Master intercom system and the Local intercom system be replaced with a new PBX based system capable of both functions. This will eliminate the potential for a catastrophic system failure due to the existing PBX that is no longer being supported by the manufacturer. Existing field cabling can be reused. Also, by combining both the Master and Local intercom systems and interfacing them with the PLC system, the master stations could still be used to call remote (Local) intercom stations through the use of the keypad thereby facilitating a level of redundancy if either the PLC or touch screen systems were to fail.
