CLARK COUNTY
WASHINGTON

DEPARTMENT OF COMMUNITY DEVELOPMENT
BUILDING SAFETY DIVISION

RE: Camas Court House

Friday the 8th, an inspection was performed at '89 C St, Camas' to investigate possible compliances to code for a possible future addition or alteration and ADA minimum requirements.

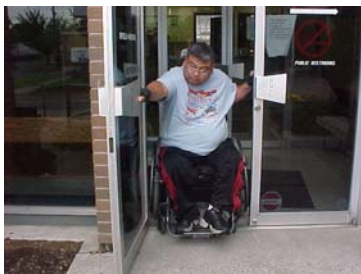
Item # 17
Issue: Doors do not meet accessibility requirements for width. Current width for one door is 28.5". Both doors open width is 57.5"
Issue:
Location: Interior and Exterior Doors – SE Entrance
Code: ANSI 404.2.1 Double-Leaf Doors and Gates – At least one of the active leaves of doorways with two leaves shall comply with sections 404.2.2 and 404.2.3
ANSI 404.2.2 Clear Width – Doorways shall have a clear opening width of 32" minimum.
Notes: Automatic doors could be installed where both doors would open thereby providing the necessary width required by code.

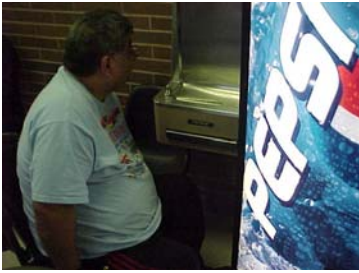
Item # 18

Issue: Drinking Fountain - Hallway

1. Spout Height – Current Height 37"
2. Clearance – Obstructed by chairs and soft drink machine

Location: Main Hallway

Code: ANSI 602.4 Spout Height – Spout outlets of wheelchair accessible drinking fountains shall be 36 inches maximum above the floor.
ANSI 602.2 Clear Floor Space – A clear floor space complying with Section 305, positioned for a forward approach to the drinking fountain, shall be provided. The floor space shall be centered on the drinking fountain.
ANSI 305.2 Size – The clear floor space shall be 48 inches minimum in length and 30 inches minimum in width.

Notes: The soft drink machine will need to be moved to another location in order to provide the required clear floor space for access to the drinking fountain.

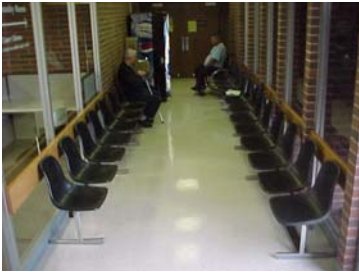
Item # 19

Issue: No Wheelchair Space

Location: Hallway Seating outside Courtroom

Code: ANSI 802.6 - Integration of Wheelchair Space Locations – Wheelchair space locations shall be an integral part of any seating area.
ANSI 802.3 Width – A single wheelchair space shall be 36 inches minimum in width.
ANSI 802.5 - Approach The wheelchair space location shall adjoin an accessible route. The accessible route shall not overlap the wheelchair space location.

Notes: Remove a section of the standard seats.

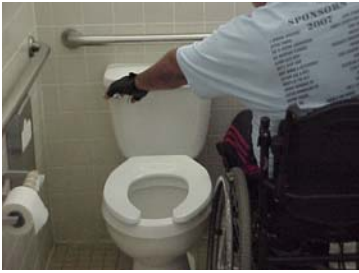
Item # 20
 Issue: Flush Control Location
 Issue: Vertical Grab Bar
 Location: Accessible Restroom
 Code: ANSI 604.6 Flush Controls - Hand operated flush controls shall be located on the open side of the water closet.

ANSI 604.51. Fixed Side wall Grab Bars – (States in part) ... A vertical grab bar 18 inches minimum in length shall be mounted with the bottom of the bar located 39 inches and 41 inches above the floor, and with the center line of the bar located between 39" and 41 inches from the rear wall.

Notes: Installation of a 36" bar may be unattainable due to location of toilet and other plumbing fixtures.

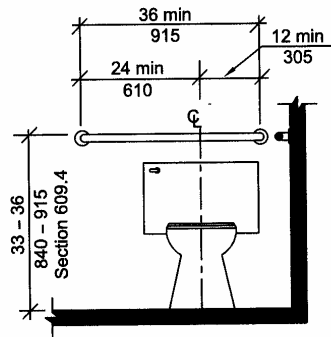
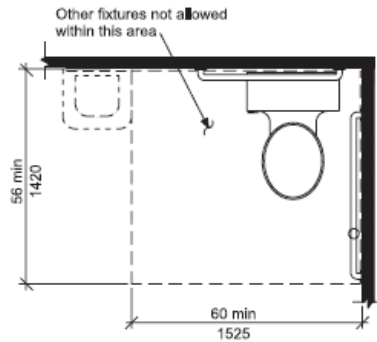
Item # 21
 Issue: Rear Wall Grab Bar Length and Placement
 Issue: Size of Water Closet for Clearance
 Location: Accessible Restroom
 Code: ANSI A117.1-2003 Fig. 604.5.2

Notes: The current rear wall grab bar is 24" in length and should be a minimum of 36 inches. Also, the bar should be off-centered as indicated in diagram above.

Extending width of water closet will not be possible unless a renovation is conducted.

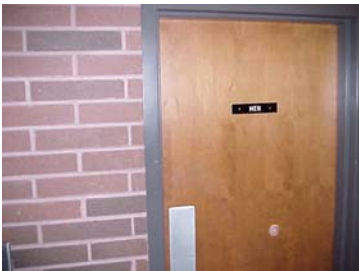
Item # 23

Issue: Directional Signage

Location: Inaccessible Restrooms

Code: IBC 1110.2 Directional Signage – Directional signage indicating the route to the nearest like accessible element shall be provided at inaccessible public toilets and bathing facilities.

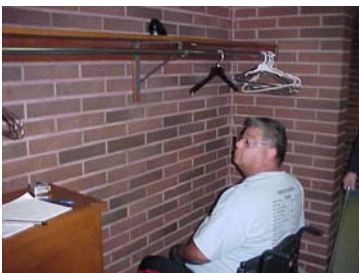
Item # 24

Issue: Height and Reach Range

Location: Hallway Coat Hanger

Code: ANSI 308.2 Forward Reach
ANSI 308.2.1 Unobstructed – Where a forward

<p>shall be 48 inches maximum above the floor.</p> <p>Notes: Current height of the coat bar is 66 inches Coat hooks can be attached to the brick wall on the right side of existing coat bar. Maximum height of these hooks cannot exceed 48 inches above the floor.</p>

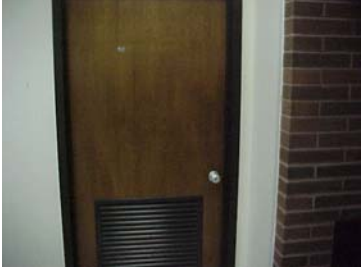
<p>Item # 25</p> <p>Issue: Door Knobs</p> <p>Issue:</p> <p>Location: Correction Officer Door</p> <p>Code: ANSI 404.2.6 Door Hardware – Handles, pulls, latches, locks and other operable parts on accessible doors shall have a shape that is easy to grasp with one hand and does not require tight grasping, punching, or twisting of the wrist to operate. Operable parts of such hardware shall be 34 inches minimum and 48 inches maximum above the floor.</p>

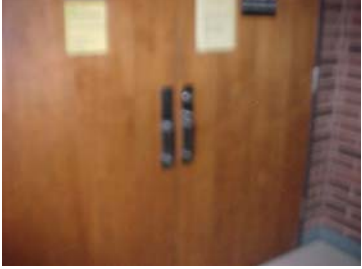
<p>Item # 26</p> <p>Issue: Door Handles</p> <p>Issue:</p> <p>Location: Courtroom Doors</p> <p>Code: ANSI 404.2.6 Door Hardware – Handles, pulls, latches, locks and other operable parts on accessible doors shall have a shape that is easy to grasp with one hand and does not require tight grasping, punching, or twisting of the wrist to operate. Operable parts of such hardware shall be 34 inches minimum and 48 inches maximum above the floor.</p>

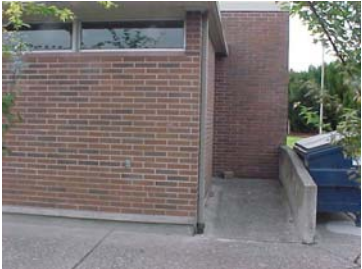
<p>Item # 27</p> <p>Issue: Directional Signage – Door is usually locked</p> <p>Issue:</p> <p>Location: NE Corner of Building –Ramped Entrance</p> <p>Code: IBC 1110.2 - Directional Signage Directional signage indicating the route to the nearest like accessible element shall be provided. These directional signs shall include the International Symbol of Accessibility. Sign Sample: Signs must meet ANSI Chapter 7 Communication Elements and Features</p>
