SCHOFIELD BLOCK

HISTORIC PRESERVATION OPTIONS DISCUSSION

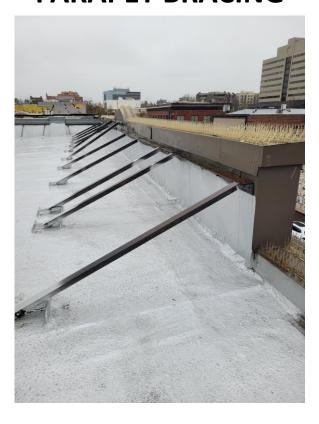
PARAPET BRACING

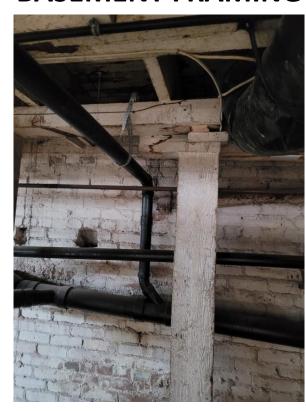
BASEMENT FRAMING

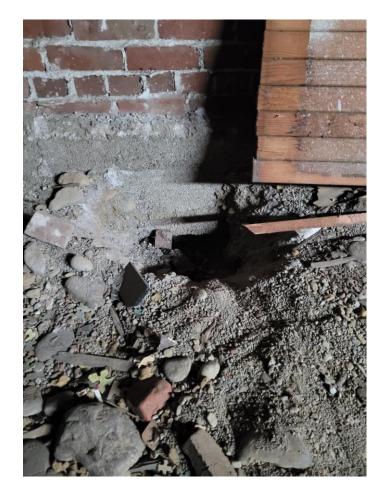
NO FOOTING UNDER **BEARING WALLS**

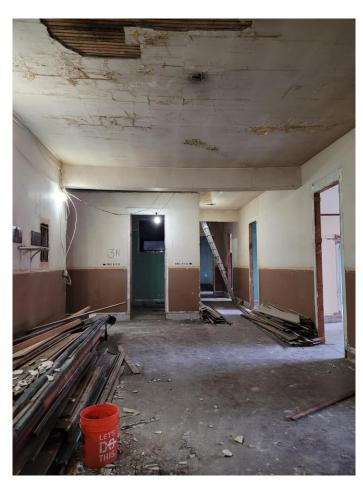
BEAM BENDING UNDER ROOF LOADS

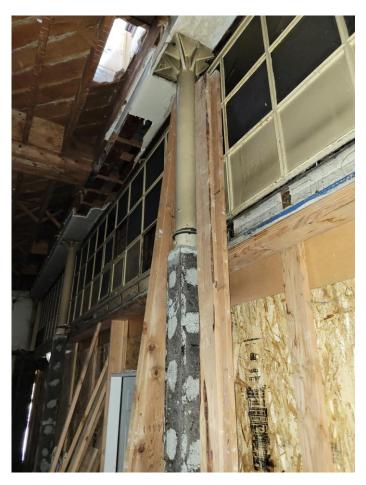
POSTS SUPPORTING WOOD BEAM
