Intensive-level Documentation of the Clark County Poor Farm Buildings and Poor Farm Cemetery Remote Sensing Project, Clark County, Washington

County: Clark County
Legal Location: T2N, R1E, Section 11
USGS 7.5-minute quad: Vancouver, WA
Type of Project: Intensive-level Historic Properties Survey and Remote Sensing
Results of Survey and Subsurface Probing: N/A
Field Notes: On file at SWCA, Portland Office

SWCA Project Number 16314
SWCA Report Number 2010-265
July 6, 2010

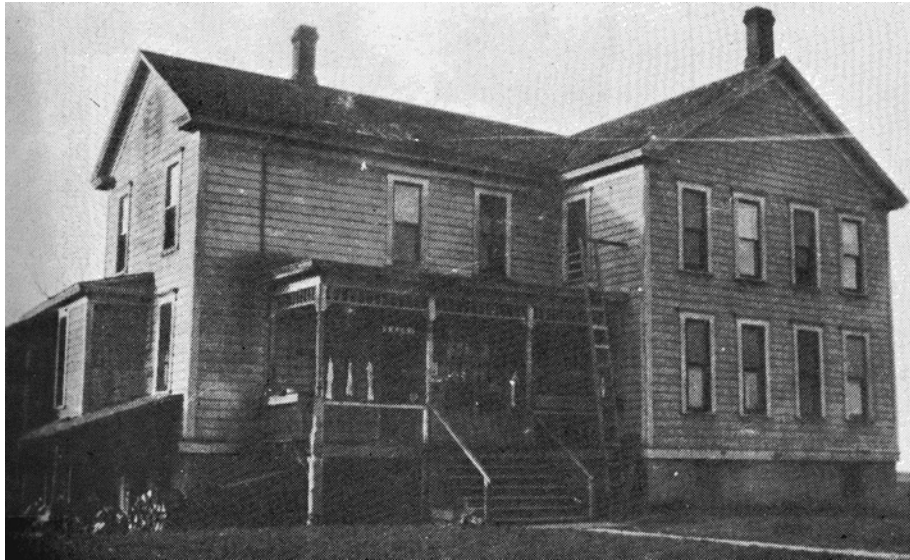
Figure 3. Ca. 1895 Poor Farm building, east side, view to the northwest.

Photo taken in 1921, before the building burned completely the following year. Source: Allworth 1976:15. Photo credit: Olive McCafferty Harris.

Beginning in 1873, Clark County operated a poor farm on the property. It is unclear when the first building was constructed, but by 1898, a large, two-story Colonial Revival house was located there, at approximately the location of the present building (Figure 3). An 1898 article in the *Vancouver Independent* states that the county had built a house on the property, costing \$3,000, and that the superintendant had built a wagon shed "to take care of the wagon which former superintendents have allowed to stand out in the weather until it was all but ruined." The article does not indicate when the house was built, but the implication is that it was shortly before the 1898 article, suggesting that an earlier structure had been there before the 1890s. In 1922, a fire broke out, completely destroying the building (Harshman et al. 2001:i, xii; Allworth

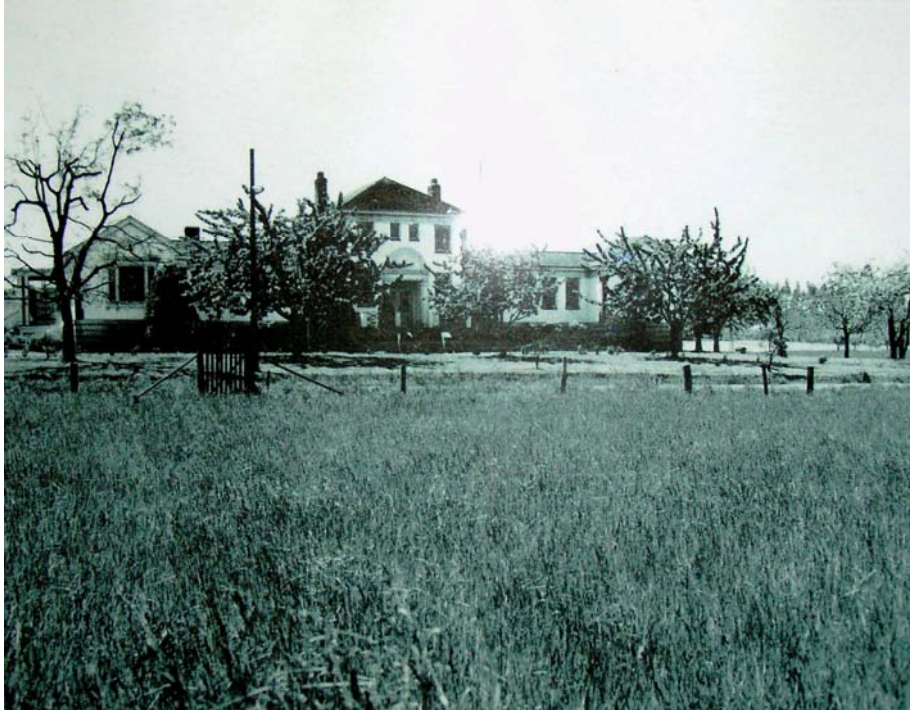
Figure 4. View of the 1926 Clark County Poor Farm Main Building, viewed across NE 78th Street (then called Poor Farm Road) towards the front of the building.

The view is to the southwest. Photo taken ca. 1944, on display in Clark County Poor Farm Main Building.

In January 1926, Clark County entered into a contract with the firm of DeYoung and Roald, an active firm in the Portland vicinity between 1920 and 1930, to design a new Poor Farm facility to replace the one that had burned in 1922. A partnership between architects James W. DeYoung (active from 1909 to 1959) and Knud A Roald (active from 1910 to ca. 1960), the firm was responsible for the designs of the New Heathman Hotel, the Rex Arms Apartments, and (with Rapp & Rapp) the Paramount Theater, the Portland Theater (now part of the Performing Arts Center) among many other buildings in and around Portland (Ritz 2002:101, 335). The New Heathman Hotel, at 712 SW Salmon Street in Portland, was built in 1927, and was listed in the National Register of Historic Places (NRHP) in 1984. The Paramount Theater, at 1037 SW Broadway, was built in 1927 and listed in the NRHP in 1976 (Oregon Historic Sites Database 2010). The style that they chose, being a somewhat scaled-down iteration of the Italian Renaissance style, commonly used for government buildings and large-scale commercial buildings seeking to create a sense of responsibility, orderliness, and prosperity in the viewer. This was achieved through the massing and ornamentation of the Clark County Poor Farm main building and its contemporary subordinate structures (Figures 4 and 5).

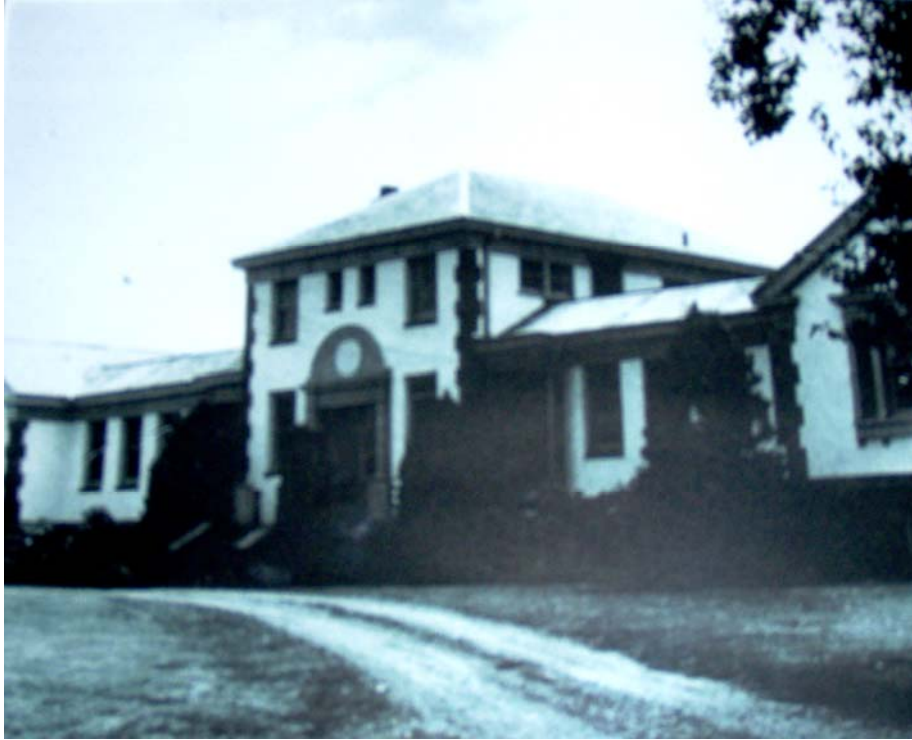
Figure 5. Ca. 1944 view of the main entrance, Clark County Poor Farm Main Building. The view is to the southeast.

Photo on display in Clark County Poor Farm Main Building.

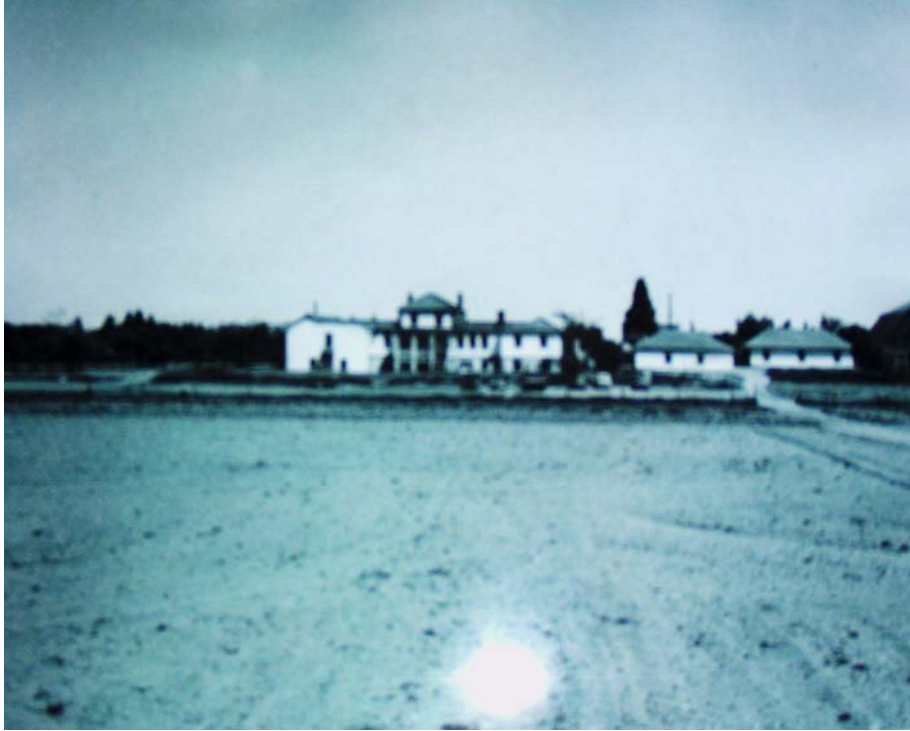
Figure 6. View of the 1926 Clark County Poor Farm Main Building (center of photo), 1926 detached garage (middle of three buildings), and 1936 milk house (at right), viewed towards the north.

Photo taken ca. 1944, on display in Clark County Poor Farm Main Building.

In 1936, several improvements were made to the poor farm property, including the construction of a separate milk house to the east of the main building, northeast of the 1926 garage (Figure 6). This building was built to separate the milk-handling from the laundry, where it had been located up to that point. The building was also used for vegetable storage. The same year, the basement of the main building was subdivided into very small individual rooms in which residents slept. Prior to this the basement was a large, open area full of cots. Also in 1936, showers were installed for the first time (Harshman et al. 2001:viii-ix).

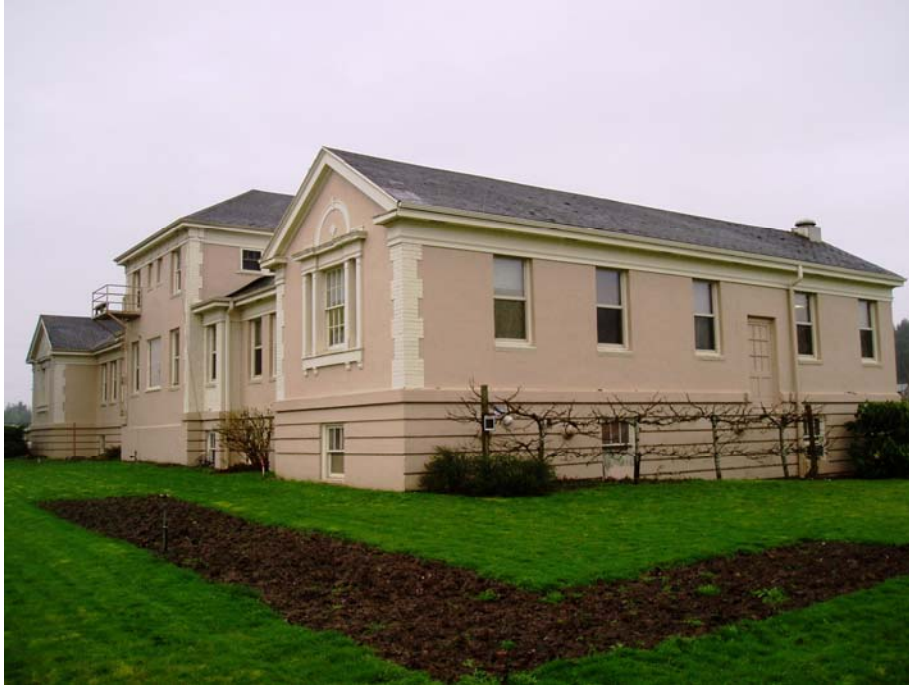
Figure 8. Clark County Poor Farm Main Building, view across the north elevation (left) and west elevation (right). The view is to the southeast.

The Clark County Poor Farm main building is a large, concrete building in the Italian Renaissance style, built in 1926 (Figure 8). The building has three masses: a two-story, hipped-roofed central mass with one-story, forward-projecting, gabled wings on each side. The building has a rusticated daylight basement, topped by a beltcourse, above which the walls are stucco, and feature brick quoins at all outside corners. Centered on the front (north) elevation of both gabled wings is a large, Palladian-motif window with a central 10-over-10 wood sash window flanked by 2-over-2 wood sash windows, all capped by a heavy entablature. The central window is topped by a molded arch with a brick diamond in the center. The gables have heavy-molded cornices and cornice returns, while the elaborated cornice along the hipped roof of the main central mass features triglyphs and guttae across the principal (north) elevation. The cornice continues across the side and rear elevations of the main mass, but without the triglyphs and guttae. Windows (aside from the Palladian-motif windows) are generally 1-over-1 steel or vinyl windows, though some of the original 6-over-1 wood sash windows remain, as do both original diamond-pattern windows in the second floor, principal elevation of the central mass. All of the original 3-over-1 wood sash basement windows are intact, except the rear elevation, where windows were originally 6-over-1, two out of six of which have been replaced (one with aluminum slider windows and the other with a steel fixed window). Most first floor windows have been replaced with 1-over-1 steel or vinyl windows, though fenestration has not been

altered, and all retain their original brick sills. An exterior fire escape is attached to the second-floor, east window on the principal elevation of the central mass.

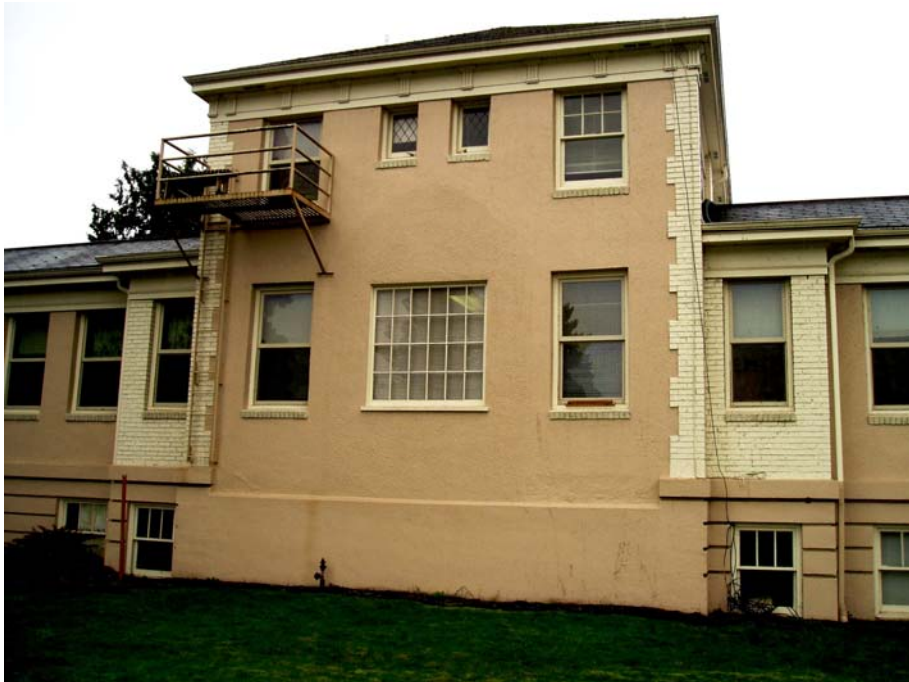
Figure 9. North elevation, Main Building, central mass. The view is to the south-southeast.

Note the stucco scarring where the original entrance was removed.

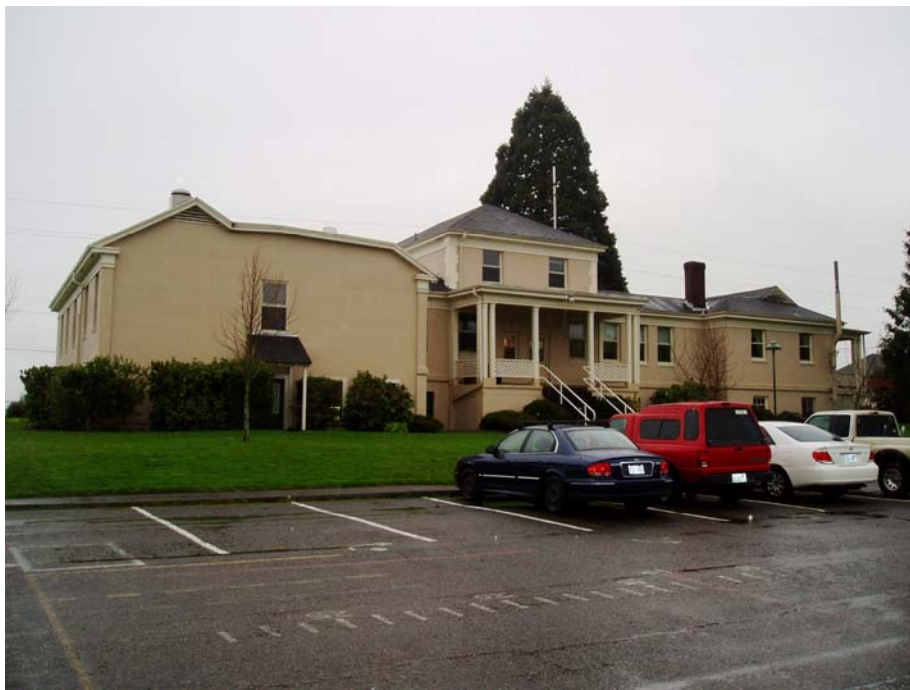
Figure 10. View of the Clark County Poor Farm Main Building, south (rear) elevation. The view is to the north-northeast.

The west elevation of the western wing has a doorway on the first floor. This door is no longer in use, and though the door itself is intact, on the inside, the short staircase that led down to it has been covered over with flooring. Exterior steps from the door have also been removed. On the rear elevation, the east wing is oblong, though based on decoration it is consistent with the rest of the building, and photographs of the elevation dating to the 1940s, appears to be part of the original design (Figures 6 and 10). On the rear (south) of the central mass is a large, rectangular porch with a very low-pitched hipped roof supported by box posts, tripled at the corners. The porch itself is supported by heavy concrete piers, and the porch continues the cornice molding carried by the rest of the building. Aside from concrete infill between the concrete piers and lattice in the rails, the porch appears intact. Flanking the porch on both sides are modern, paired steel basement entry doors. On the south end of the east elevation of the east wing, a smaller, matching porch provides access to the original kitchen area.

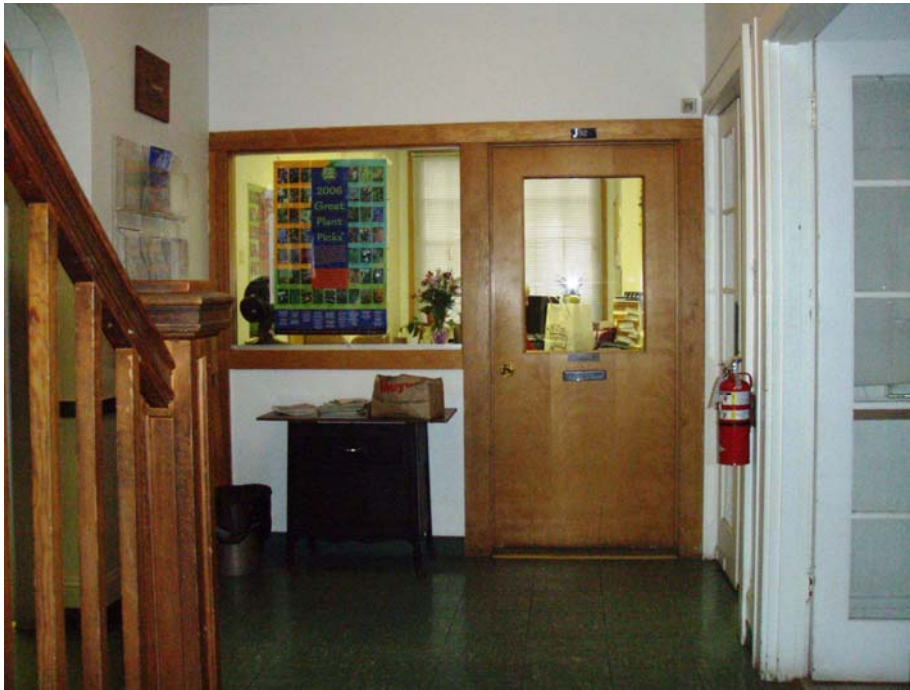
Figure 11. Interior view of central entry hall.

The first floor was altered during the Washington State University ownership, most notably by the removal of the recessed entry at the center of the central mass. The northern part of the central entry hall has been enclosed for use as a reception office (Figure 11). To the south of this, the main stair to the second floor apartment is intact, as are the French doors leading to the east wing, and the arched doorways that lead to the west wing and the east dining room (Figures 12, 13, and 14). In the east wing, south side, the living room area retains the original brick fireplace and carved wood mantelpiece, as well as the French doors from the center hall (Figure 15). The kitchen, located in the southeast corner of the building, retains some of the original built-in cabinets, though some of the food preparation areas have been modified. The original flue for the range is intact, though the range itself is not. In the dining room, original window trim at the Palladian-motif window is intact, as is most of the interior window, door, and wall trim.

The reception office is located where the main entrance once was. This view is looking north, and the window in the rear is where the main doors were.

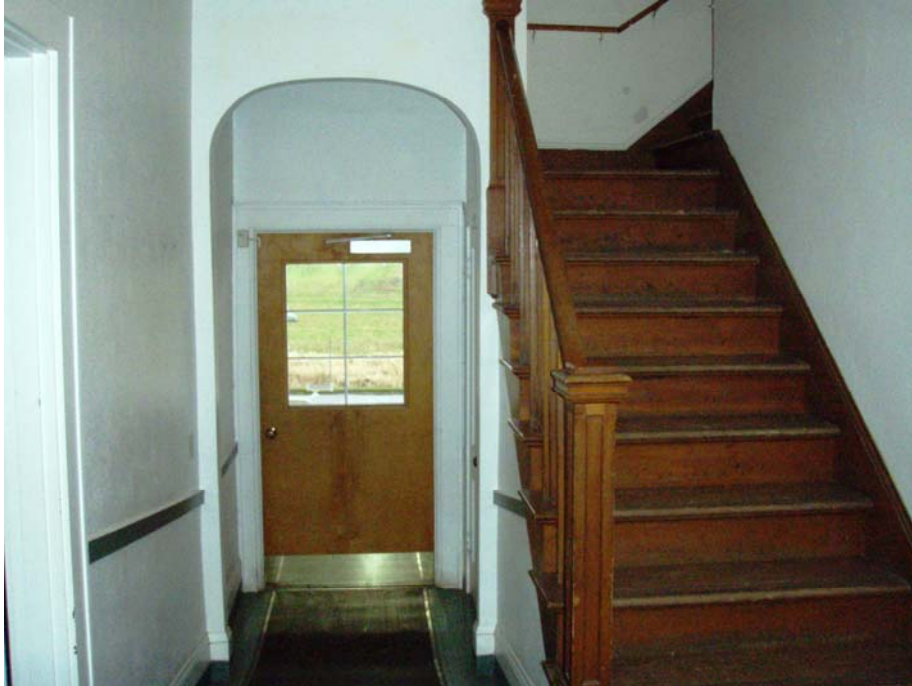
Figure 12. Interior view of central entry hall, reverse view from Figure 11, facing south.

The stairs to the right ascend to the upstairs apartment.

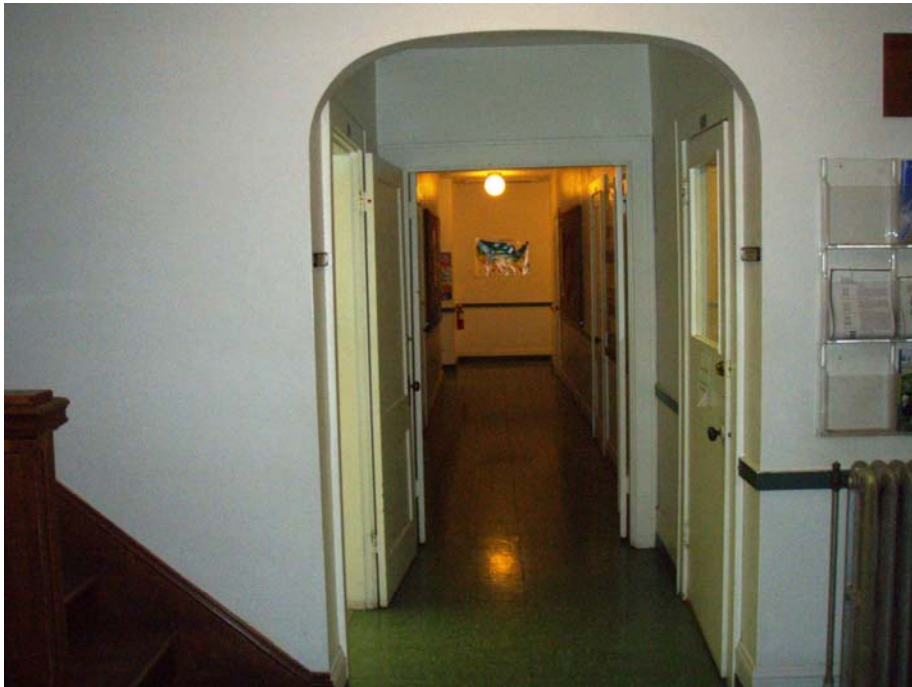
Figure 13. Interior view down the western corridor, main building.

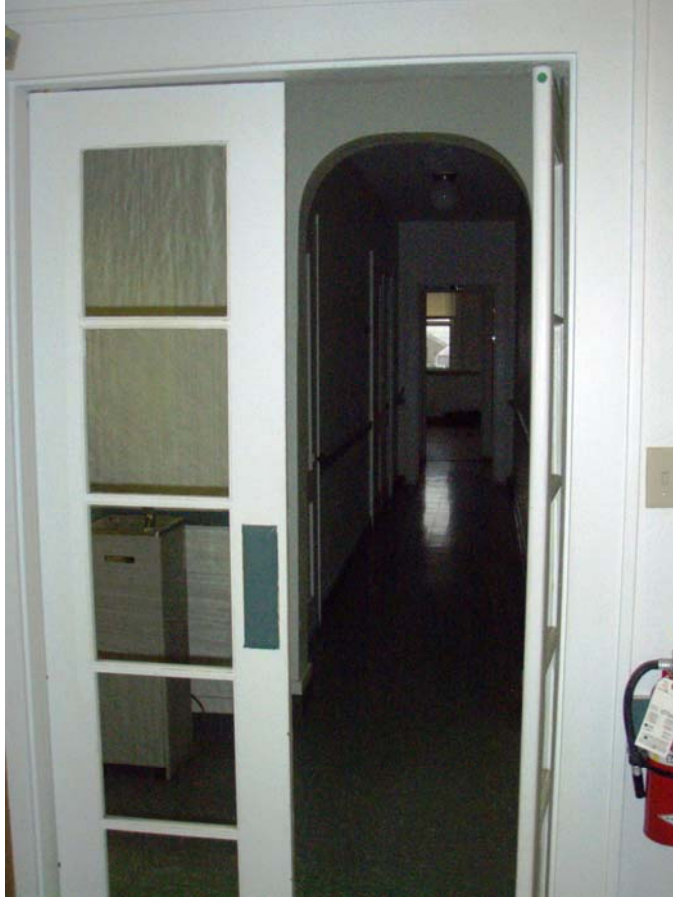
Figure 14. Interior view down eastern corridor, main building.

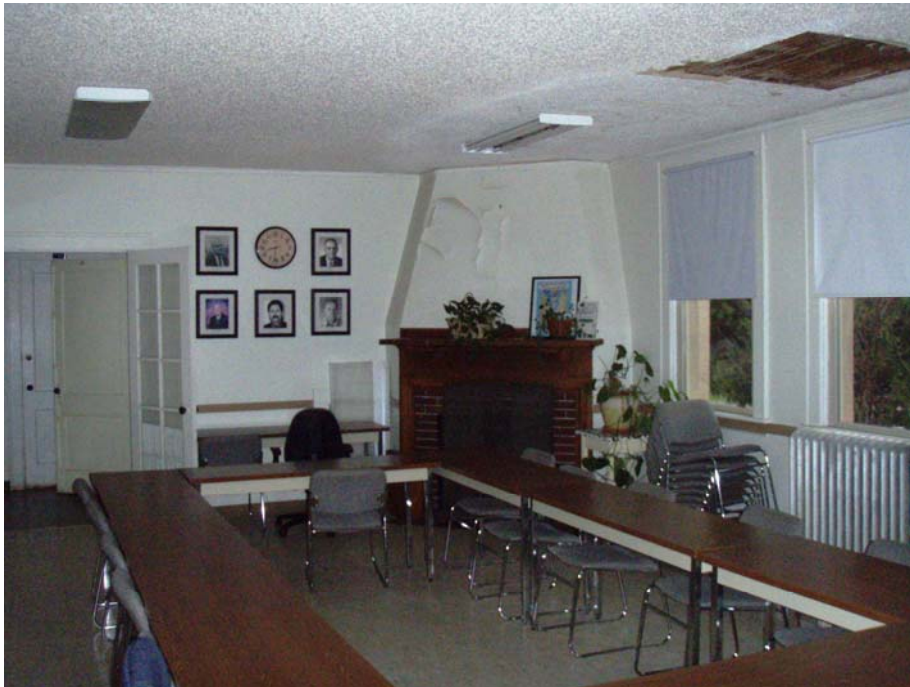
Figure 15. Interior view, south recreation room, view to the southeast.

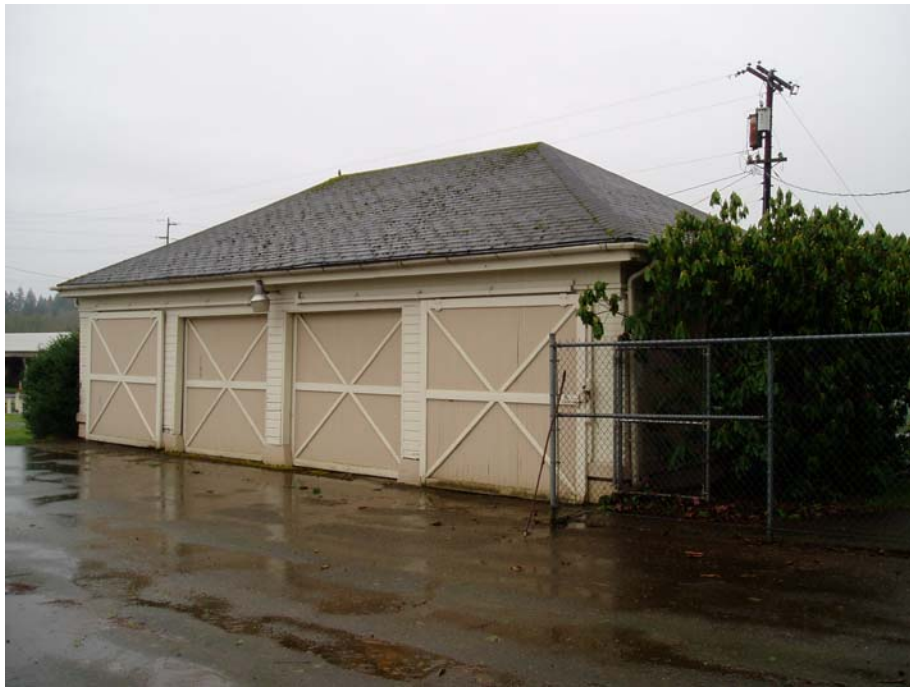
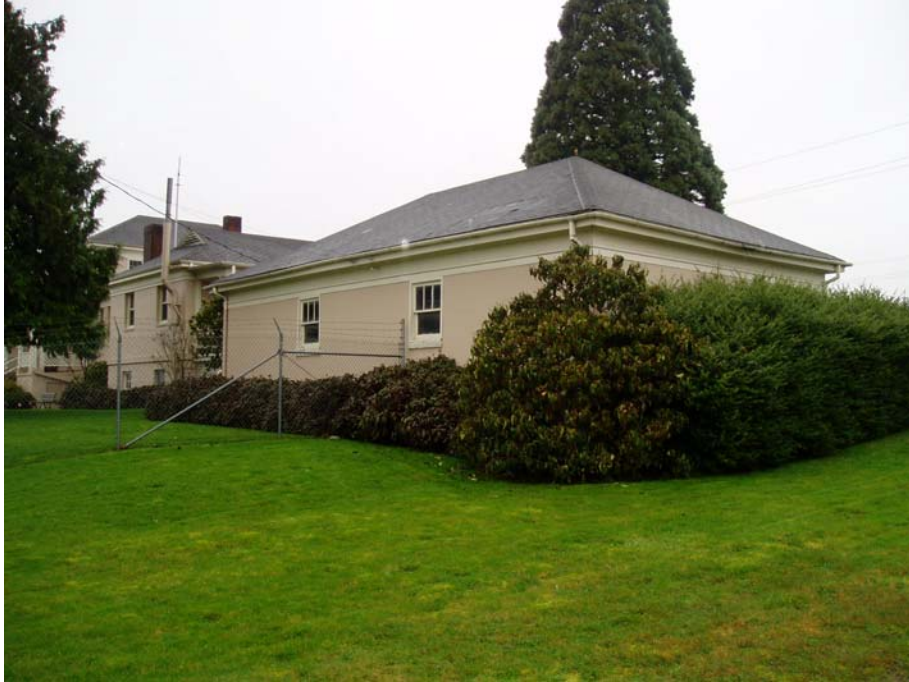
To the east of the main building is a four-bay garage building (built 1926) with a hipped roof and stylistic details to match the main building, including stucco finish, brick quoins and molded cornice (Figures 16 and 17). The garage retains excellent integrity, including all original 3-over-1 wood sash windows, and what appear to be original wood bay doors on the north elevation, the center two of which are upward operating, and the outer two of which are sliding doors.

Figure 16. Detached garage, built 1926. North elevation, view to the southeast.

Figure 17. Detached garage, built 1926. South (left) and east (right) elevations, view to the northwest.

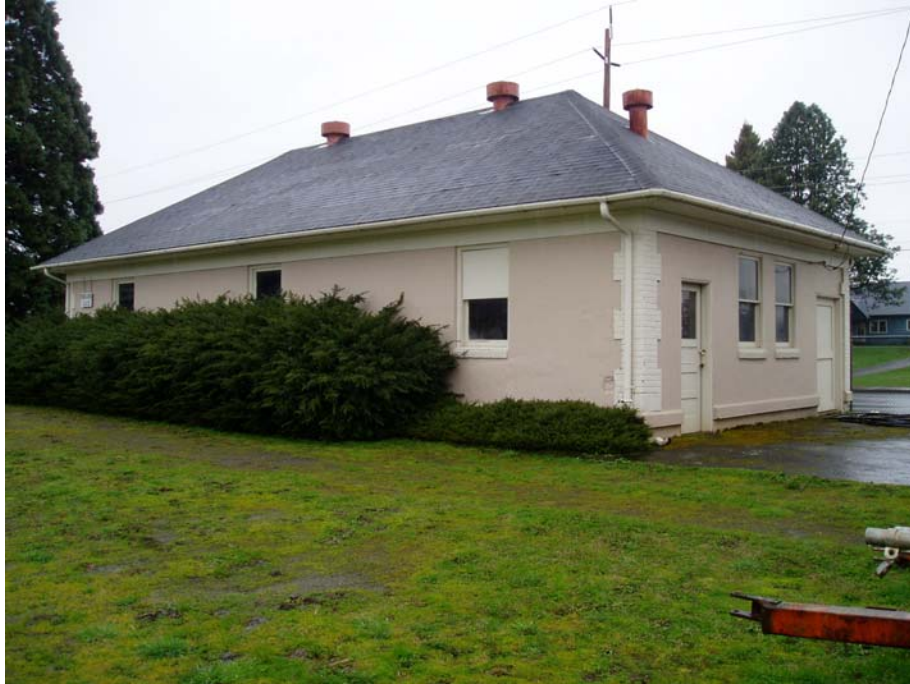
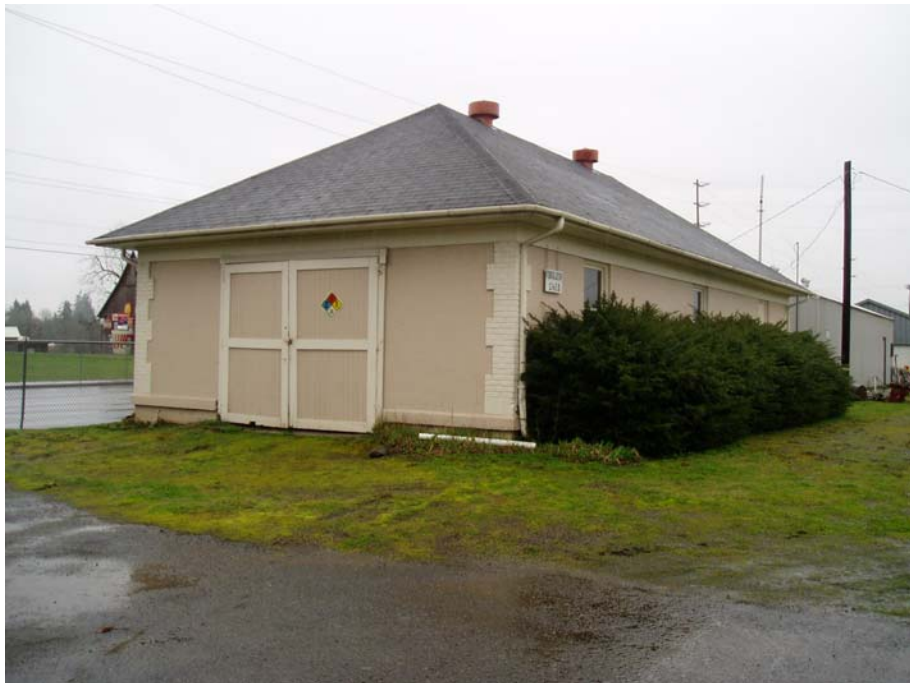
To the northeast of the garage, east of the main building, is the ca. 1936 milk house, now used for fertilizer storage (Figures 18 and 19). Although built later than the main building and garage, this building is designed with similar stylistic attributes, including a hipped roof, molded cornice (slightly different in profile from the garage), and brick quoins, though the brick used here is raked, while that on the 1926 buildings is smooth-faced. The windows on this building appear to be the original 1-over-1 wood sash windows. The paired wood vehicle doors on the west elevation of the milk house appear original, as does the entry door on the east elevation.

Figure 18. Milk house, built 1936. South (left) and east (right) elevations, view to the northwest.

Figure 19. Milk house, built 1936. West (left) and south (right) elevations, view to the northeast.

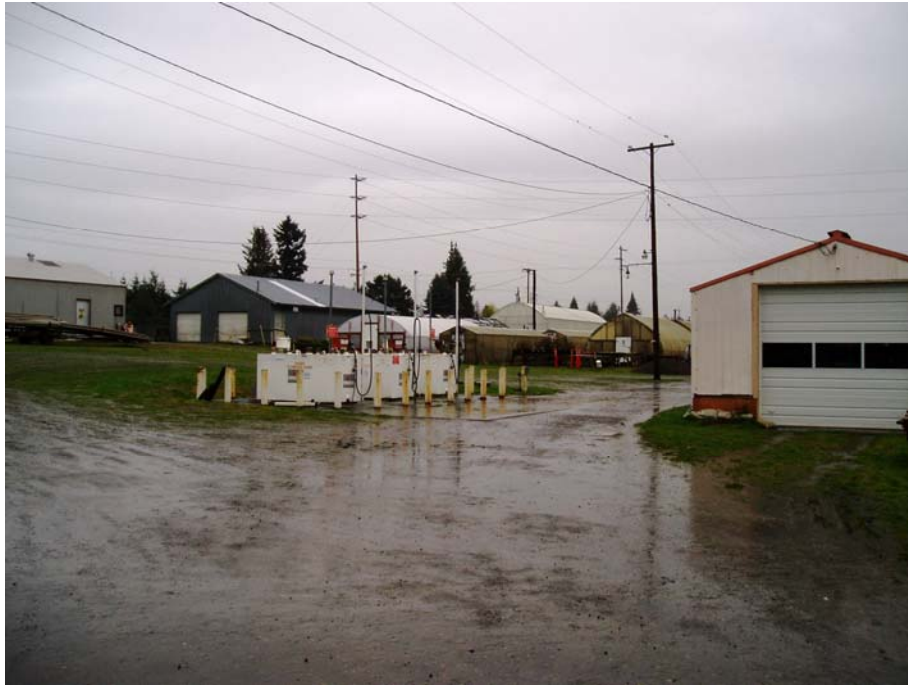
Figure 20. View of agricultural storage buildings and greenhouses to the east of the main building, built by WSU between 1960 and 1995.

Immediately to the east of the milk house is the concrete foundation and loading ramps of the large gambrel-roofed barn, evident in the ca. 1944 photographs. IT was demolished some time after 1955, since it appears in aerial photographs taken that year. According to Dave Foes,

employee at the farm since 1967, the barn was demolished before he started working there (Dave Foes, personal communication, February 26, 2010). This foundation is partially built upon, holding a ca. 1965 storage shed (Figure 20).

The view is to the east-northeast.

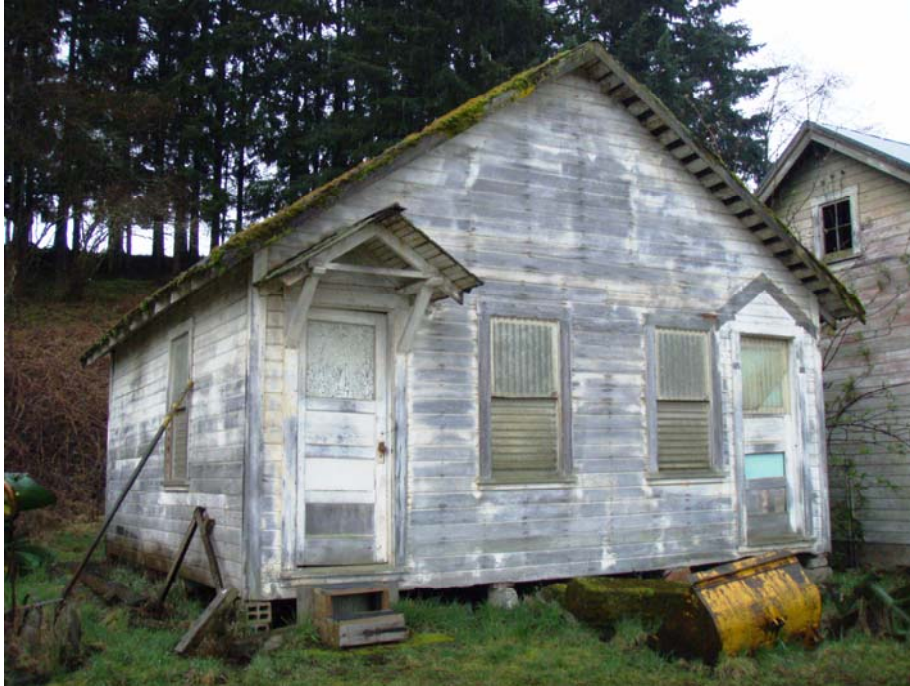
Figure 21. Bunk House, east (left) and north (right) elevations. The view is to the south-southeast.

The bunk house, located immediately to the east of the machine shed, is a ca. 1925, front-gabled building with two front entry doors, both once covered with a gabled entry hood supported by kneebraces (Figure 21). It is approximately 22-feet by 22-feet, and is oriented north, with the doors on that elevation. The entry hood over the west door (leading to the kitchen area) is no longer present. The building is clad with v-matched shiplap siding and the roof is clad with asphalt shingle. Windows are 1-over-1 wood frame windows, and all are intact, though covered over with sheets of corrugated fiberglass. The interior is divided into two rooms, with the kitchen occupying the northwest corner of the building, and then the rest of the building, which is open. The interior walls are clad with beaded tongue-in-groove, and the kitchen appears to retain its original cabinetry. The building is set on concrete blocks and structural tile – an informal approach to keeping it away from ground moisture. Overall, the bunk house is in poor condition, with significant leaking in the roof causing decay in the ceiling, which is beginning to show signs of failure. The building is currently used for storage.

The bunk house appears to have been built ca. 1920, and may be contemporary with the main building or predate it. It has been in its current position since it was moved there some time between 1955 and 1967. Its original position has been reported as being next to the main building, along the south side of NE 78th Street, but this cannot be confirmed. SWCA recommends that this building is eligible for listing in the NRHP under Criterion C as a representative example of farm-related domestic buildings of the early 20th century, and under Criterion A through its association with the agricultural functioning of the Clark County Poor Farm, to which it contributes historical significance and integrity. The building itself retains good integrity, despite having been moved to its current position. Because it is believed that the building was moved from its original position somewhere else on the property, SWCA recommends that the building retains sufficient integrity of location and setting to remain eligible for listing in the NRHP.

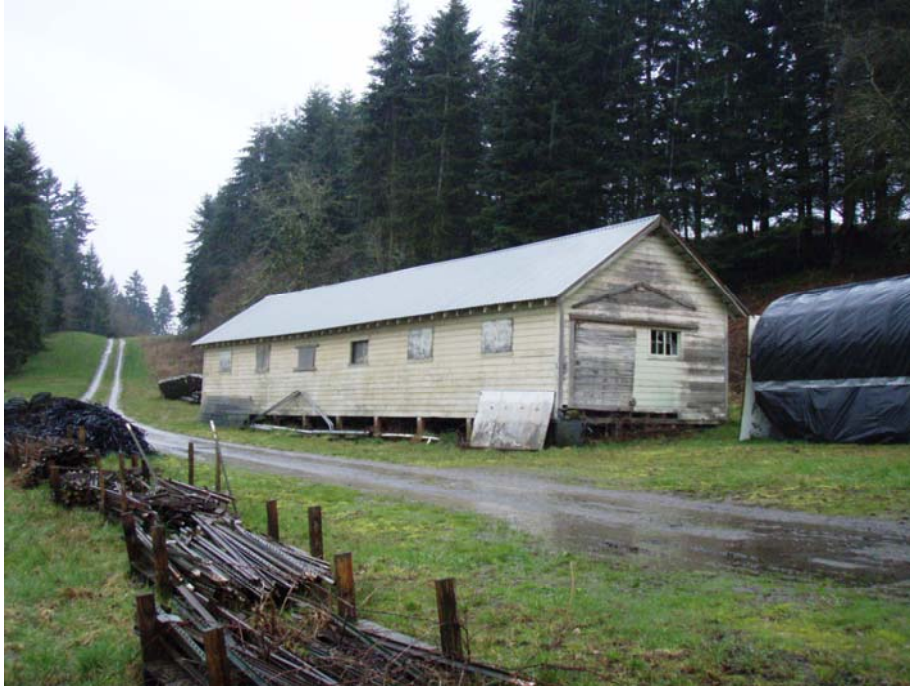
Figure 22. Hog Barn, north (left) and west (right) elevations. The view is to the southeast.

The ca. 1920 hog barn is located to the east of the bunk house, and is approximately 80-feet long and 25-feet wide (Figure 22). It is oriented east-west, and is set upon wood posts. It is clad with coved shiplap (or, “drop”) siding with cornerboards, and has 4-by-4 wood slider windows on all four elevations. Exposed rafter tails extend from beneath the eaves. The roof is clad with corrugated steel, which replaced the original wood shingle roof in 1990 (Dave Foes, personal communication with Jason M. Allen, February 26, 2010). The barn has sliding wood vehicle doors at both ends. The building is now used for storage.

that this structure was moved to its current location, however, this has not been confirmed, and the impression may simply be a result of the structure currently standing on clearly newer posts, possibly a relatively recent stabilization effort. It is known that the Clark County Poor Farm activities included raising pigs, suggesting that this structure may be original to the farm. SWCA recommends that this building is eligible for listing in the NRHP under Criterion C as a representative example of farm-related livestock barn of the early 20th century, and under Criterion A through its association with the agricultural functioning of the Clark County Poor Farm, to which it contributes historical significance and integrity.

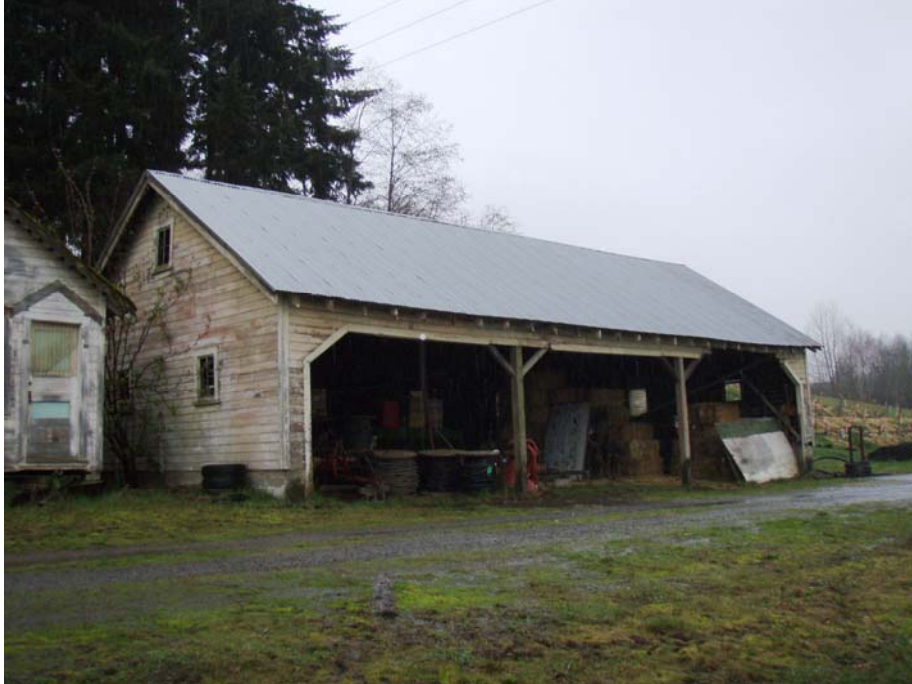
Figure 23. Machine Shed, east (left) and north (right) elevations, viewed to the southwest. The bunk house is visible at the far left.

The machine shed, built ca. 1930 is the only building of the three that appears to be in its original location (Figure 23). It is a three-bay, side-gabled machine shed with v-matched shiplap siding, cornerboards, and exposed rafter tails. The building has a dirt floor, and rests on a concrete stem-wall foundation. It has 4-light wood windows on the south (rear), east and west (side) elevations, including a four-light window in both of the gable peaks. The roof is clad with corrugated steel.

The machine shed appears to have been built ca. 1930, and may be contemporary with the main building. The machine shed does not appear to have been moved from its original location, nor does it appear to have been much altered from its original appearance. SWCA recommends that the machine shed is eligible for listing in the NRHP under Criterion C as a representative example of farm-related machine shed of the early 20th century, and under Criterion A through its association with the agricultural functioning of the Clark County Poor Farm, to which it contributes historical significance and integrity.

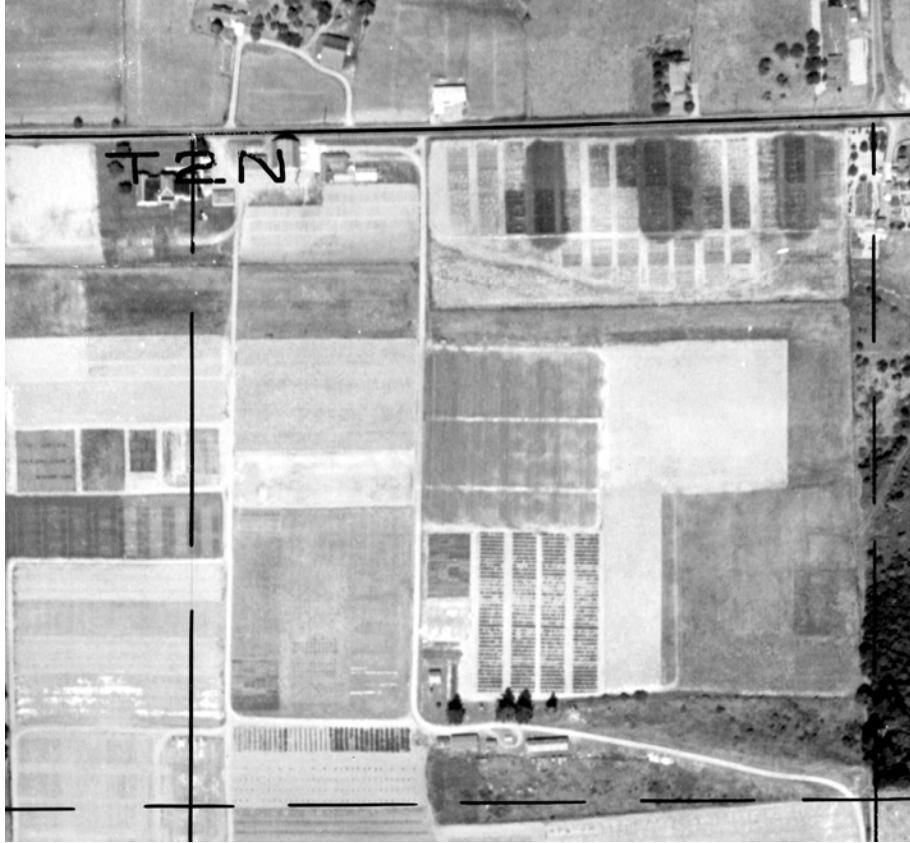
Figure 24. 1955 aerial image indicating Clark County Poor Farm.

The hog barn and machine shed both appear in their present positions on a 1955 aerial photograph (Figure 24). In addition to these, there are two smaller structures on the south side of the gravel road, but neither of these matches the dimensions of the bunk house. There is a small structure to the north of the gravel road, on the inside corner of the turn where the road changes from north-south to east-west that appears to match the dimensions of the bunk house, but it is not known if this is the same building. In addition, there is a shadow of approximately the same dimensions on the south side of 78th Street, just to the west of the main building, but writing on the aerial photograph obscures this, and it is not clear whether this is the bunk house, another structure, or even a mature tree. A 2004 archaeological predetermination report states that the bunk house was originally located along 78th Street, near the main building, but the statement is unattributed, and cannot be confirmed. It is known that the bunk house has been in its present location since at least 1967 (Dave Foes, personal communication, Feb. 26, 2010).

Main Building, Detached Garage, and Milk House are at the upper left, Machine Shed and Hog Barn at lower center. The structure indicated to the north of the Machine Shed may be the Bunk House. Source: Clark County Department of Community Planning.

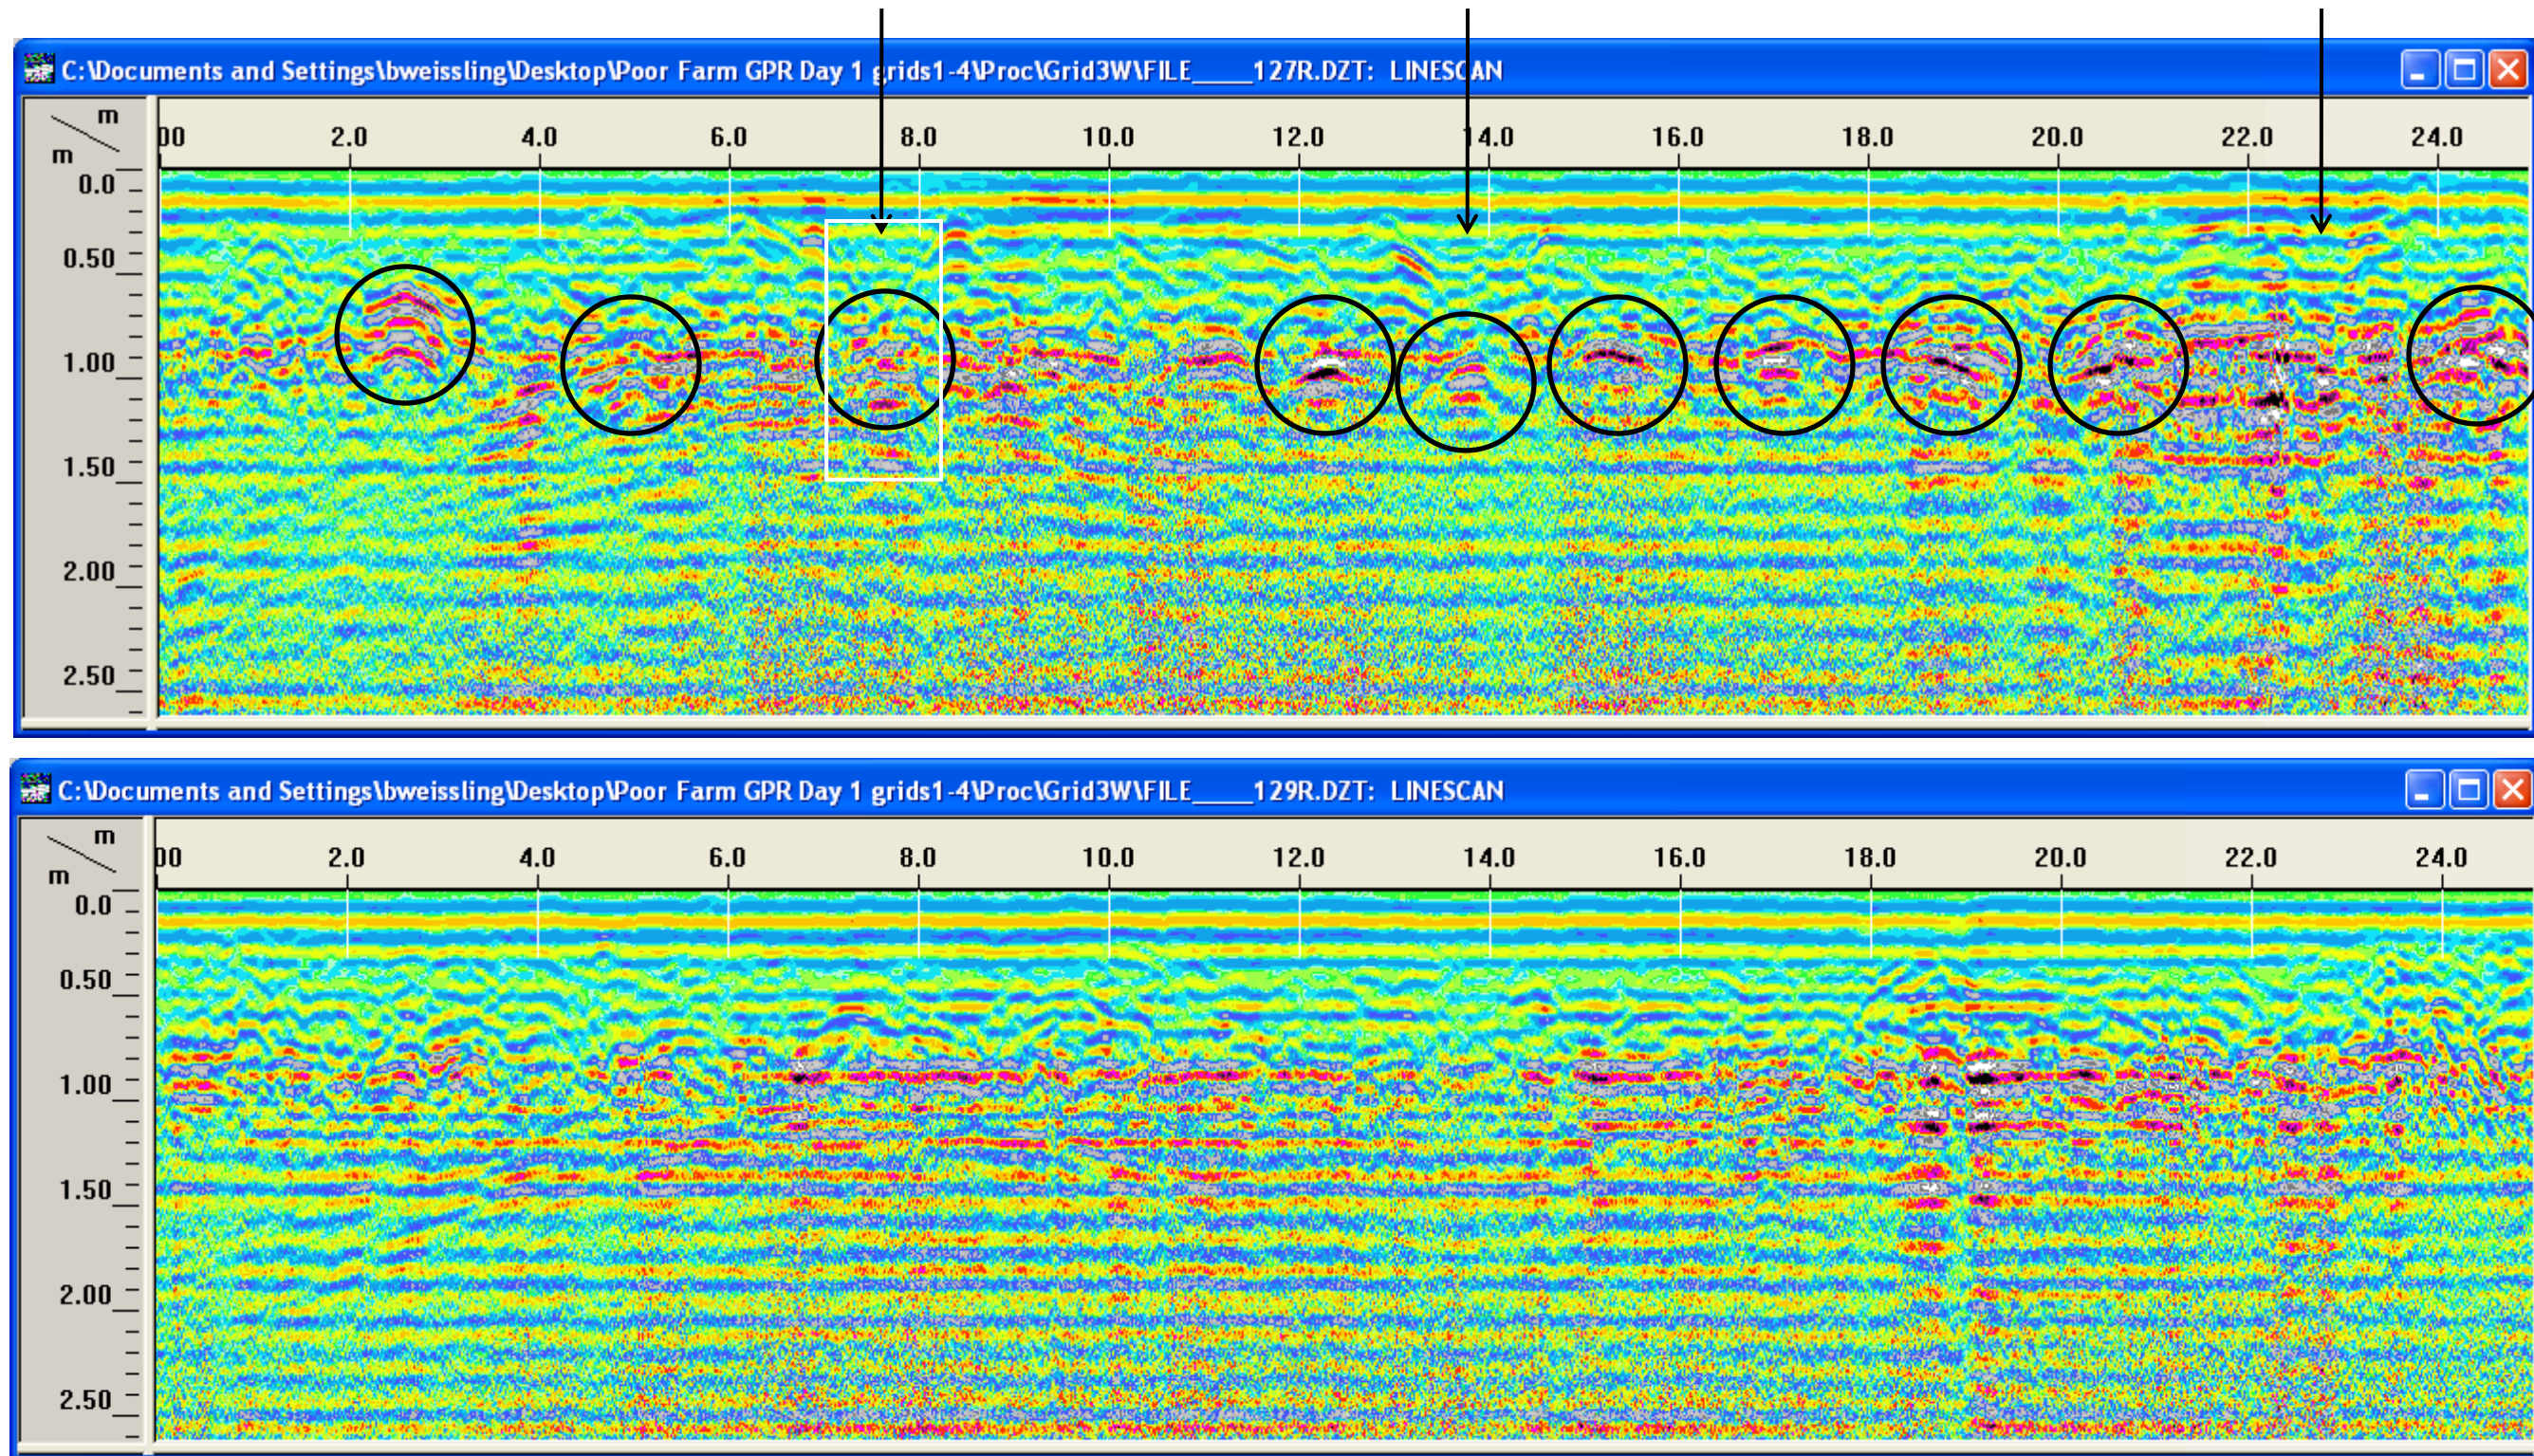
Figure 26. Radar profile line 127 (top) of grid 3 showing anomalies consistent in both depth and spacing with burials.

Note the apparent collapse features associated with the underlying mounds

White rectangle depicts approximate dimensions of burial excavation, with width (4 feet) matching width of collapse feature. Line 129 (bottom) shows a relative absence of mound or collapse type anomalies.

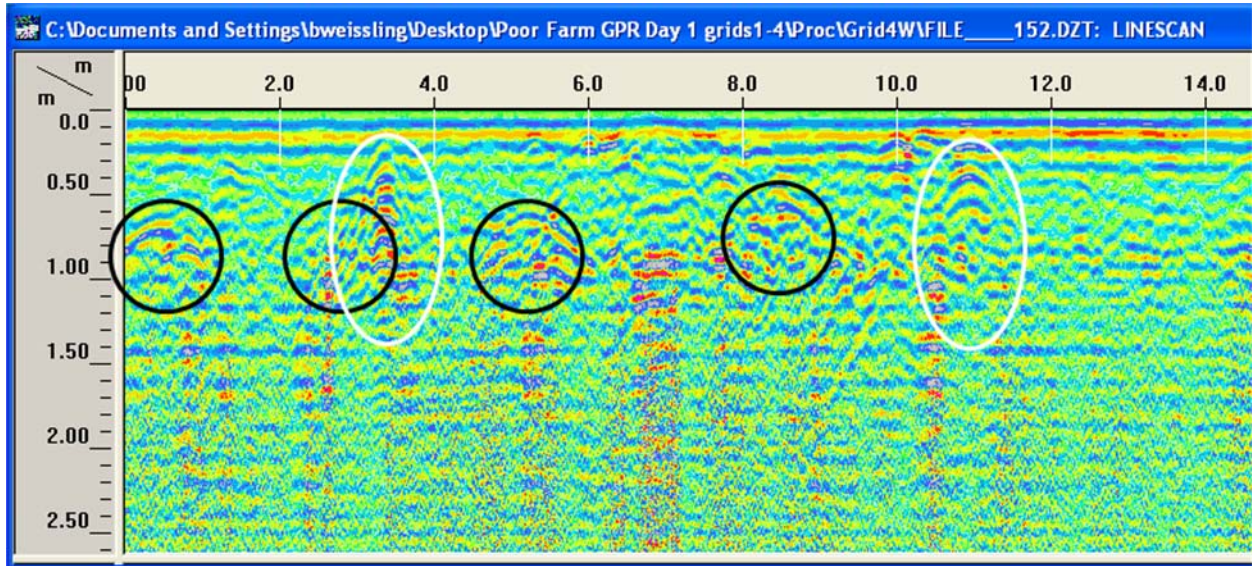
Figure 27. Beginning portion of radar profile line 152 of grid 4 showing two strong diffraction anomalies (within white ovals) that are likely associated with near-surface metallic objects.

Black circles show mound anomalies that are consistent with burials.
