Intensive-level Documentation of the Clark County Poor Farm Buildings and Poor Farm Cemetery Remote Sensing Project, Clark County, Washington

County: Clark County
Legal Location: T2N, R1E, Section 11
USGS 7.5-minute quad: Vancouver, WA
Type of Project: Intensive-level Historic Properties Survey and Remote Sensing
Results of Survey and Subsurface Probing: N/A
Field Notes: On file at SWCA, Portland Office

SWCA Project Number 16314
SWCA Report Number 2010-265
July 6, 2010

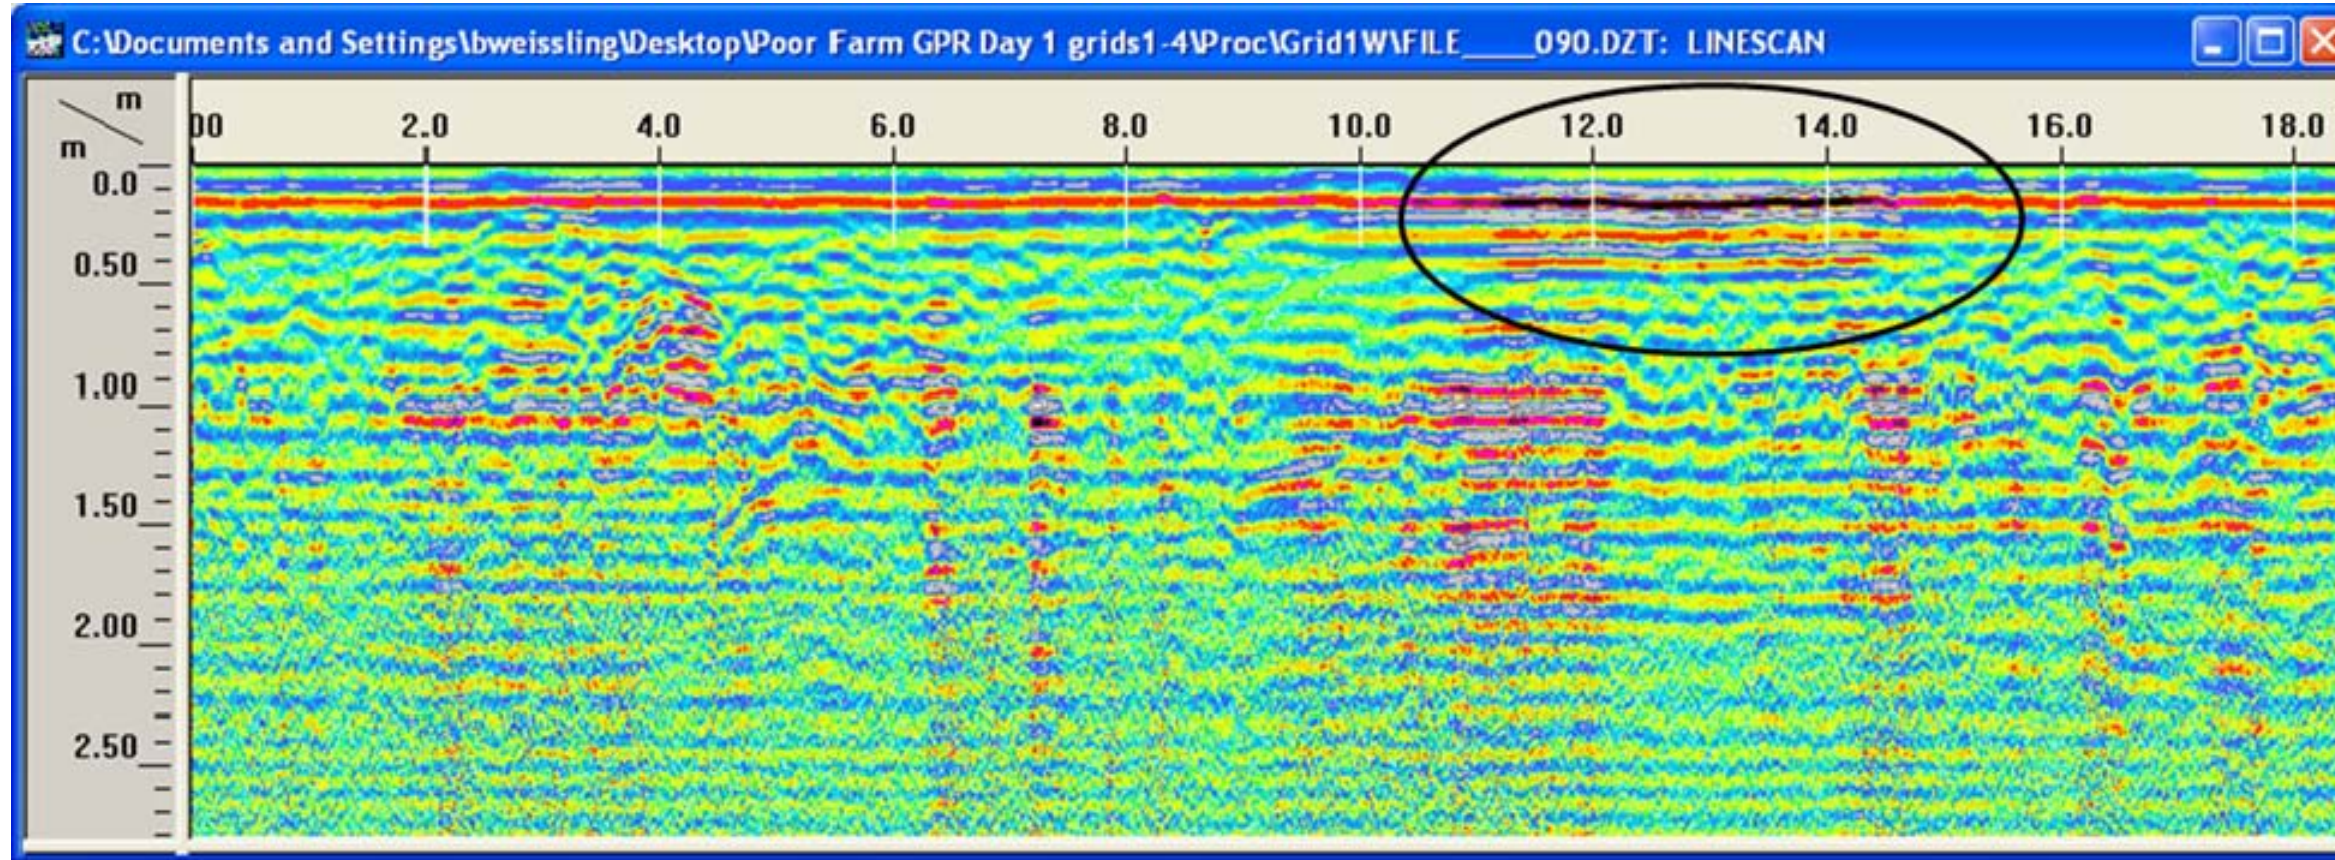
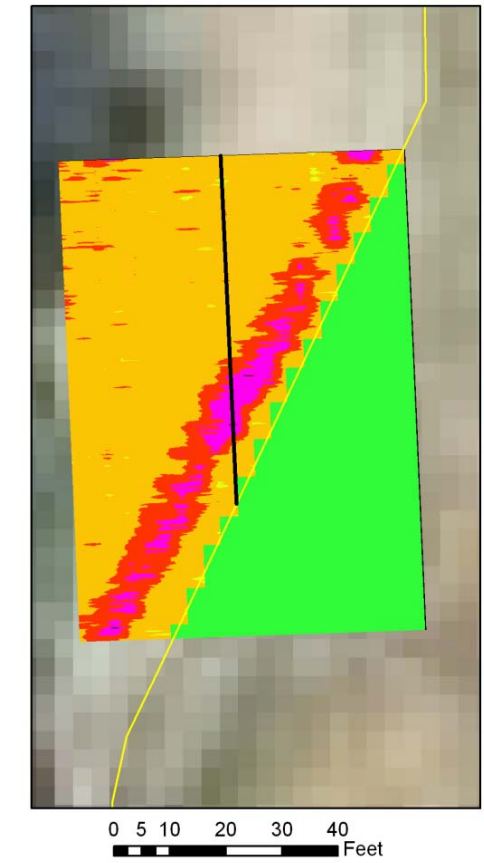
Figure 31. GPR line 90 (grid 1) showing high amplitude, near-surface radar anomaly interpreted as compact earth from a roadway.

Inset shows location of radar line crossing anomaly.

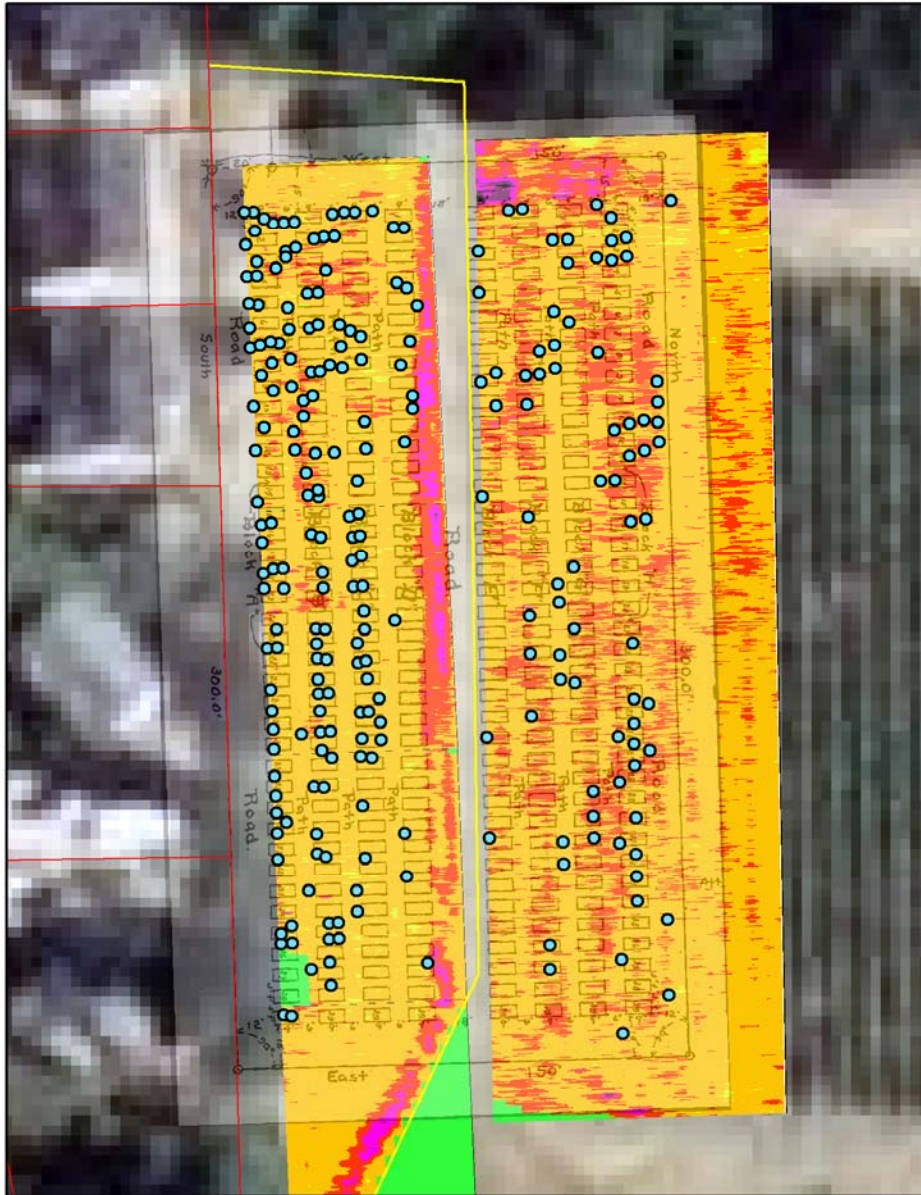
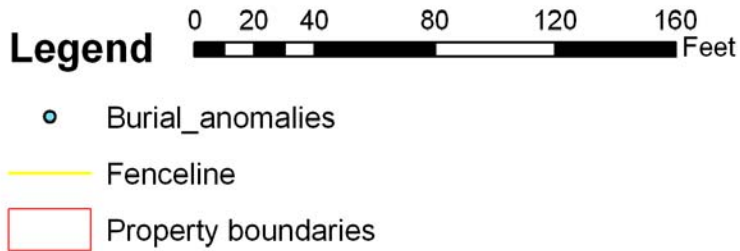
Figure 33. Final location map of Poor Farm Cemetery 1913 plat with GPR burial anomalies and cemetery access road anomaly.

The success of the utilization of ground penetrating radar for detection and delineation of burial locations and extent at the Clark county Poor Farm Cemetery has been clearly demonstrated by this geophysical survey effort. It can be reasonably asserted that the boundaries of the platted cemetery have been located to within a few feet. As such, it is highly probable that the roadway anomaly located immediately west and adjacent to the existing interior fence represents the historical interior roadway of the cemetery. As that historical roadway most likely did not impinge on existing burials, it may serve in the present context as the most favorable route for visitor ingress and egress to the site.

Geophysical investigations at the Clark County Poor Farm Cemetery have determined that the present chain link fence thought to surround the cemetery does not reflect the true boundaries of the cemetery in terms of the platted cemetery boundary, nor the locations of interments. Rather, the fence line appears to encompass only the western half of the cemetery, while the eastern half has been subject to agricultural practices for more than 50 years. SWCA has found that interments in the cemetery conform to the plat diagram for the cemetery, and that the plat generally represents an accurate view of burial locations. SWCA recommends that the fence around the cemetery be moved to represent the proper boundaries of the cemetery in order to properly protect the integrity of the burials. In addition, SWCA recommends that the now-determined extent of burials be used in future project planning in order to avoid disturbance of burials.

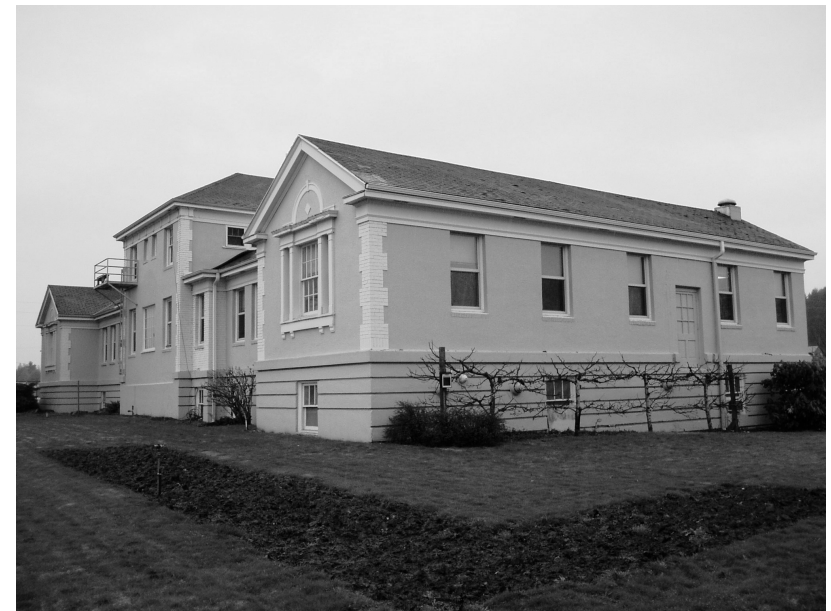
View of Clark County Poor Farm Main Building, view to the southeast taken 2/26/2010

The Clark County Poor Farm main building is a large, concrete building in the Italian Renaissance style, built in 1926 (Figure 8). The building has three masses: a two-story, hipped-roofed central mass with one-story, forward-projecting, gabled wings on each side. The building has a rusticated daylight basement, topped by a beltcourse, above which the walls are stucco, and feature brick quoins at all outside corners. Centered on the front (north) elevation of both gabled wings is a large, Palladian-motif window with a central 10-over-10 wood sash window flanked by 2-over-2 wood sash windows, all capped by a heavy entablature. The central window is topped by a molded arch with a brick diamond in the center. The gables have heavy-molded cornices and cornice returns, while the elaborated cornice along the hipped roof of the main central mass features triglyphs and guttae across the principal (north) elevation. The cornice continues across the side and rear elevations of the main mass, but without the triglyphs and guttae. Windows (aside from the Palladian-motif windows) are generally 1-over-1 steel or vinyl windows, though some of the original 6-over-1 wood sash windows remain, as do both original diamond-pattern windows in the second floor, principal elevation of the central mass. All of the original 3-over-1 wood sash basement windows are intact, except the rear elevation, where windows were originally 6-over-1, two out of six of which have been replaced (one with aluminum slider windows and the other with a steel fixed window). Most first floor windows have been replaced with 1-over-1 steel or vinyl windows, though fenestration has not been

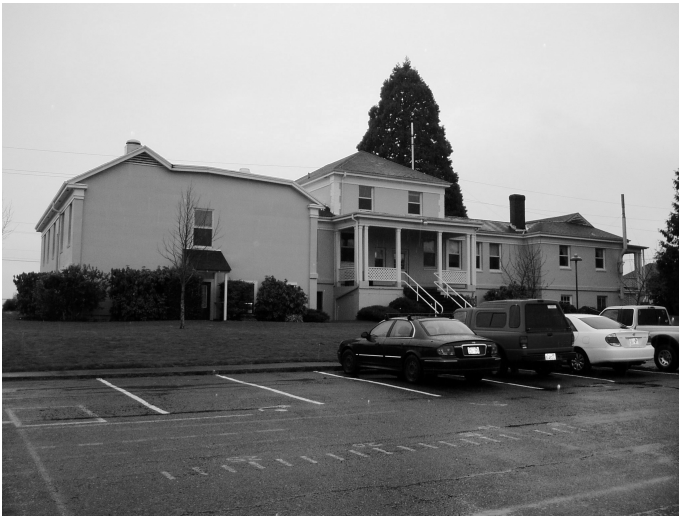
View of Clark County Poor farm Main Building, view to the northeast **taken** 2/26/2010

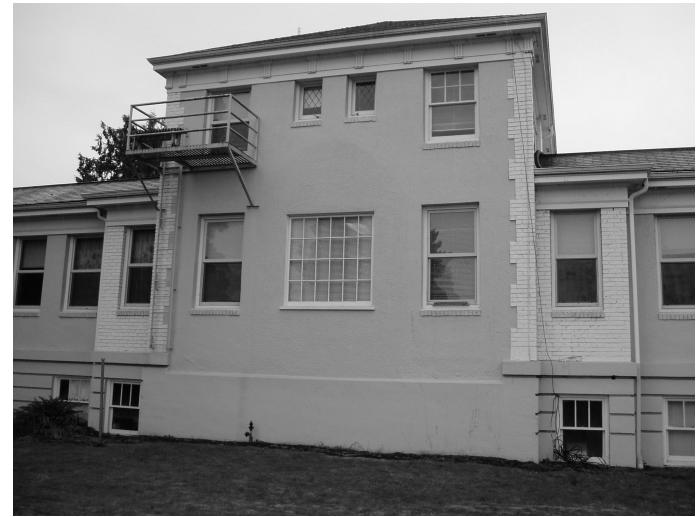
View of Clark County Poor Farm Main Building, view to the south **taken** 2/26/2010

Comments: Central Mass, north elevation (original entry removed from center)

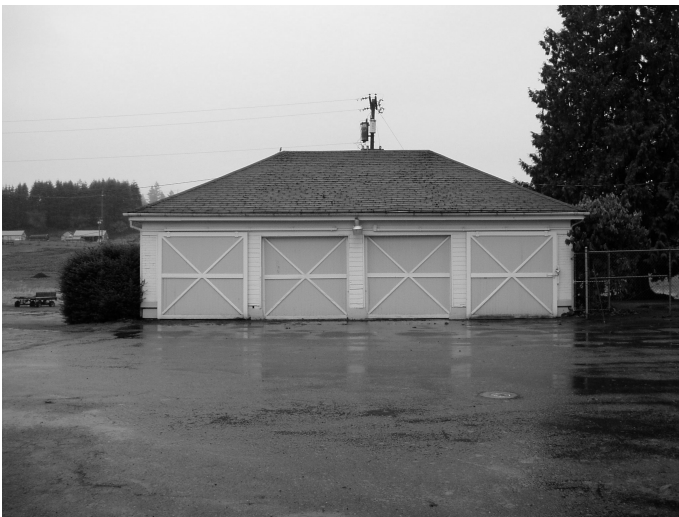
View of Clark County Poor Farm Detached Garage, view to the south **taken** 2/26/2010

Comments: north elevation

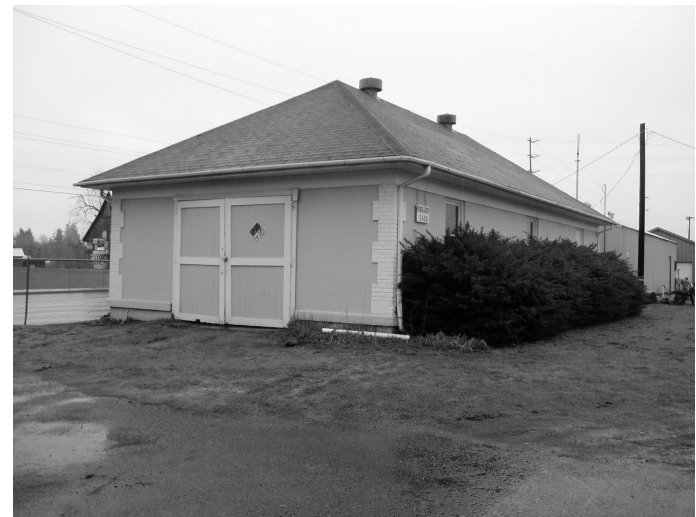
View of Clark County Poor farm Milk House, view to the northeast **taken** 2/26/2010

To the northeast of the garage, east of the main building, is the ca. 1936 milk house, now used for fertilizer storage (Figure X). This building, though built later than the main building and garage, is designed with similar stylistic attributes, including the hipped roof, molded cornice (slightly different in profile from the garage), and brick quoins, though the brick used here is raked, while that on the 1926 buildings is smooth-faced. The windows on this building appear to be the original 1-over-1 wood sash windows. The paired wood vehicle doors on the west elevation of the milk house appear original, as does the entry door on the east elevation.

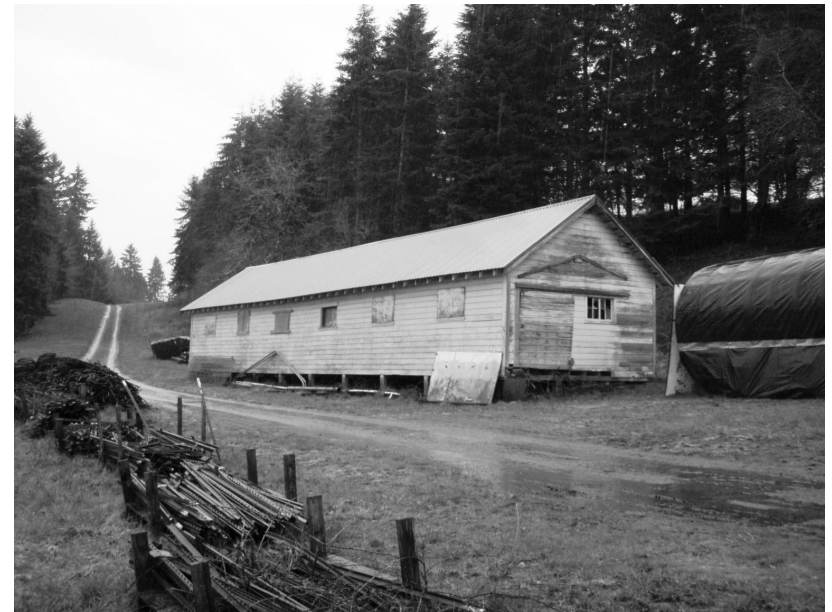
View of Clark County Poor Farm Hog Barn, view to the southeast taken 2/26/2010

The ca. 1920 hog barn is located to the east of the bunk house, and is approximately 80-feet long and 25-feet wide (Figure 22). It is oriented east-west, and is set upon wood posts. It is clad with coved shiplap (or, “drop”) siding with cornerboards, and has 4-by-4 wood slider windows on all four elevations. Exposed rafter tails extend from beneath the eaves. The roof is clad with corrugated steel, which replaced the original wood shingle roof in 1990 (Dave Foes, personal communication with Jason M. Allen, February 26, 2010). The barn has sliding wood vehicle doors at both ends. The building is now used for storage.

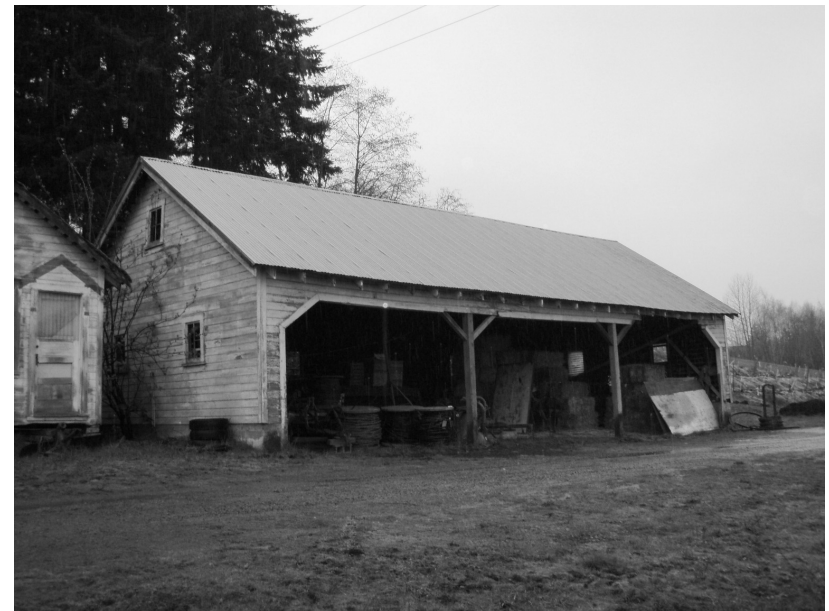
View of Clark County Poor Farm Machine Shed, view to the southwest taken 2/26/2010

The machine shed, built ca. 1930 is the only building of the three that appears to be in its original location (Figure 23). It is a three-bay, side-gabled machine shed with v-matched shiplap siding, cornerboards, and exposed rafter tails. The building has a dirt floor, and rests on a concrete stem-wall foundation. It has 4-light wood windows on the south (rear), east and west (side) elevations, including a four-light window in both of the gable peaks. The roof is clad with corrugated steel.
