PRPJ0000287/CRP391112 MASON CREEK BARRIER IMPROVEMENTS

QUESTIONS and ANSWERS

Mason Creek Fish Passage Barrier Removal Project

Wetland Delineation Report

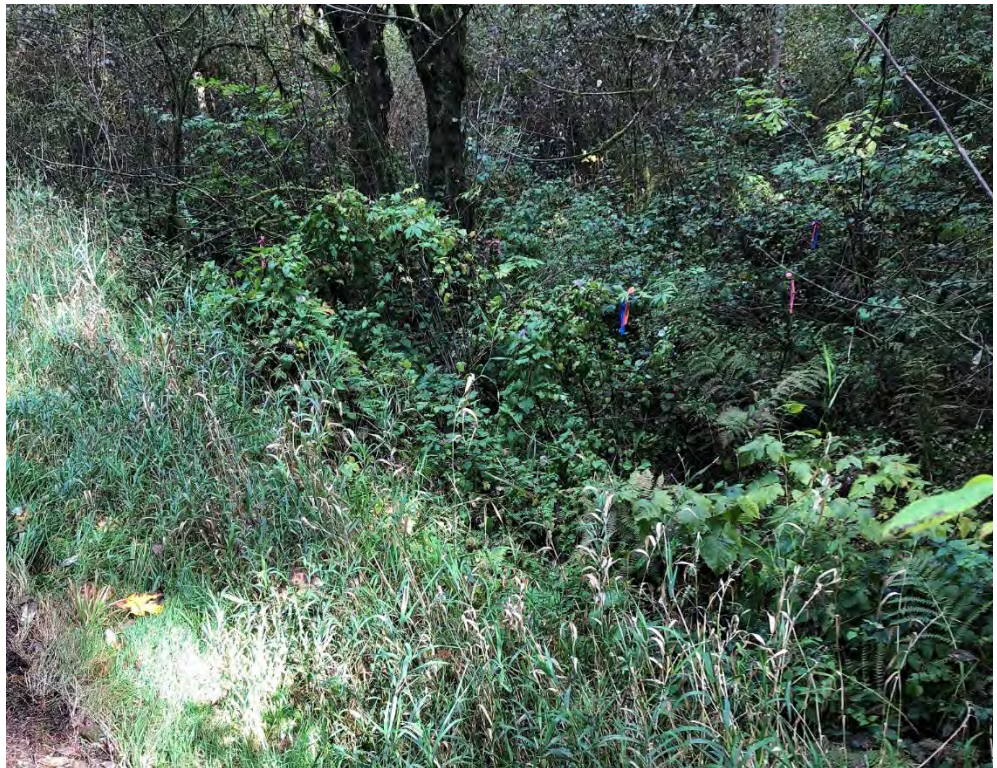
Photo No. 2	Date: 10/10/19

Direction Photo Taken: Northeast			
Description: Photo shows the northern portion of Wetland A where it extends up a topographically defined swale. The steep road embankment of NE 102nd Avenue (bottom left) defines the western boundary of the wetland.

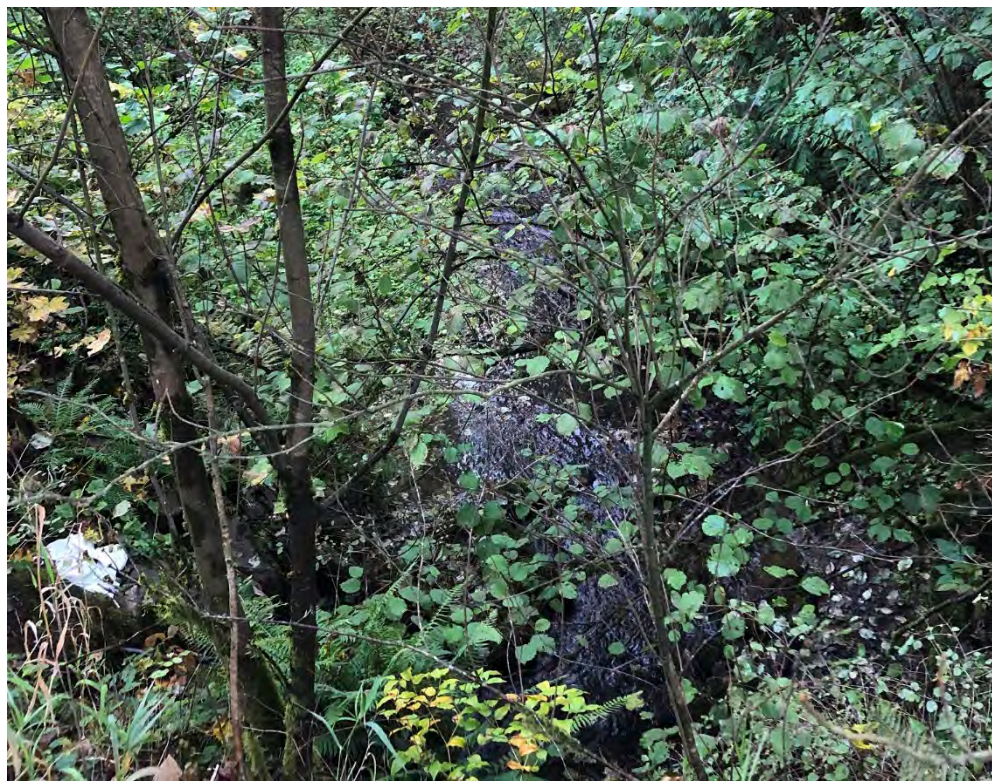
Photo No. 3	Date: 10/10/19
Direction Photo Taken: East	
Description: Photo shows Mason Creek just before it enters the culvert inlet at NE 102nd Avenue (bottom). Trees and shrubs that make up the riparian area provide shade and habitat benefits to the creek.

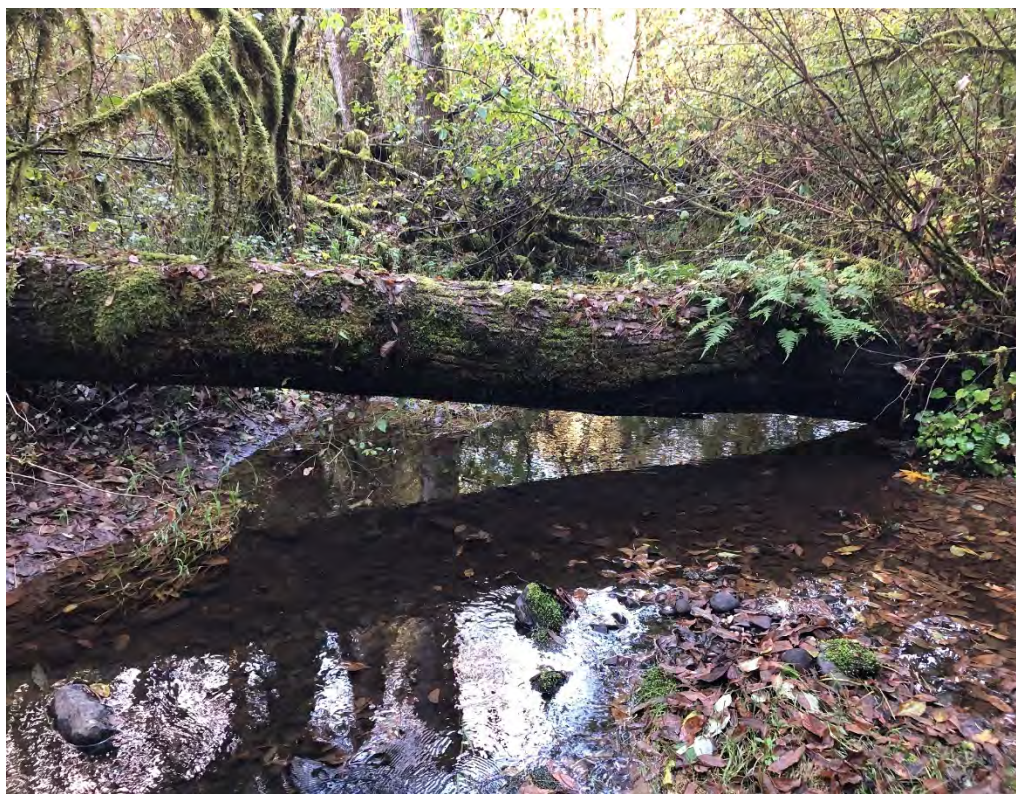
Photo No. 4	Date: 10/10/19
Direction Photo Taken: Northeast	
Description: Just upstream of the proposed culvert replacement project, a large fallen log straddles Mason Creek, providing shade and habitat complexity.

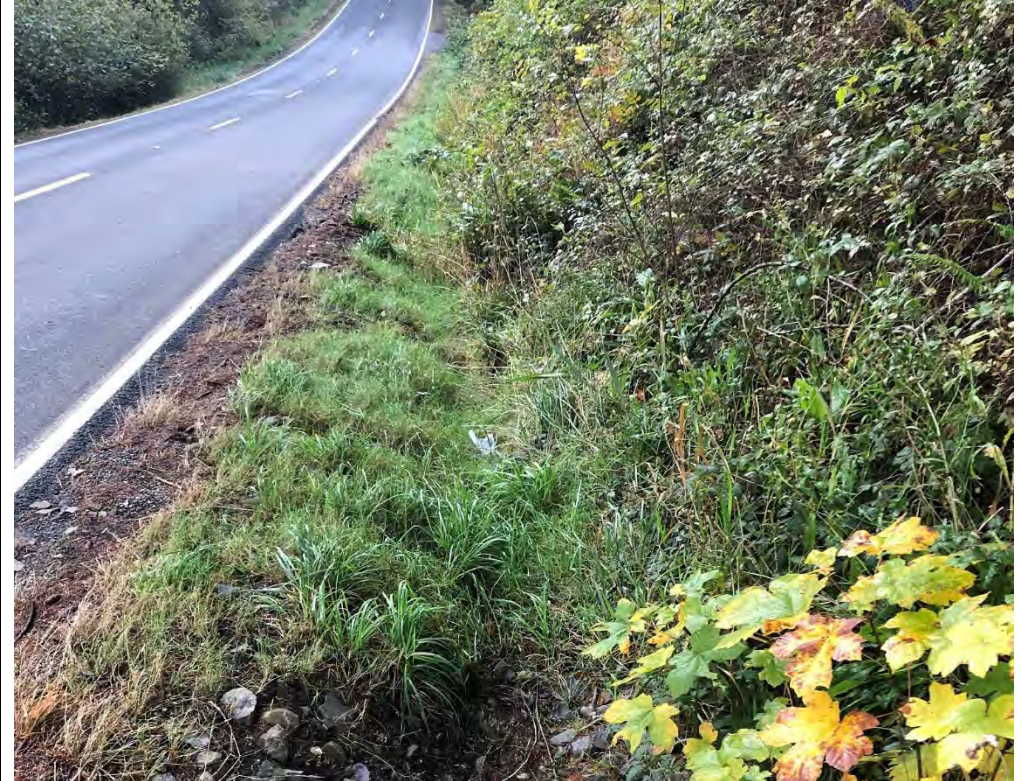
Photo No. 5	Date: 10/10/19

Direction Photo Taken: North		
Description: NE 102nd Avenue slopes down toward Mason Creek from the north and south. Road runoff is conveyed to the creek via vegetated roadside ditches.
