Vancouver Lake Integrated Aquatic Vegetation Management Plan (IAVMP)

Prepared by Justin Collell,
Clark County Noxious Weed Board Coordinator

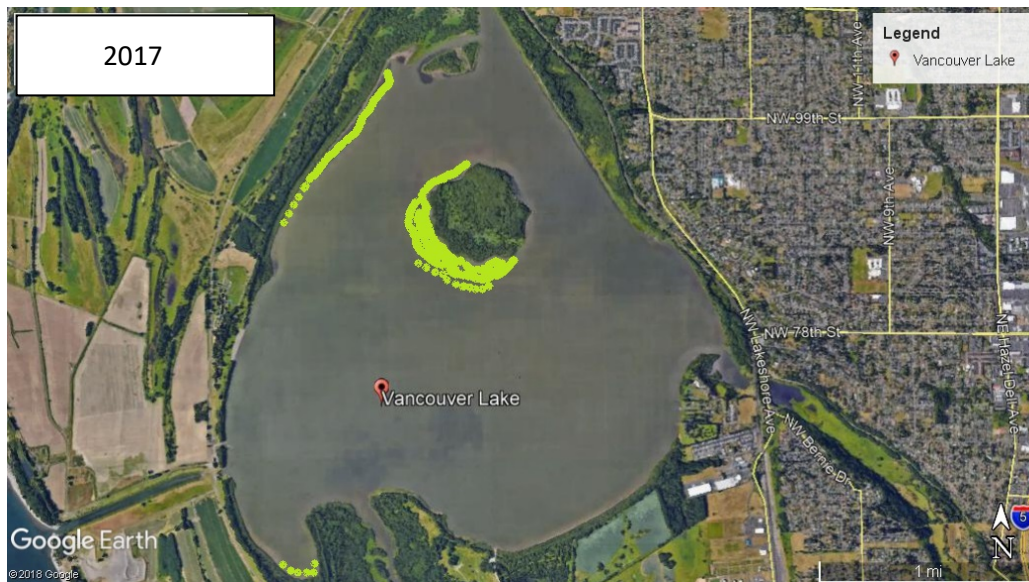
Of these species, EWM has spread the most since first detection and is illustrated by comparing Figure 1, Figure 2, and Figure 10. Milfoil causes recreational, economic and ecological damage by changing how residents, visitors, and wildlife use and enjoy infested lakes. It overtakes habitat and outcompetes native aquatic plants, lowering plant species diversity (Madsen et al., 1991). Dense mats of EWM at the water's surface inhibit all water recreationists such as swimmers, rowers, sailors, paddlers, anglers, and hunters. Across Washington, the total direct impacts to boating from EWM are estimated at \$5,140,000 (Cohen et al., 2017). Hunters using the WDFW wildlife area at the southern end of the lake have expressed fear of their dogs getting entangled in milfoil, or having difficulty walking through it themselves. The WDFW wildlife area at the end of La Frambois road is shown in Figure 5 along with the other beneficial use areas at Vancouver Lake.

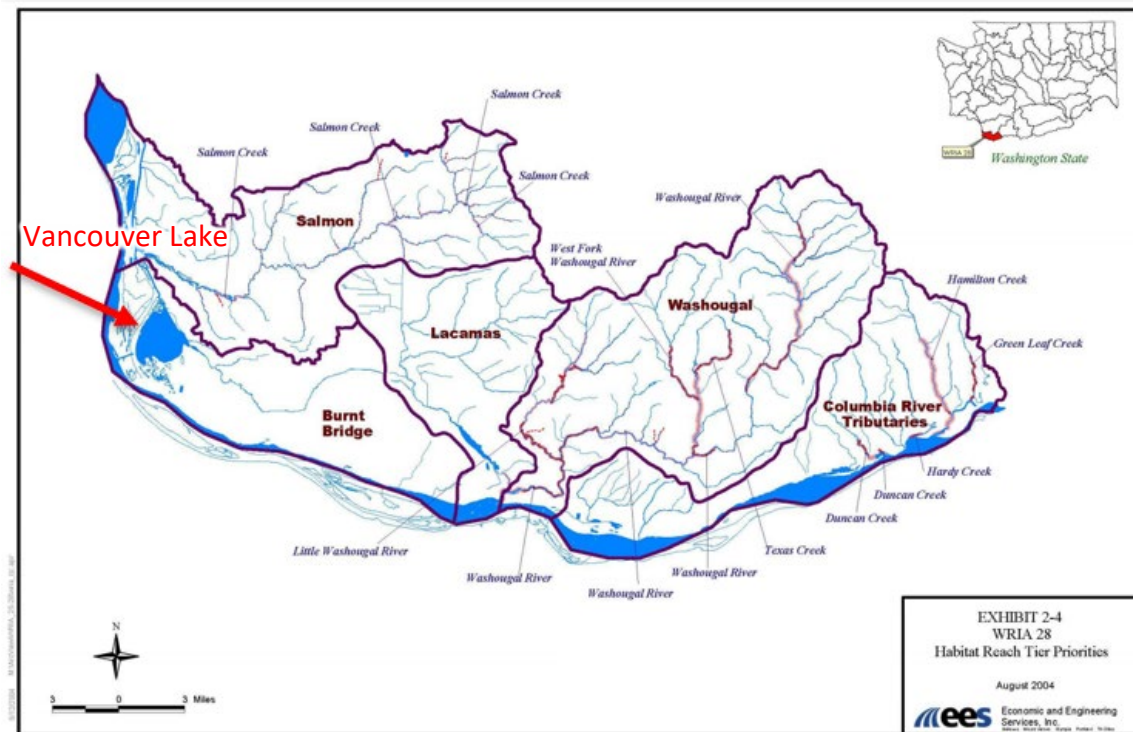
Figure 3. Water Resource Inventory Area 28 boundaries (Map credit: Salmon-Washougal and Lewis Watershed Management Plan, Lower Columbia Fish Recovery Board)

Vancouver Lake is one of several large, shallow lakes in the lower Columbia River floodplain and may have been formed by a series of Missoula Floods coursing through the Columbia River channel, and then further worked by the river itself with seasonal inundation. Historically, the lake was connected to the Columbia River through Mulligan Slough to the south and Lake River to the north. Diking and filling along the south and west lake shoreline and along the Columbia River shoreline led to the eventual separation of the lake and the river (Clark County, 2004). As part of a project to dredge the lake and create the flushing channel in the 1980's, Turtle Island was created towards the north end of the lake. Vancouver Lake is part of Water Resource Inventory Area (WRIA) 28, see Figure 3.

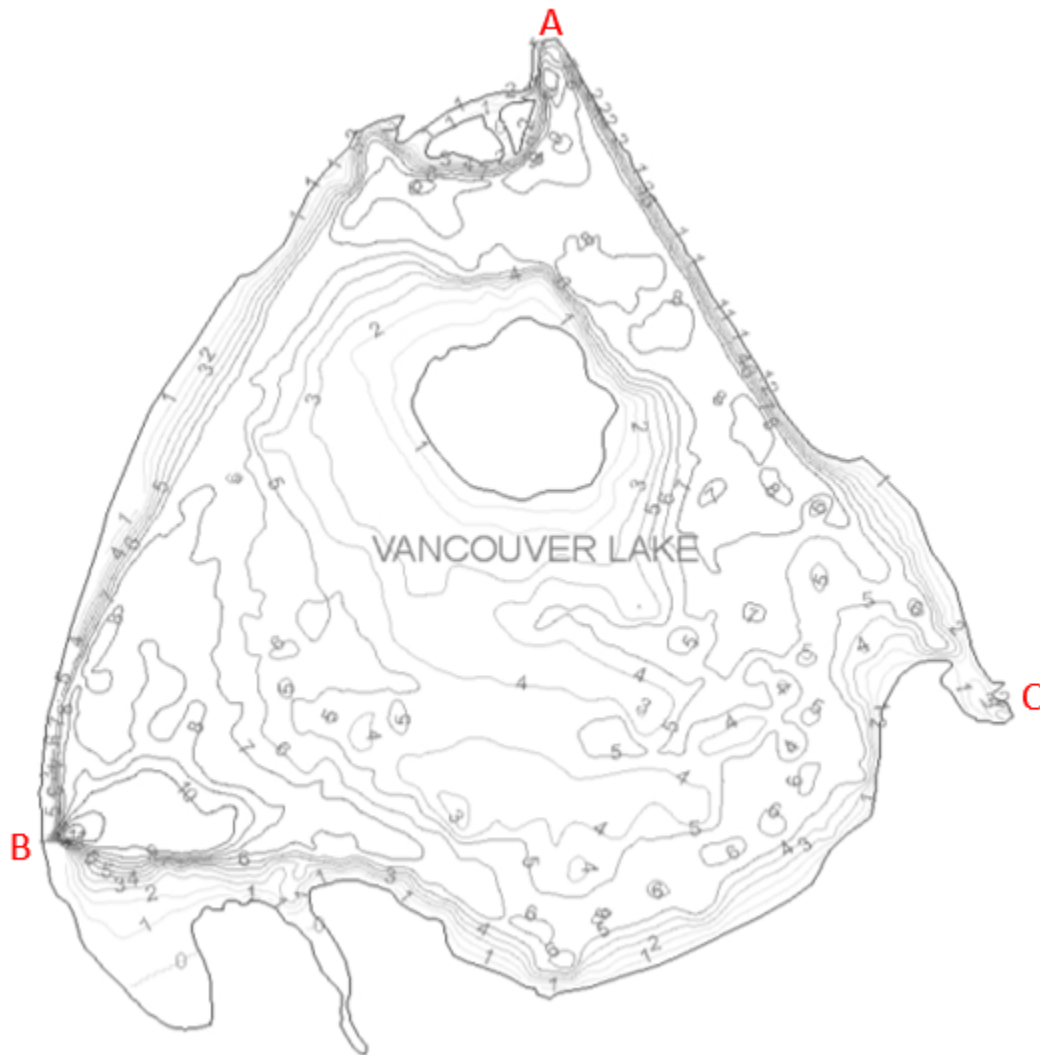
Figure 4. Vancouver Lake's relative water depth contours in feet based on GPS and depthfinder data collected by Spenser Vines as part of his Eagle Scout project work (October 11, 2004). Water flows into the lake from Burnt Bridge Creek (Point C), and sometimes from Lake River (Point A), and the flushing channel (Point B). Water only flows out via Lake River (Point A).

Vancouver Lake has a surface area of about 2,300 acres and a maximum width of over two miles. Its depth is highly variable, but the lake is considered to be very shallow with a mean depth of less than three feet and a maximum depth of about twelve feet near the dredged area at the mouth of the flushing channel (Figure 4). The lake's deepest parts are located along the east and west shorelines, in channels along the margins of the lake, leaving the majority of open water near the middle of the lake less than four feet deep throughout much of the year.

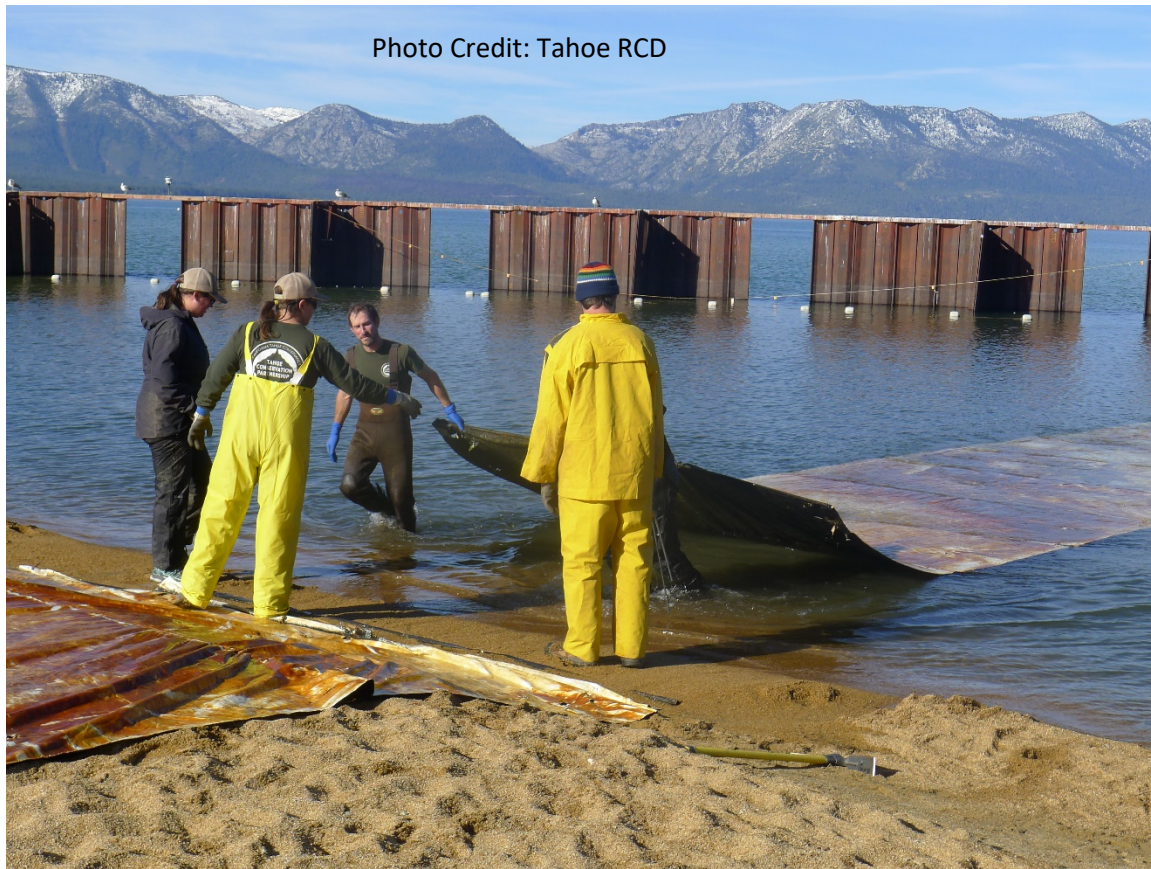
Figure 8. Workers using bottom barriers

The duration of weed control depends on the rate that weeds can grow through or on top of the bottom screen, the rate that new sediment is deposited on the barrier, and the durability and longevity of the material. For example, burlap left in place may rot and tear within two years and in one season plants can grow through window screening material, or on top of felt-like fabric. Regular maintenance is essential to extend the life of most bottom barriers. Barriers should be removed annually at the end of the growing season so the accumulated substrate on top of the barriers does not become new rooting habitat for unwanted plants, (Figure 8).

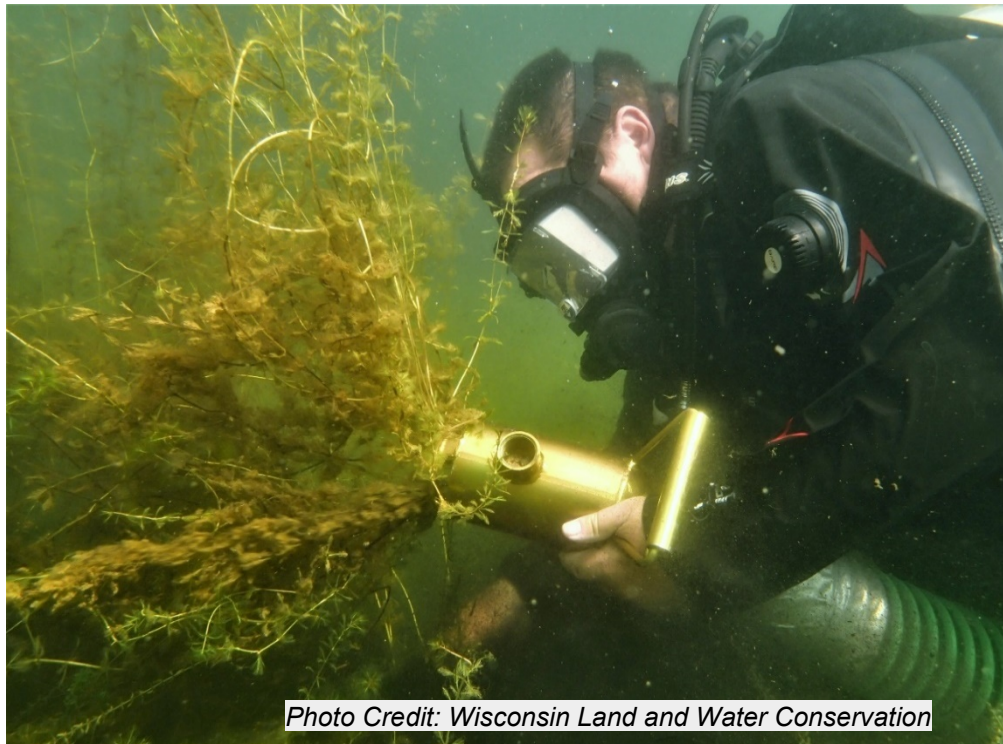
Figure 9. DASH removing Eurasian watermilfoil

Diver-Assisted Suction Harvesting is distinguished from hand-pulling using a suction hose that pulls plant material to the surface where it is captured by a boat. Hand-pulling and Diver-Assisted Suction Harvesting (DASH) use divers to visually identify and manually dislodge invasive aquatic plants (Figure 9) and requires a support team including a boat for weed removal and safety. When divers can see the weeds that they are targeting, hand pulling and DASH can be effective, but expensive.
