CLARK COUNTY
WASHINGTON

ADA Compliance Program Fairgrounds ADA Accessibility Survey

Date of Survey: August 9, 2006 and May 10, 2010
Survey Conducted by: Clark County Citizen ADA Advisory Board

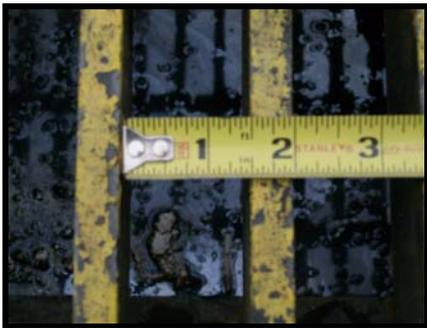
Many of the surface drainage grate openings exceed ½ inch in width. These openings are a potential hazard to persons in mobility devices (i.e. wheelchairs, canes, walkers) as the wheels or other support devices can become lodged causing the mobility device to turn over.

Grate in Midway with 1.5" opening

- Replace grates that meet ANSI Code 302.3

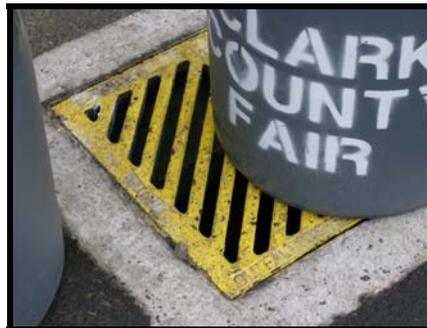
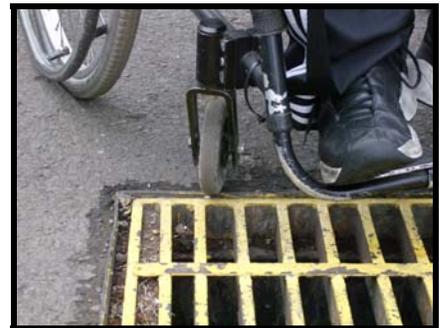
Wheelchair wheel can be easily inserted into the grate opening resulting in wheelchair falling over.

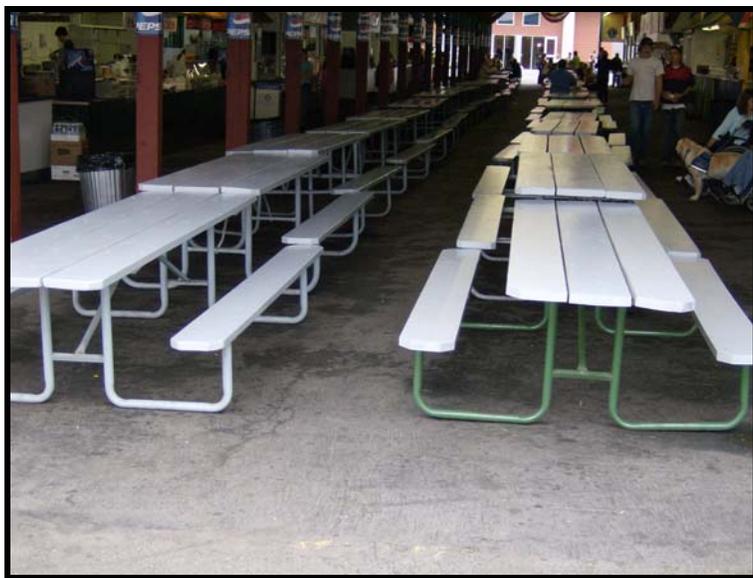
The picnic tables in the food court should be adequately spaced to allow for the passage of wheelchairs (36 inches) Also, there are no designated areas for persons in wheelchairs to utilize this area.

Food court tables and access aisles need to be maintained for wheelchair passage

- Ensure adequate passageway is maintained around the perimeter and center aisle of existing tables in the food court
- Establish areas in the food court for persons in mobility devices. Approximately 2-3 tables should be specifically constructed for use by persons with disabilities and their care persons. The area should also be signed for restricted use.
- Accessible picnic tables should be pedestal construction and anchored to the floor. Four stool-type seats for care persons should be installed with the table and anchored to the floor. This layout allows for four care persons and four wheelchairs to occupy the table.

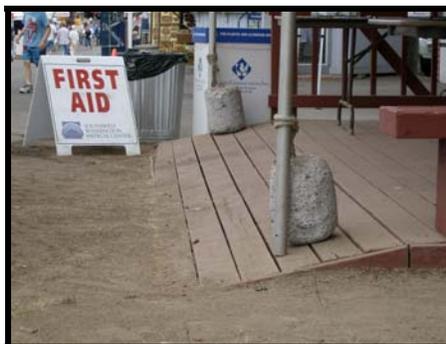
First Aid station ramp is too steep.

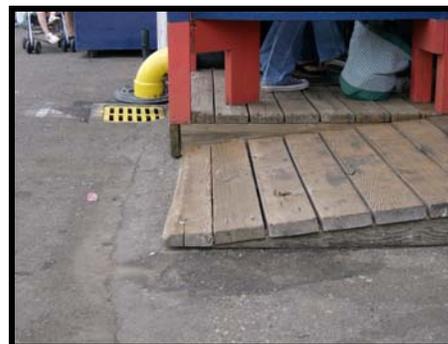
Food concession ramp – South side of South Hall 1 – is too steep. The edge of the ramp on the floor is too high – Approx 1” lip.

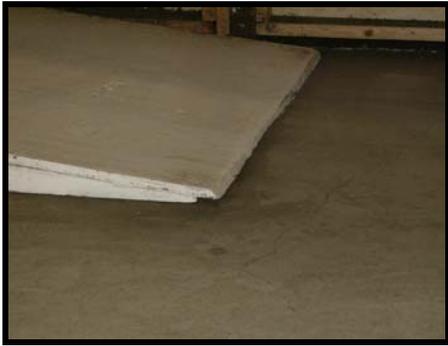
Ramp on west end of horse riding arena to elevated spectator platform appears to be too steep. The edge of the ramp on the floor is too high – Approx 1" lip.

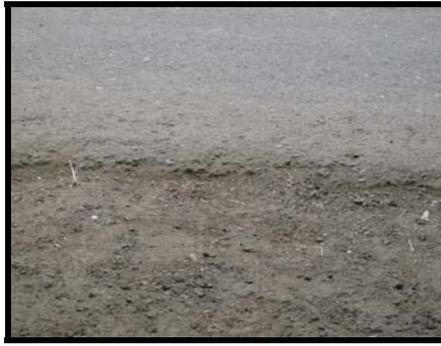
The pavement edge to the vendor displays on the south side of the horse riding arena are too high. Wheelchairs could easily fall over. Also, elevated edges are a potential trip and fall hazard.

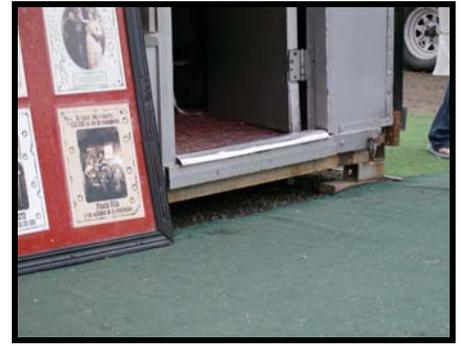
Many vendor displays are inaccessible to persons with wheelchairs or mobility devices such as walkers.

Note: Numerous manufactures now fabricate portable ramps, with some specifically designed to bridge curbs and are appropriate for use at a temporary event; such as the fair. For safety reasons, it is critical that ramp be designed not to move or shift from frequent use and is securely attached so a person would not tip or fall out of their wheelchair or mobility device.

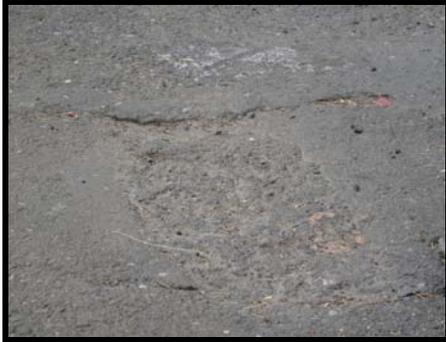
Pavement indentation on SW corner of Clark County Dairy Women’s Association booth. Indention is about 1.75 inches deep.

- Survey complex and level out all pathway indentions.
- Barricade problem areas that cannot be repaired. Ensure there is an alternate accessible route around any barriers.
- The amusement park area should be paved for accessibility. If cost prohibitive, consideration should be given to paving paths throughout this area or acquiring interlocking mats that can used as a temporary means of providing pathways through the amusement ride areas.
- Staff should ensure that accessible areas are kept clear of obstructions and debris.

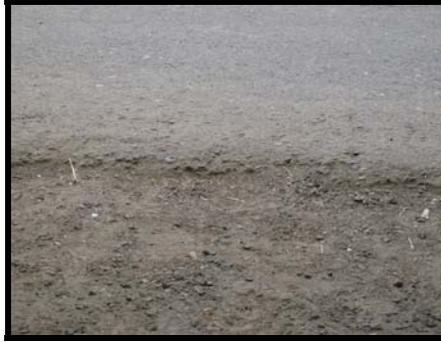
The pavement edge to the vendor displays on the south side of the horse riding arena are too high. Wheelchairs could easily fall over. Also, elevated edges are a potential trip and fall hazard.

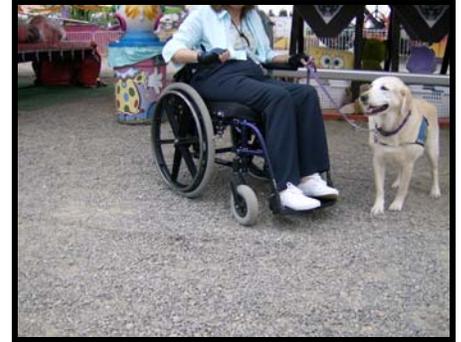
Deep and loose gravel in amusement ride area makes it very difficult to push or maneuver a wheelchair

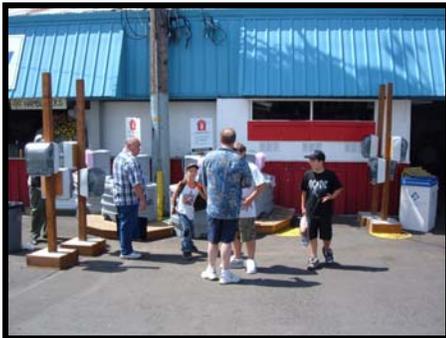
Limited level area on east side of food court. Aisle way should be monitored to ensure there is an adequate passageway for persons in mobility devices.

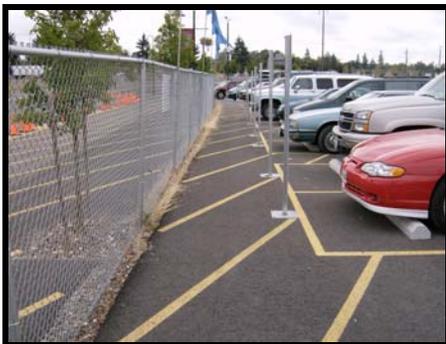
Access aisle in NW parking lot should be kept clear of debris

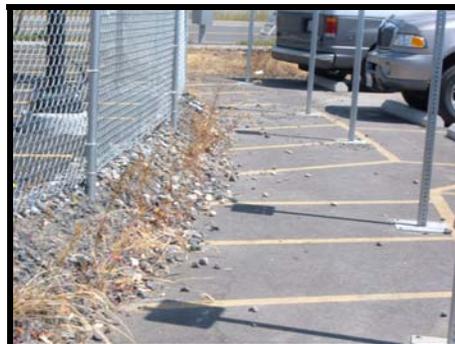
Access aisle in NW parking lot should be kept clear of debris

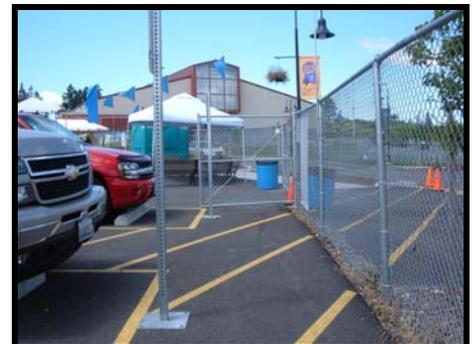
Gate should not block access to access aisle

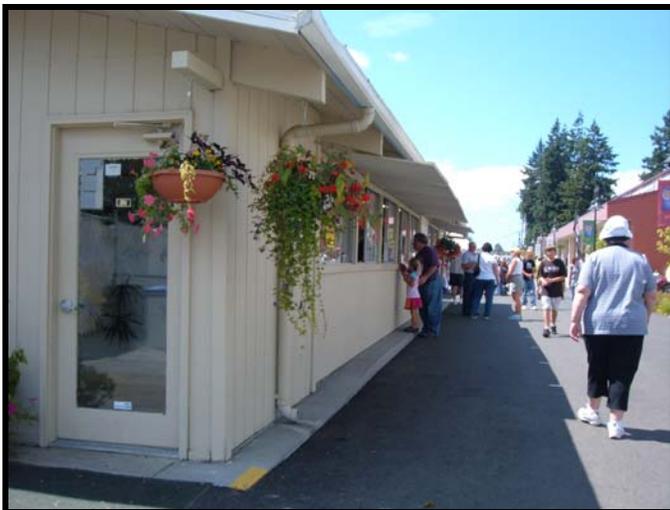
The vendor service and information building on the NE corner of the fairgrounds is not accessible to persons with disabilities.

The services provided from this building are not accessible to persons with disabilities.

- Install a window to accommodate persons in mobility devices
- Ensure employees occupying this building are alert to the needs of persons with disabilities and provide services to them when needed.

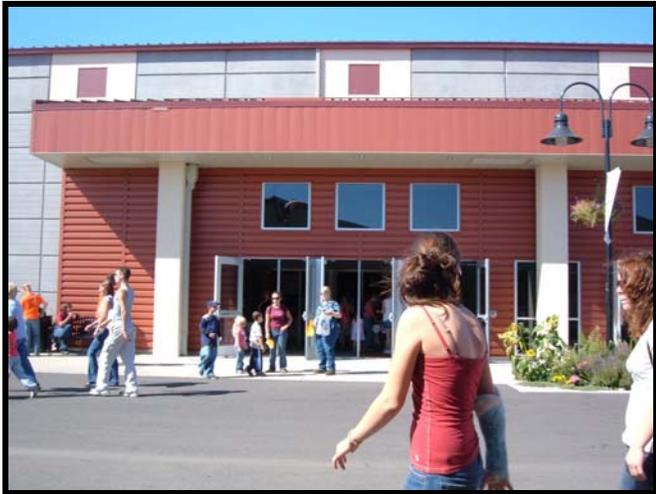
The Exhibition Center has one automatic door leading into the south side of the building. To enter the actual exhibition hall, patrons must walk through a small foyer and through a second set of doors. There is no automatic door on the second set of doors.

A second automatic door on the interior foyer door of the Exhibition Center should be installed.

Install a second automatic door on the interior entrance to the exhibition hall for use by persons in mobility devices.

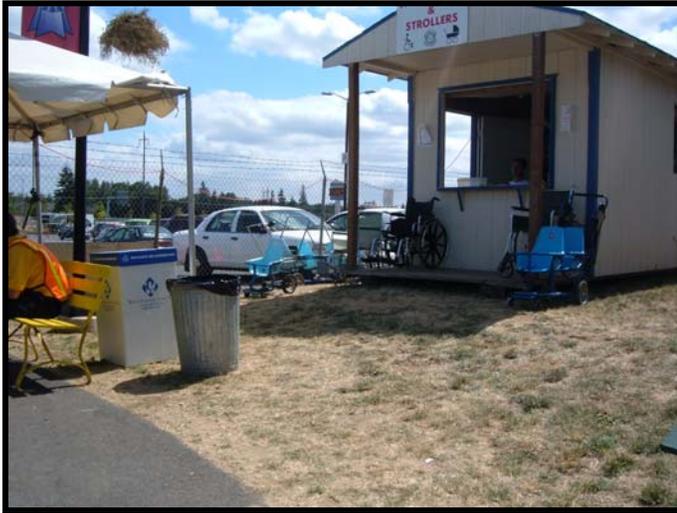
The mobility services buildings are inaccessible to persons with disabilities. (Ramps configurations)

The East side accessibility service shed is poorly located. The ground surface is sloped and rough. The shed is located behind the admission gate ... it should be located on the edge of the Midway pavement and staffed by knowledgeable staff with an array of services and information.

- Ensure employees occupying these buildings are alert to the needs of persons with disabilities and provide services to them when needed.
- Ensure buildings are staffed at all times by competent and knowledgeable individuals.
- Suggest installation of ramps to buildings
- Pamphlets should be available detailing available services, locations of accessible restrooms, locations of parking for the disabled, locations of first aid stations and how to request a reasonable accommodation.

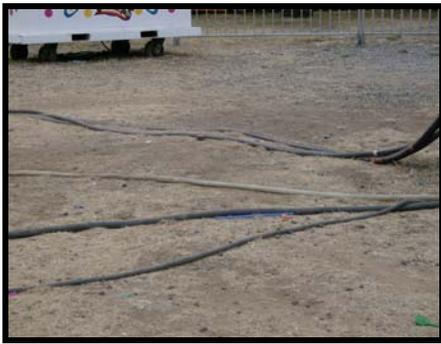
Numerous electric cords cross pedestrian paths. Some of the cords are covered with protective mats; others are not. Cords are difficult to negotiate in mobility devices.

Electrical cords in pedestrian pathways.

- The amusement park area should be paved or a hard-pan surface applied for accessibility. If paved, trench boxes that can be opened by workers should be installed where cables can be laid under the surface or electrical conduits located throughout the amusement park area.
- If paving is cost prohibitive, mats should be acquired to cover the cords that have the proper slope and will not bunch up resulting in trip and fall hazards.

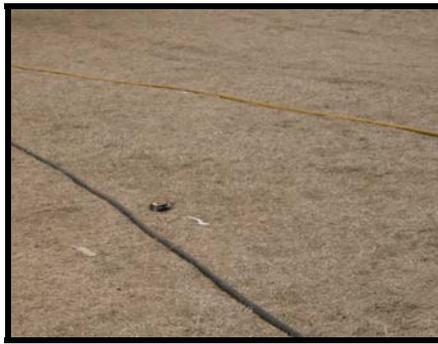
Electrical cords in pedestrian pathways.

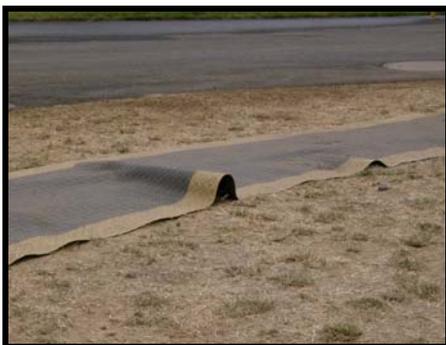
Mats in amusement park area pose a trip and fall hazard and are very difficult to negotiate in a mobility device

Currently, there are two type of mats used to cover some of the aforementioned electrical cords. Suggest that only mats that can be laid down flat and not pose a trip and fall hazard be utilized. Also, mats should have slopes that can be negotiated as opposed to the steep incline mats that are located in some areas of the amusement rides.

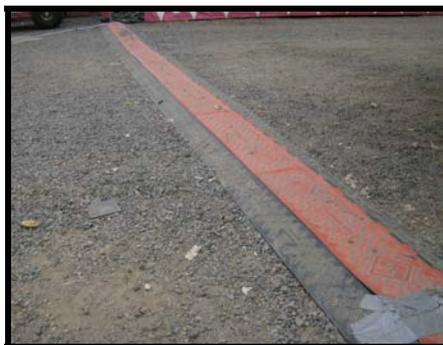
This mat provides better protection to the cords and pedestrians. However, the slope of the pad is a little too steep and is difficult to cross in a wheelchair

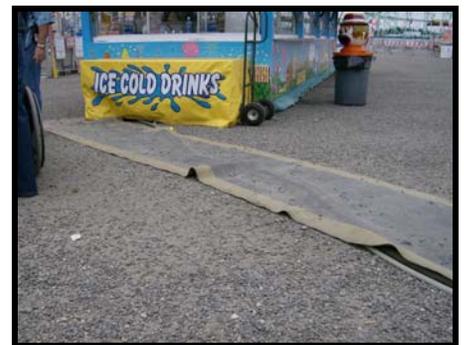
Mats in amusement park area pose a trip and fall hazard and are very difficult to negotiate in a mobility device

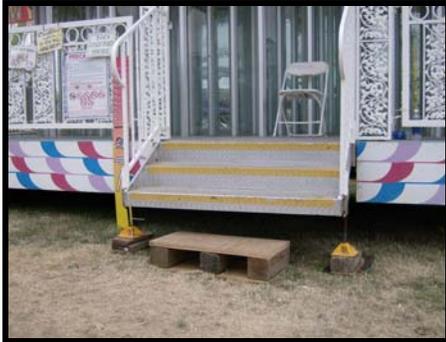
With no ramp, this ride is inaccessible to persons in mobility devices

- Vendors should be required to provide ramps to accessible rides
- A copy of the United States Access Board Guidelines on Accessible Amusement Rides should be distributed to ride vendors and asked to comply with the guidelines to the greatest extent possible. (See Appendix A)

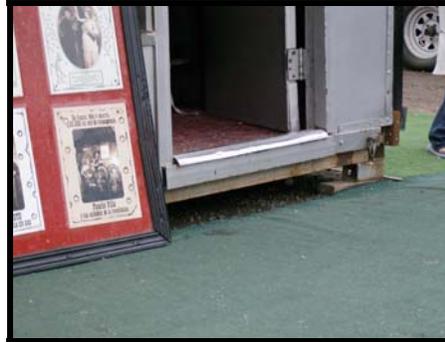
With no ramp, this display is inaccessible to persons in mobility devices

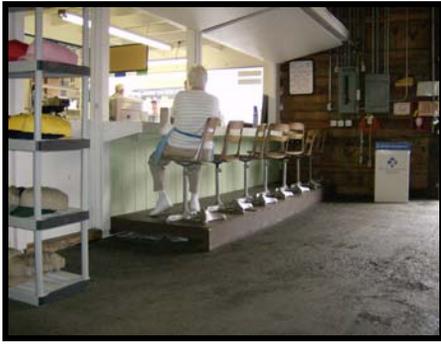
This concession stand is inaccessible to persons with disabilities

- Require signage at all vendor displays advising persons with disabilities that the vendor will assist them if they are unable to access services, merchandise or products offered.
- Educate vendors regarding their obligations under the Americans with Disabilities Act to offer equal services to all persons.
- Have vendors provide ramps or other areas where services are provided for persons with disabilities

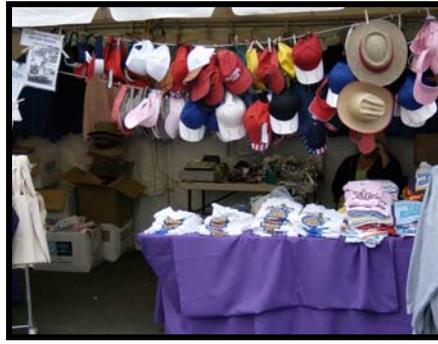
Merchandise that is elevated on racks or shelves cannot be accessed by some persons with disabilities

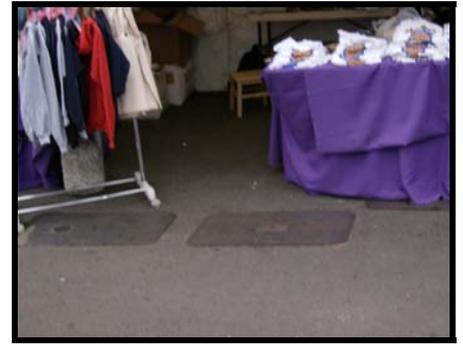
Aisle ways may be inaccessible to persons in mobility devices such as wheelchairs
