Tower Crest Neighborhood Park

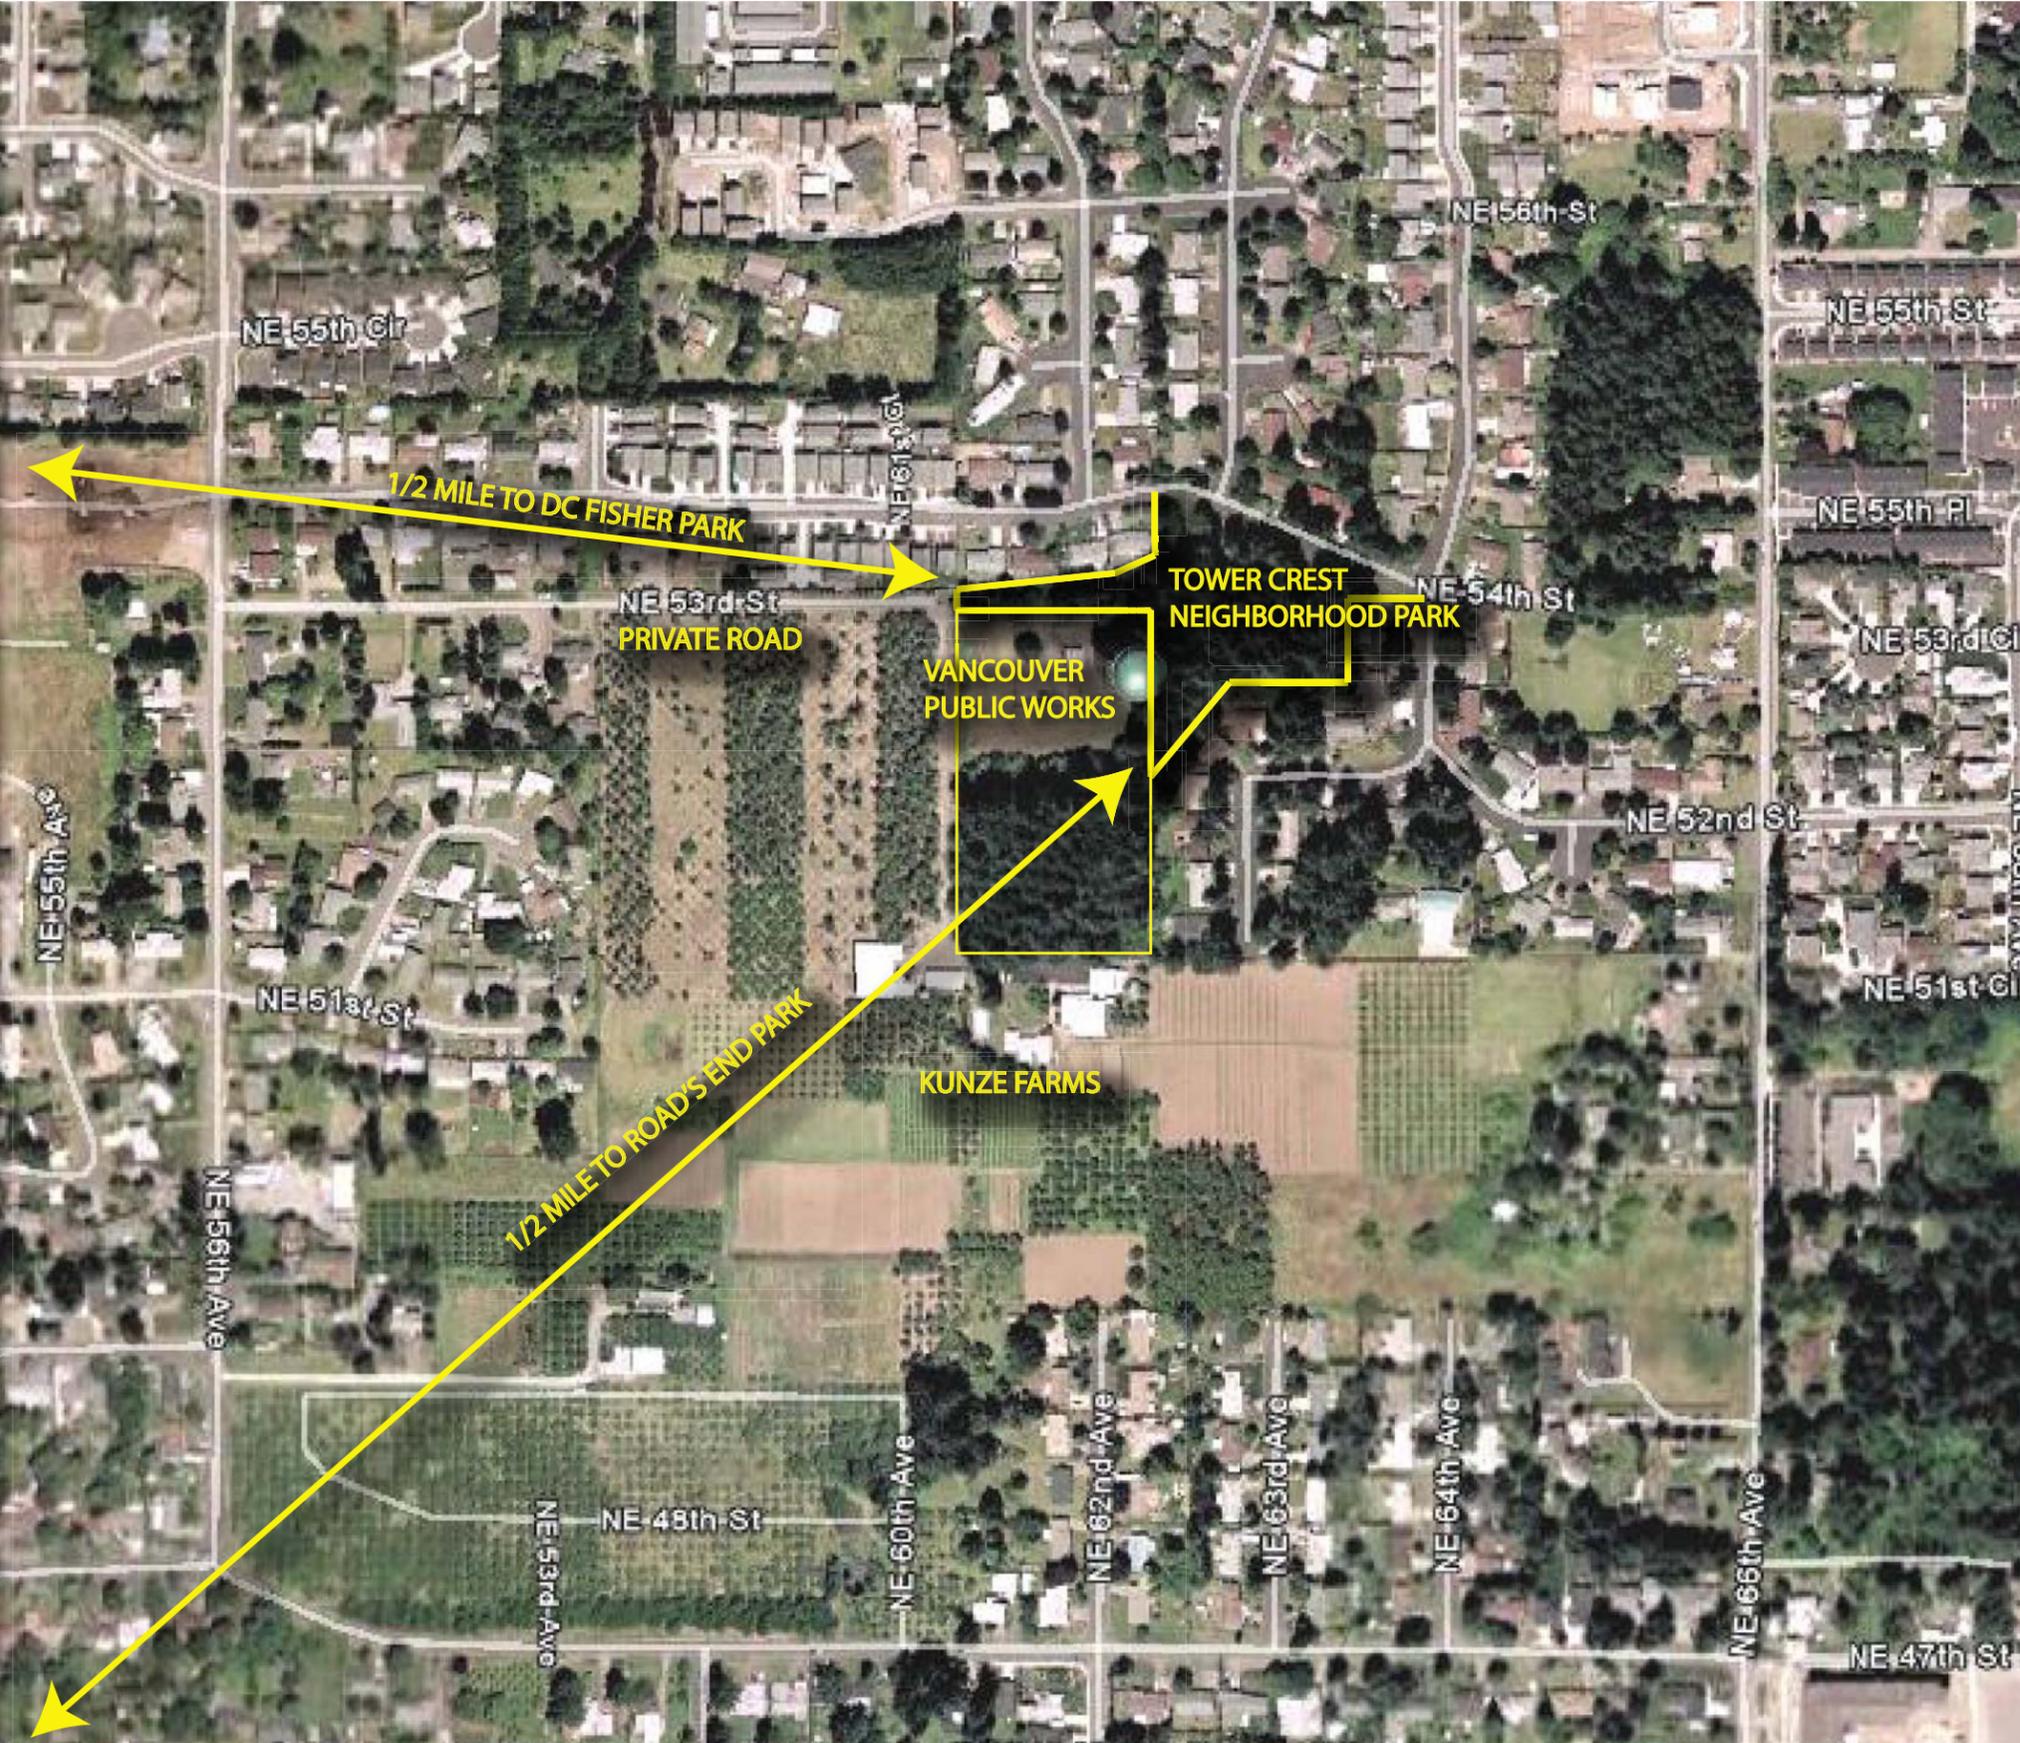
SITE ANALYSIS:
 THE SITE IS A BEAUTIFUL YET ISOLATED FIR OASIS WITH MATURE TREES AND A HEALTHY UNDERSTORY OF PLANT MATERIALS. IVY AND OTHER INVASIVES ARE CREEPING IN AND SHOULD RECEIVE ATTENTION.

TOPOGRAPHY IS GENTLE FROM SOUTH TO NORTH WITH A DRAMATIC DROP NEAR NORTHEAST 54TH STREET. THIS GRADE CHANGE IS UTILIZED FOR HAZARDOUS BICYCLE JUMPS AND AS A RESULT THE SOIL IS ERODING INTO THE STREET AND STORM SEWER.

GENERALLY THE SITE IS SURROUNDED BY PRIVATE LAND OWNERS WITH THE EXCEPTION BEING FOUND ON THE SOUTHWEST CORNER WHERE VANCOUVER PUBLIC WORKS OWNS AND MANAGES LAND THAT IS OFTEN UNDERSTOOD TO BE A PART OF THE PARK SITE.

A STORM DRAIN AND SANITARY SEWER RUN INTO AND THROUGH THE PARK.

IN TERMS OF HABITAT, AS MENTIONED ABOVE THE SITE IS ISOLATED SO ITS BROAD ECOLOGY VALUE IS LIMITED. HOWEVER, MANY ANIMALS HAVE BEEN FOUND ON THE SITE RANGING FROM COYOTES TO DEER.

FROM A SECURITY STANDPOINT THE NEIGHBORHOOD IS CONCERNED ABOUT CRIME THAT DOES OR MAY TAKE PLACE WITHIN THE PARK. THE HEAVY FOREST LIMITS VISIBILITY AND ALLOWS FOR UNDESIRABLE ACTIVITIES.

FENCING AROUND THE SITE VARIES IN LOCATION AND ENCROACHMENT TO THE PARK.
