Re: Infiltration Study

NE 94th Avenue: NE Padden Parkway to NE 99th Street (CRP #350822)
Clark County, Washington
15915-08

This report summarizes the results of our infiltration study for the NE 94th Avenue road improvement project located in unincorporated Clark County, Washington.

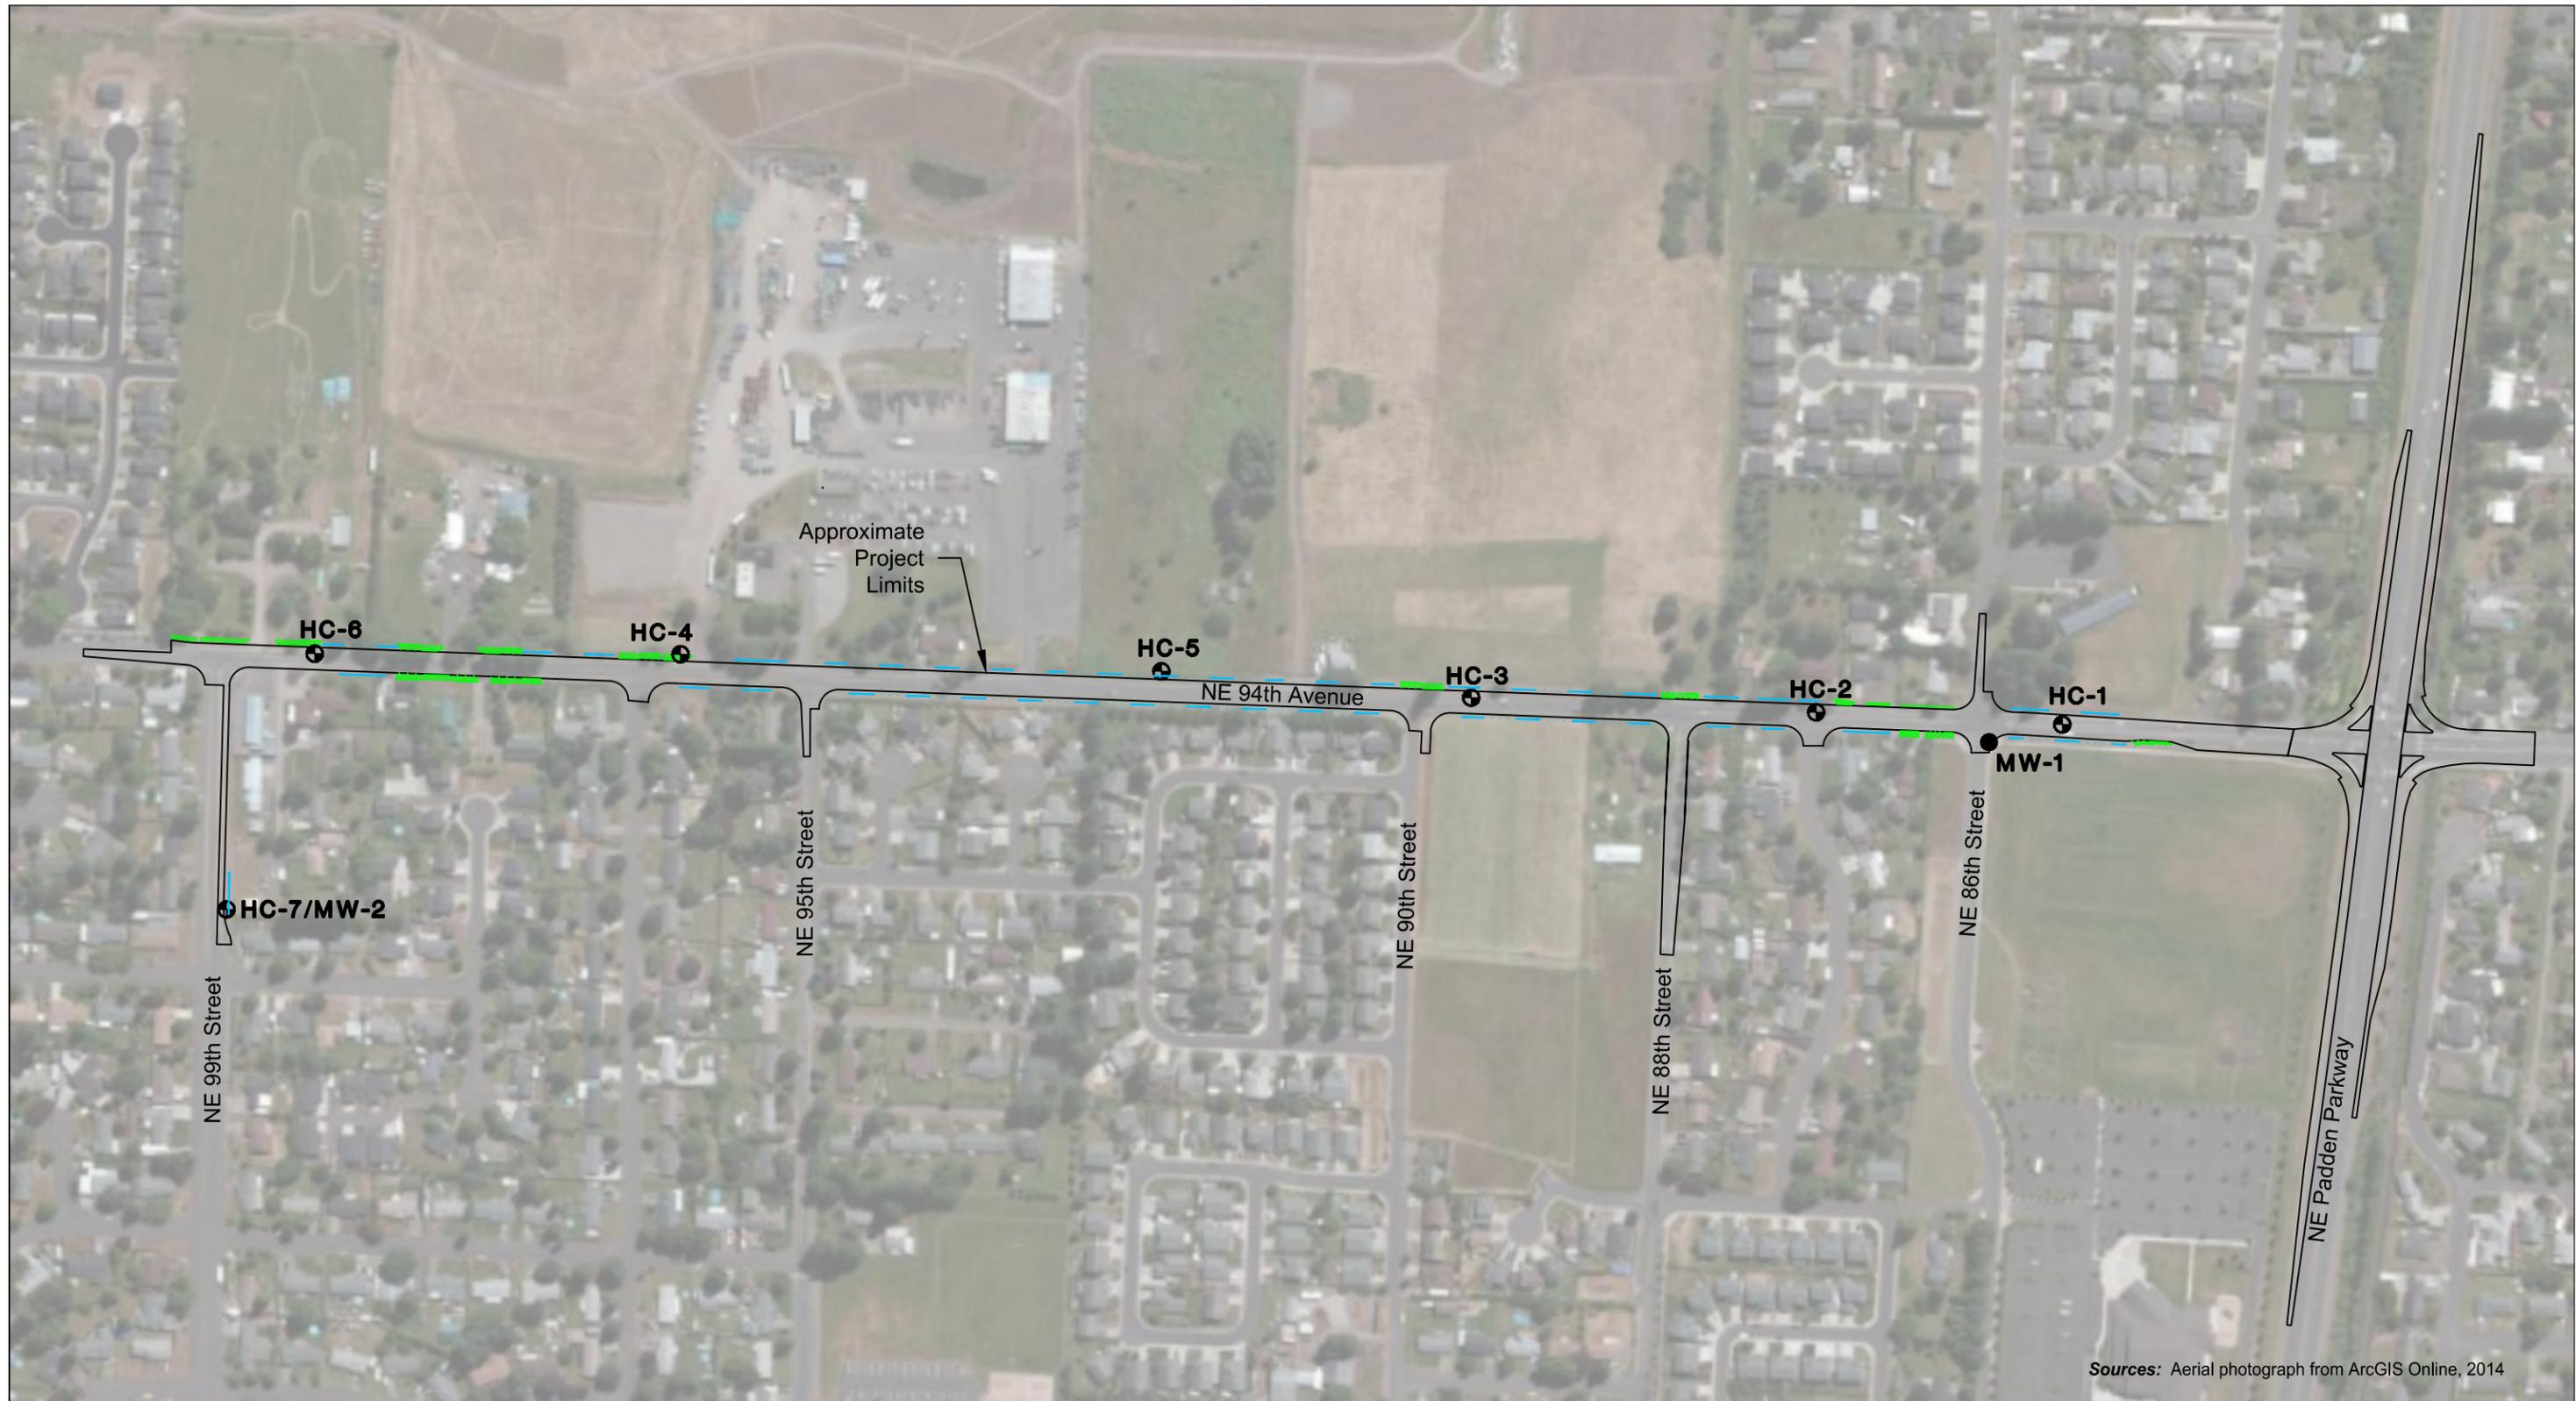
Approximate Exploration Location and Number

Our understanding of the subsurface conditions is based on our research and information collected from our field explorations completed for this project. The locations of the explorations are shown on Figure 2, and the exploration logs are included in Attachment A.

We completed seven borings (HC-1 through HC-7) along the project alignment, each to a depth 16.5 feet below ground surface (bgs). Eight *in situ* infiltration tests were performed either within or adjacent to these borings at depths of approximately 3 and 5 feet bgs. Four of the infiltration tests were completed in borings (HC-1B, HC-3B, HC-6B, and HC-7B) drilled approximately 3 to 4 feet away from the main borings.
