# SHORELINE MASTER PROGRAM PERIODIC REVIEW COMMENTS

WRITTEN COMMENTS

AUG 2019 – JUL 2020

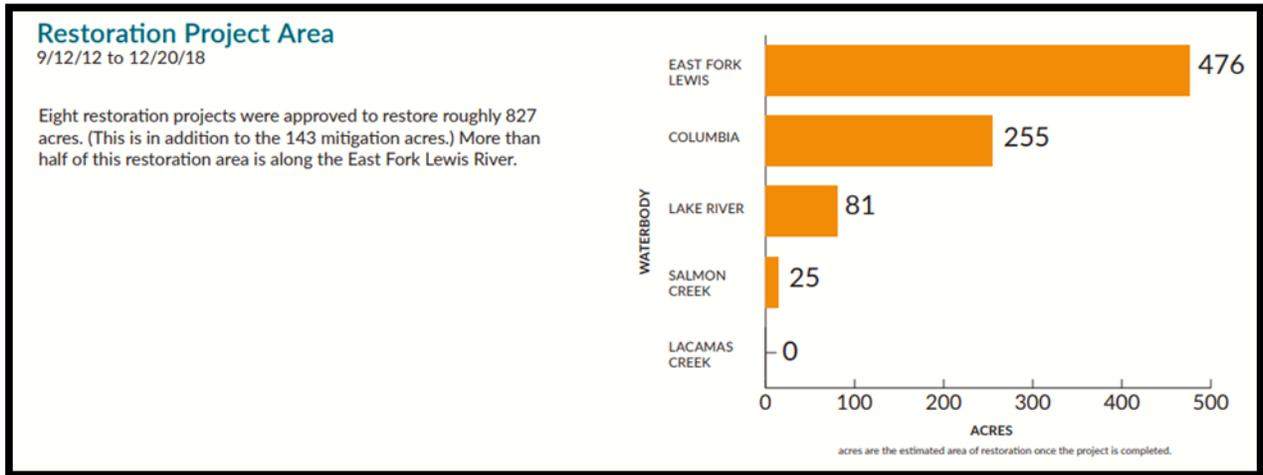
Below is an inventory of Restoration Project Areas in Clark County. As you can see from the graph, the majority (58%) of effort has occurred in the East Fork of the Lewis River Basin. Since 2000, the Lower Columbia Fish Recovery Board has delivered \$12.6 million for fish recovery efforts in the East Fork. Much of that was devoted to fish restoration efforts. Clark County has continued to acquire parcels along the East Fork through the Legacy Lands program, costing millions of dollars. In November 2017 alone, the County Councilors authorized issuing \$7 million in bonds to purchase 10 properties spread across the county. Six of which are located in the East Fork Basin

Yet, the East Fork Lewis continues to have increased temperatures and reduced flow regimes, during summer. It is on the Dept. of Ecology’s 303(d) list of rivers that fail in temperature flow and bacteria levels. Salmonid numbers returning to the East Fork are also in decline. This would indicate the restoration projects on the East Fork are not realizing their intended goals. The county is not getting a good return for the millions of dollars spent in land acquisition and restoration efforts. Current restoration efforts do not appear to be working. A shift to “Net Ecological Gain” is needed.

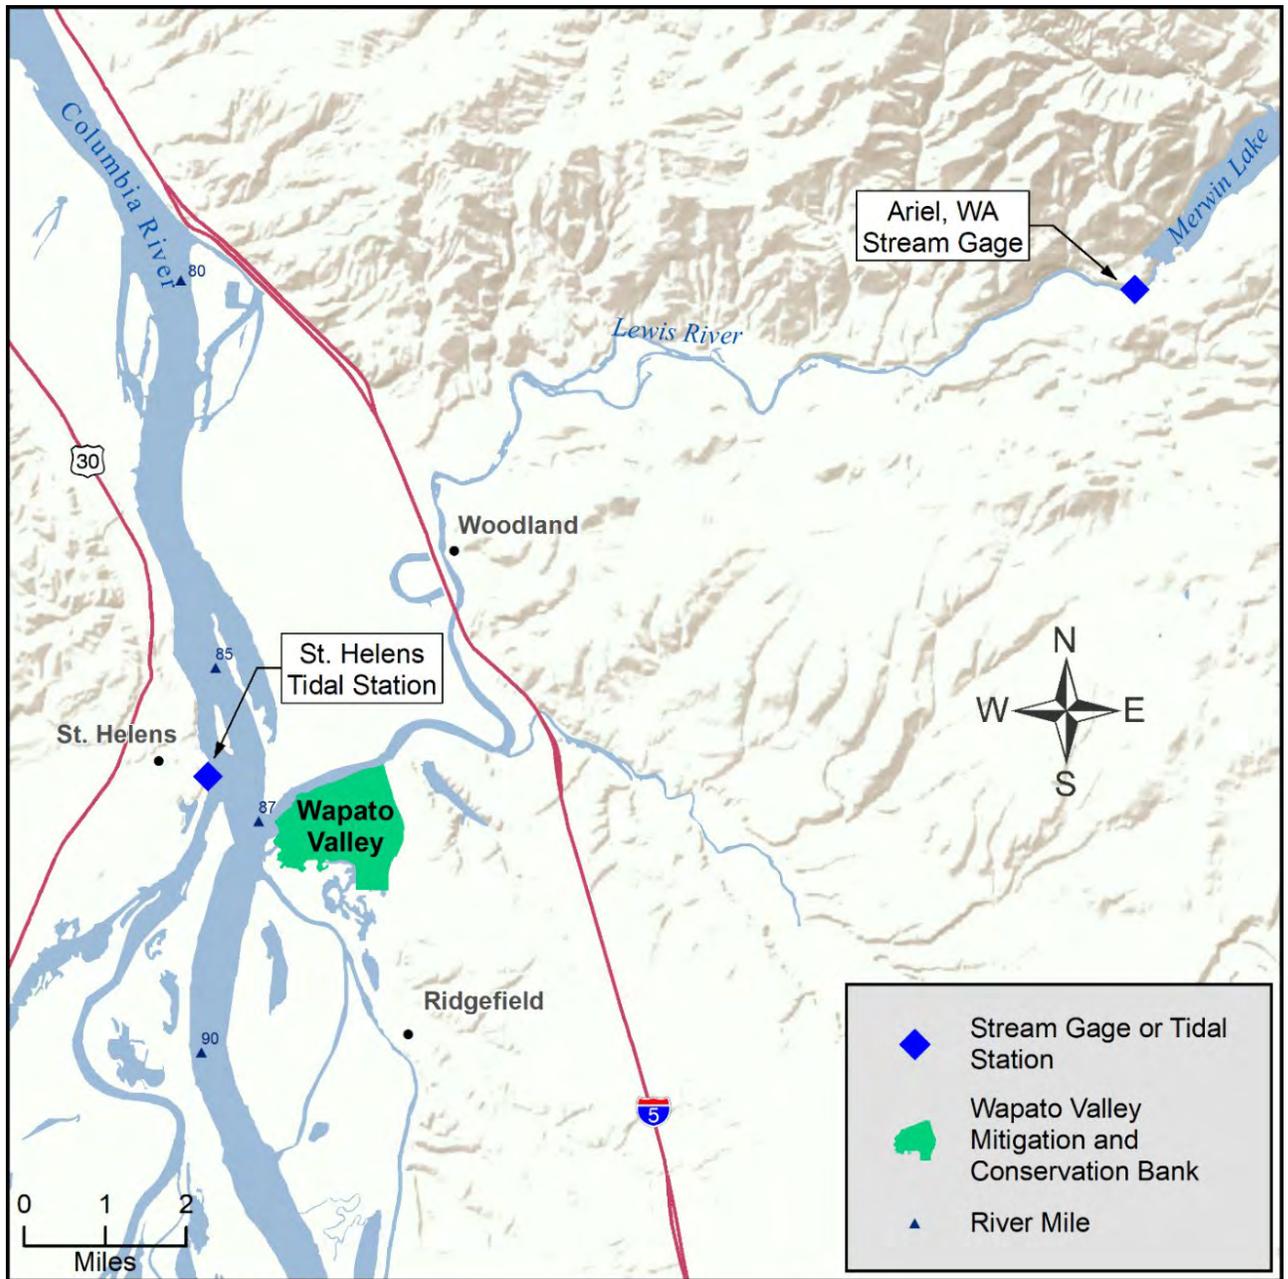
Figure 3.  
Location of the nearest tidal station and stream gage to Plas Newydd Farm and  
Wapato Valley.

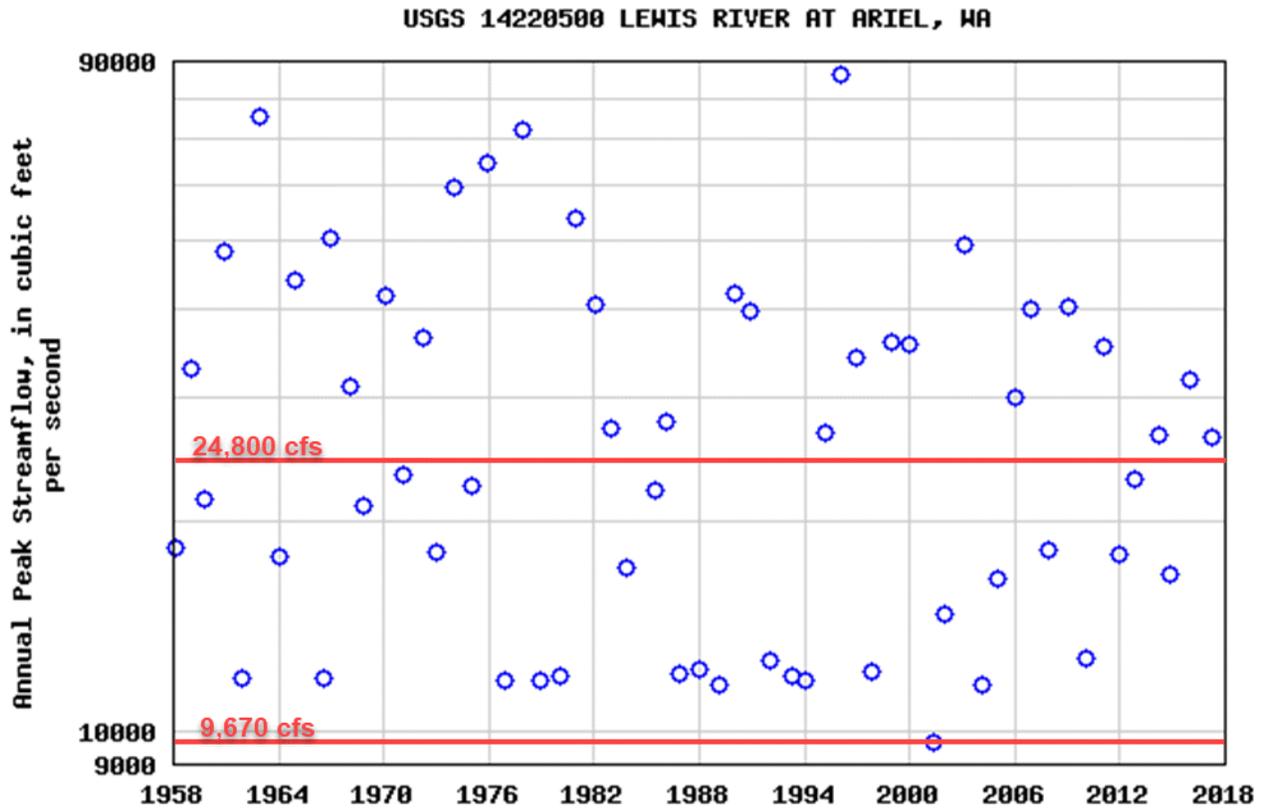
Figure 4.  
 Hydrograph of the maximum peak annual discharge data for the Lewis River 2-year and 1.01-year peak flows depicted (aka "chart method").

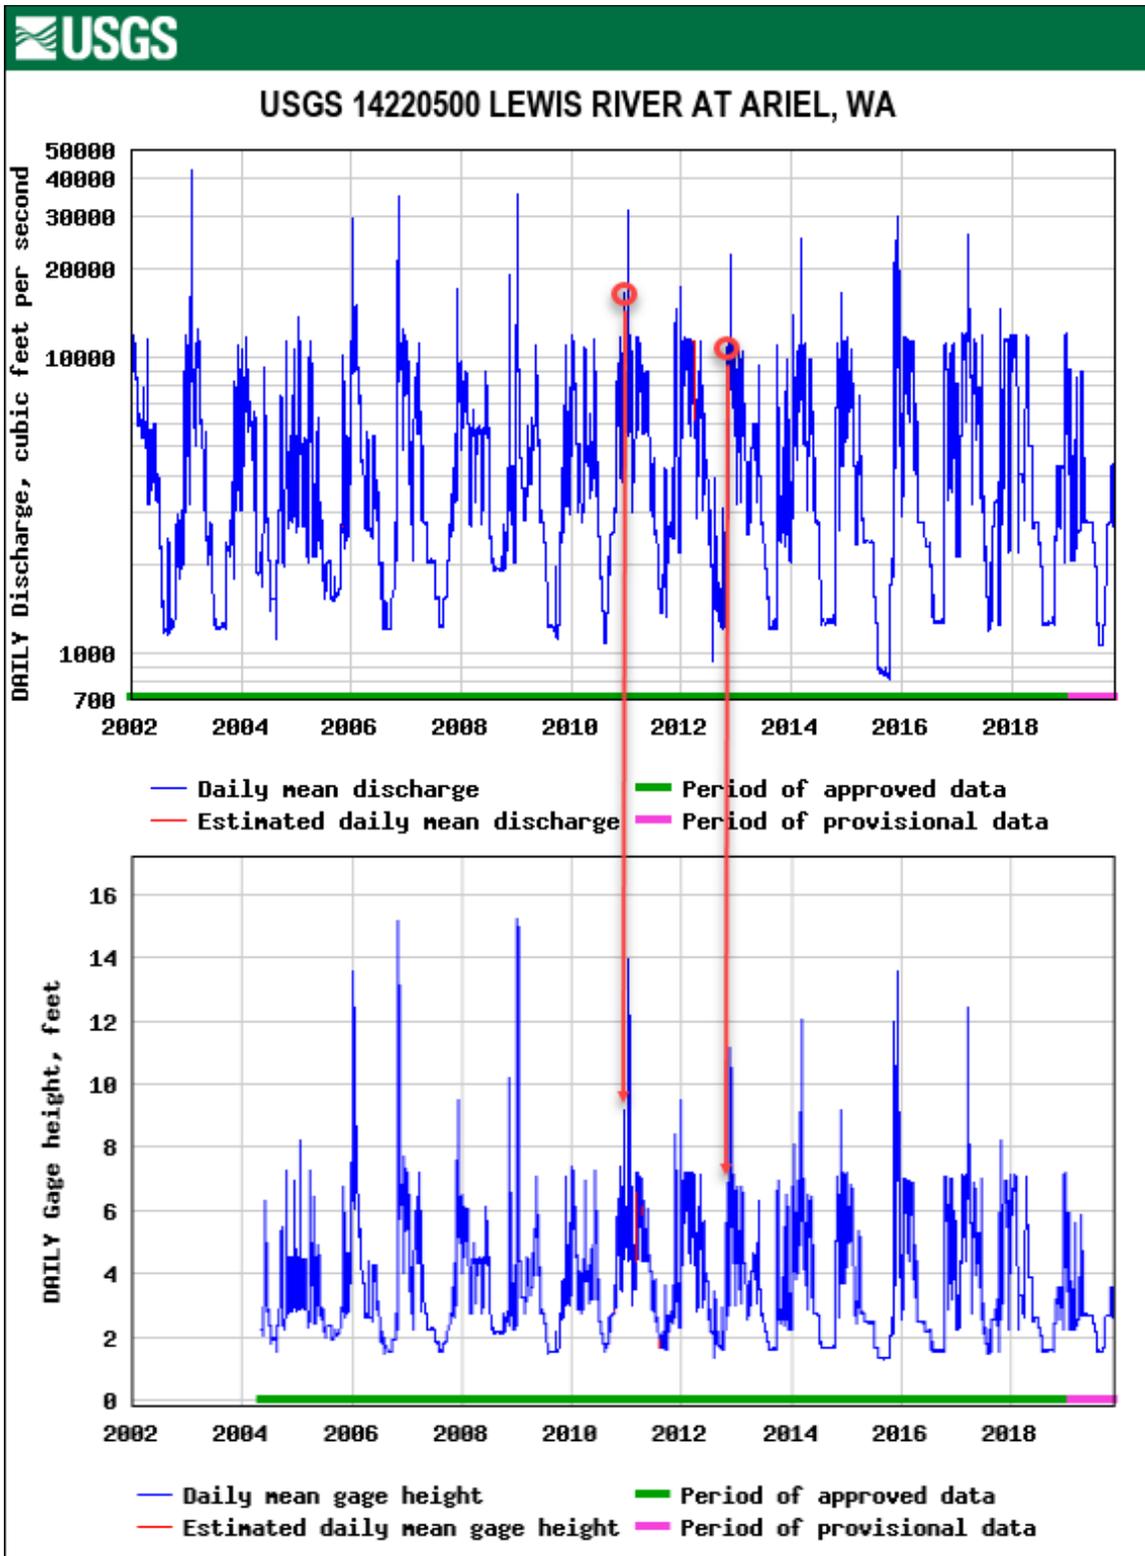
Figure 5.  
 Stage for the determined flow range values plotted on aligned discharge and stage graphs.

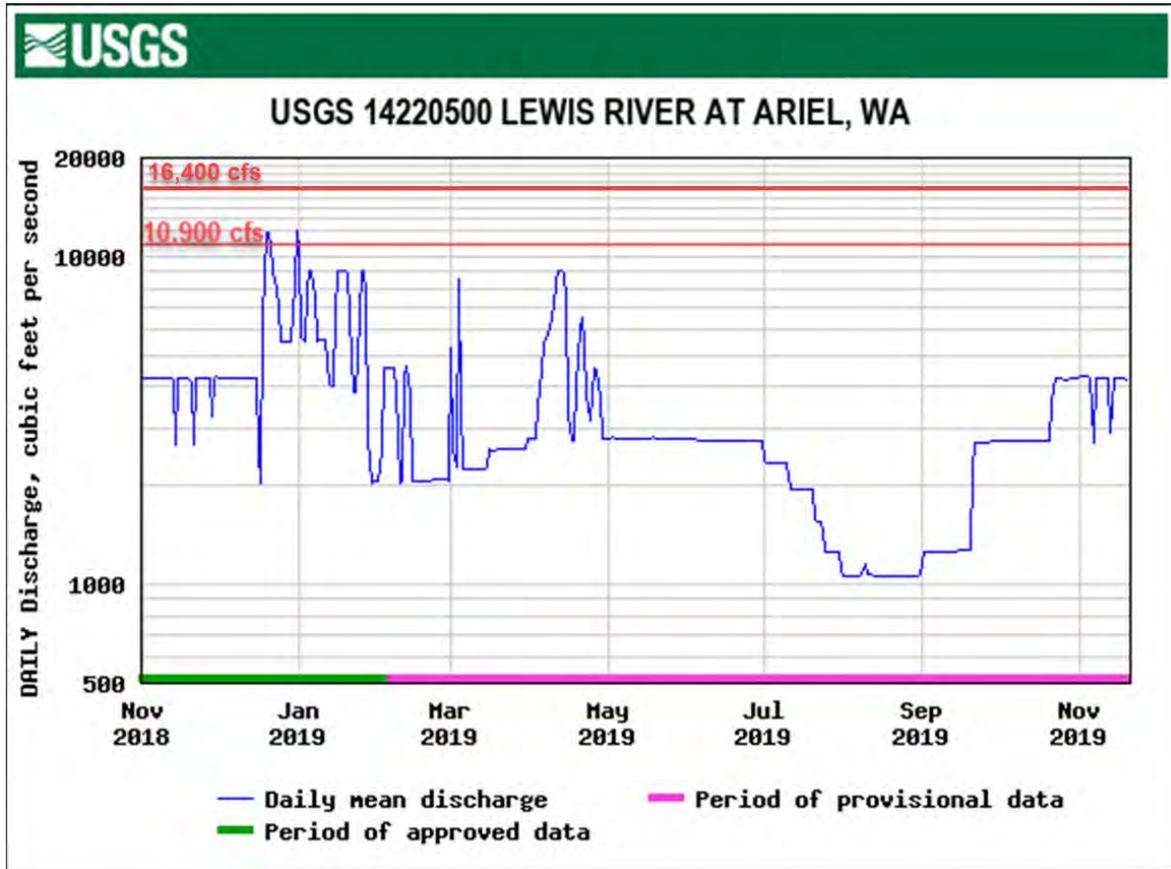
Figure 6.  
Daily discharge plotted with refined OHWM bookend limits from refined analysis.

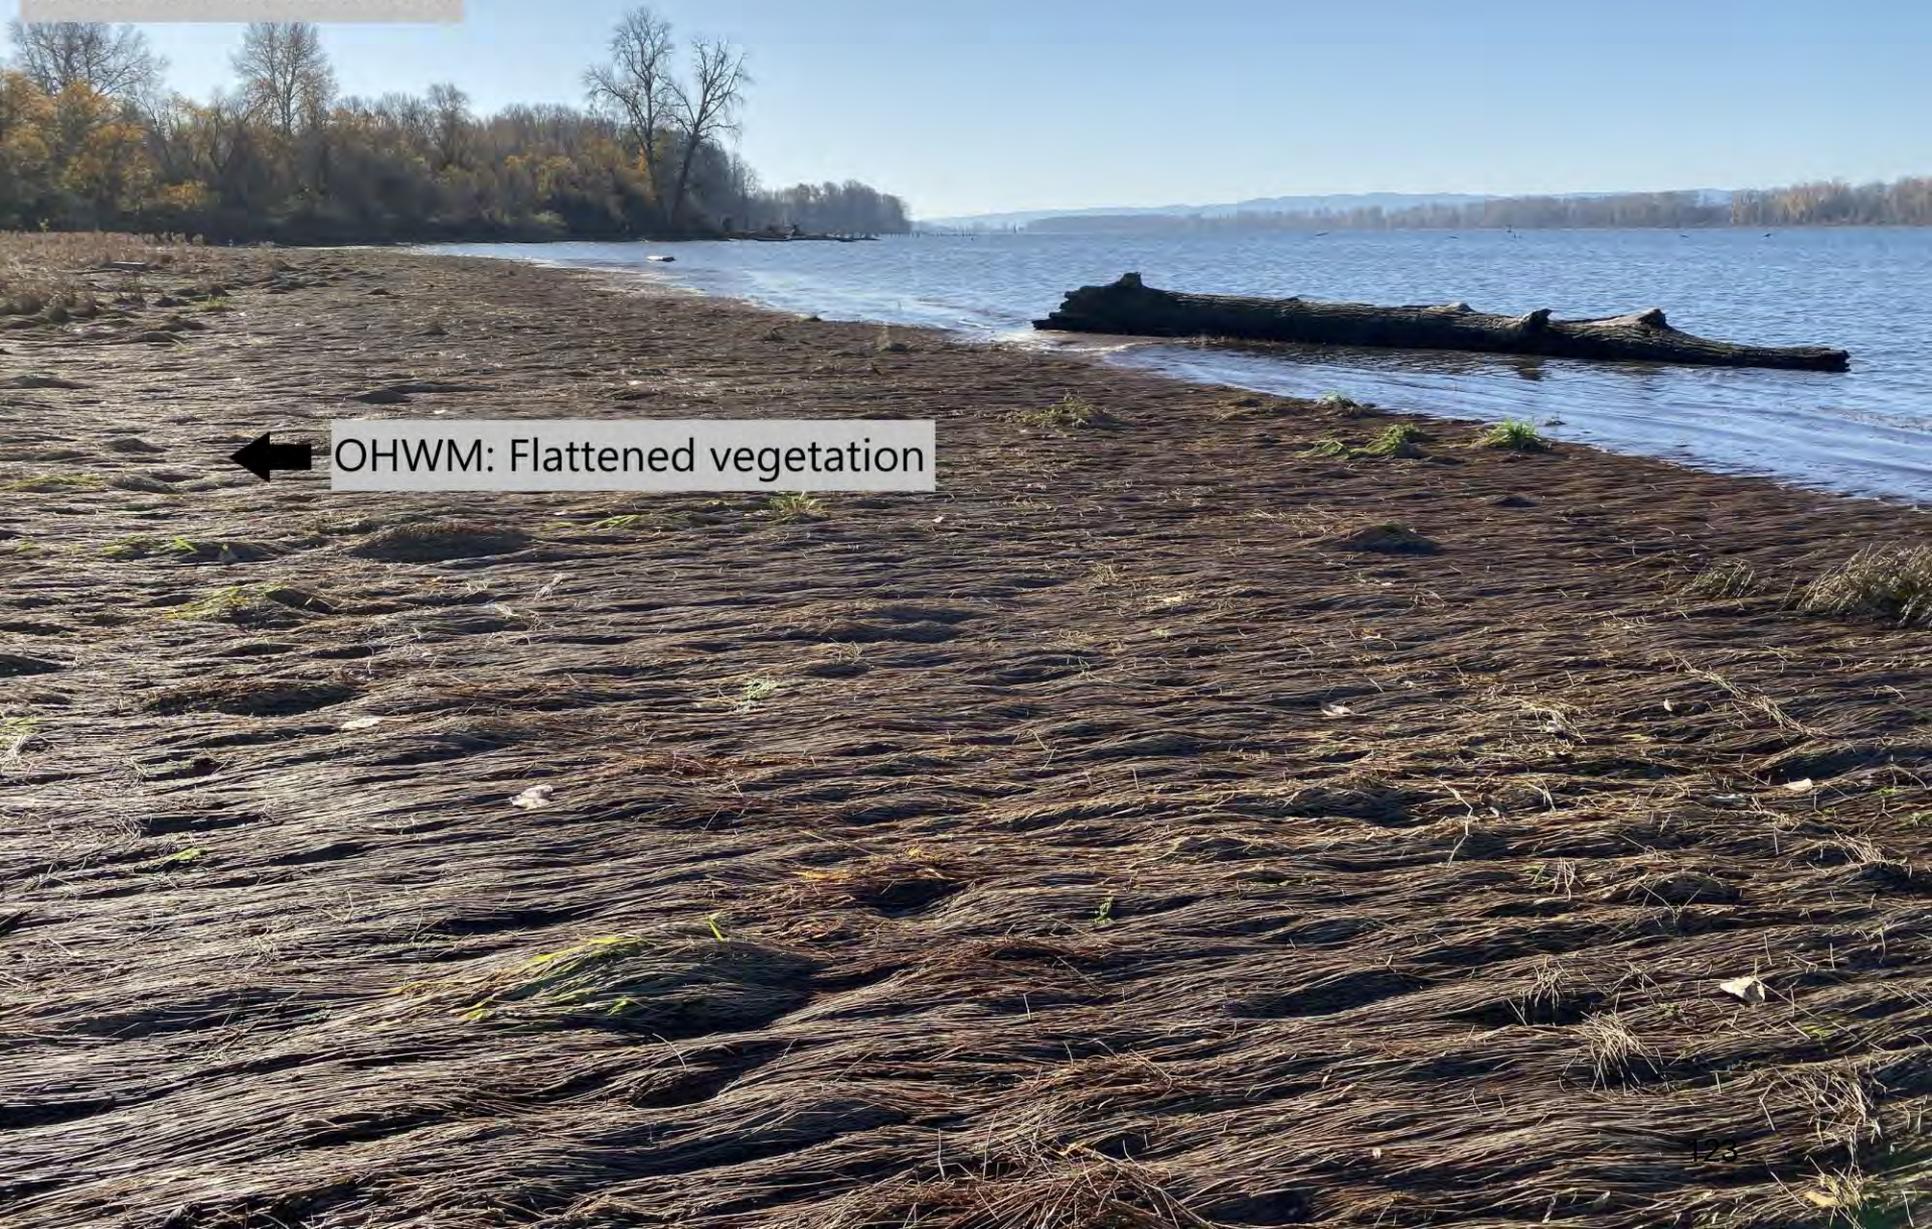
Exhibit 5  
GR-A-(1-3)

← OHWM: Flattened vegetation

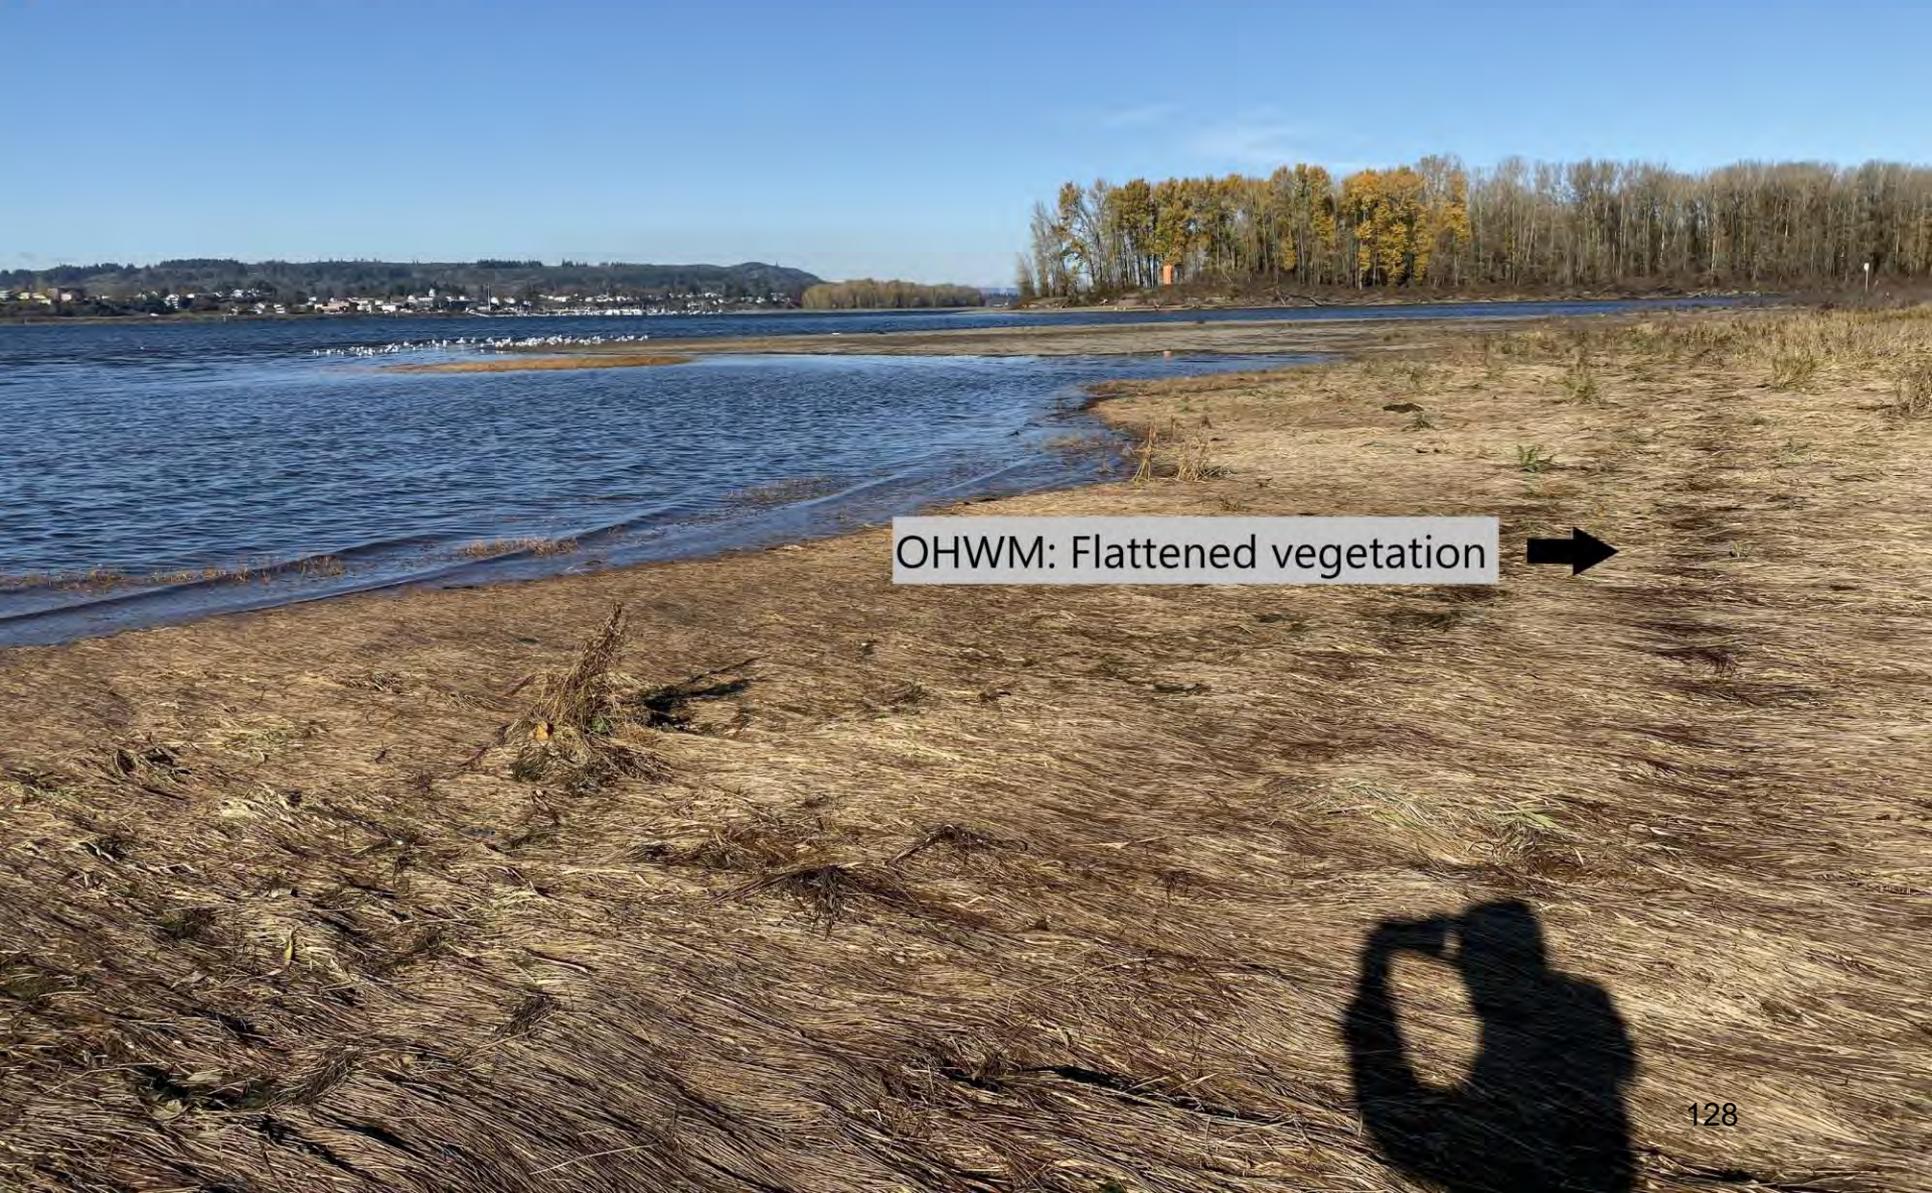
GR-B-(1-3)  
Exhibit 5

OHWL: Flattened vegetation →

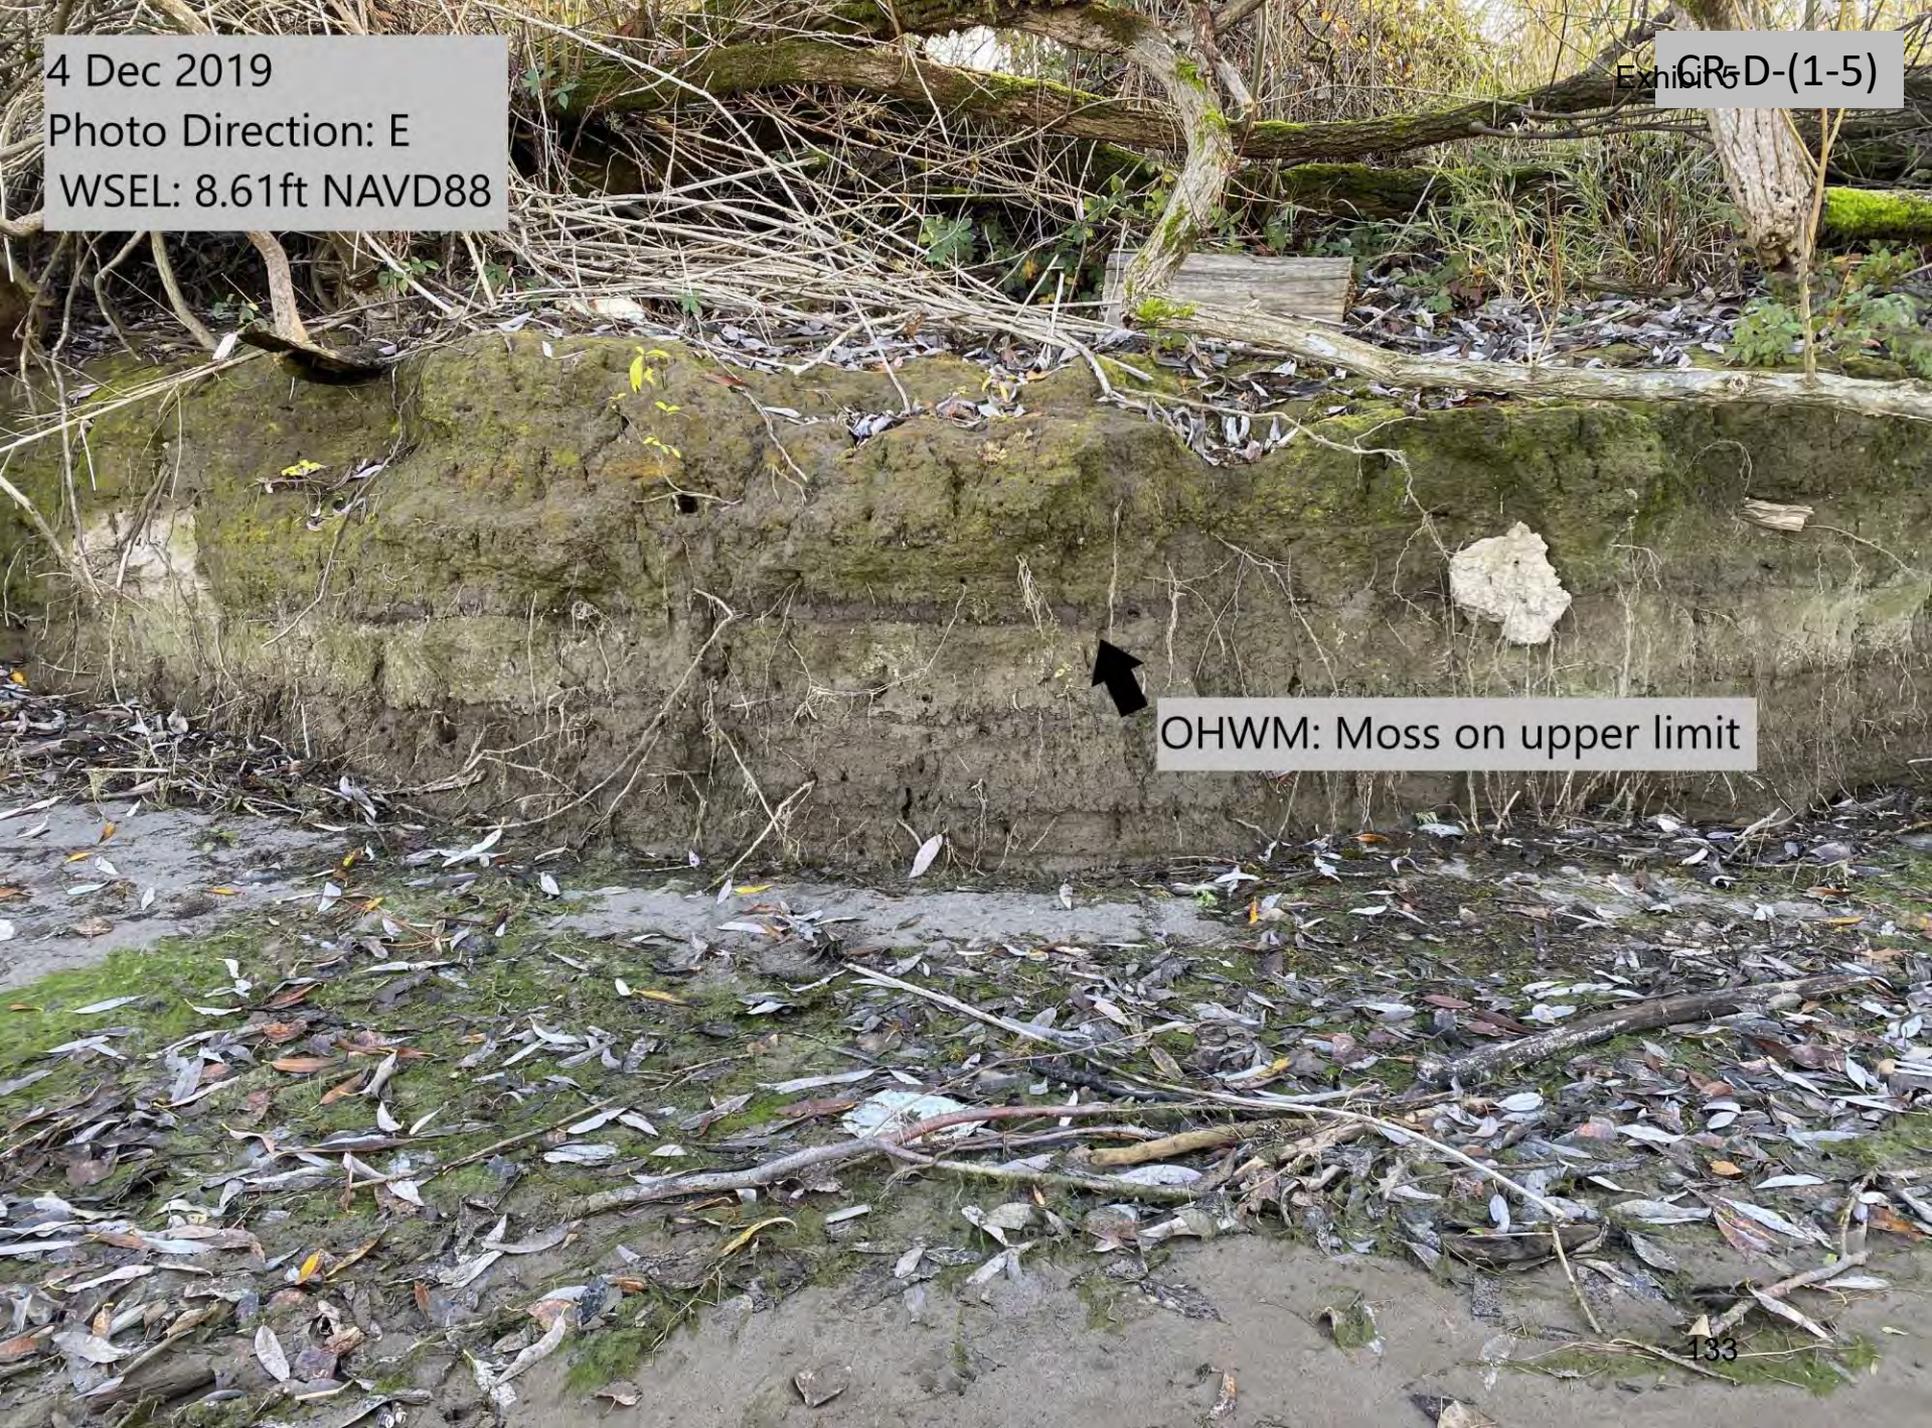
Exhibit R5 D-(1-5)

The best indicator of the OHWM at this location is the extent that moss can grow on the steeply eroded riverbanks.

OHWM: Moss on upper limit

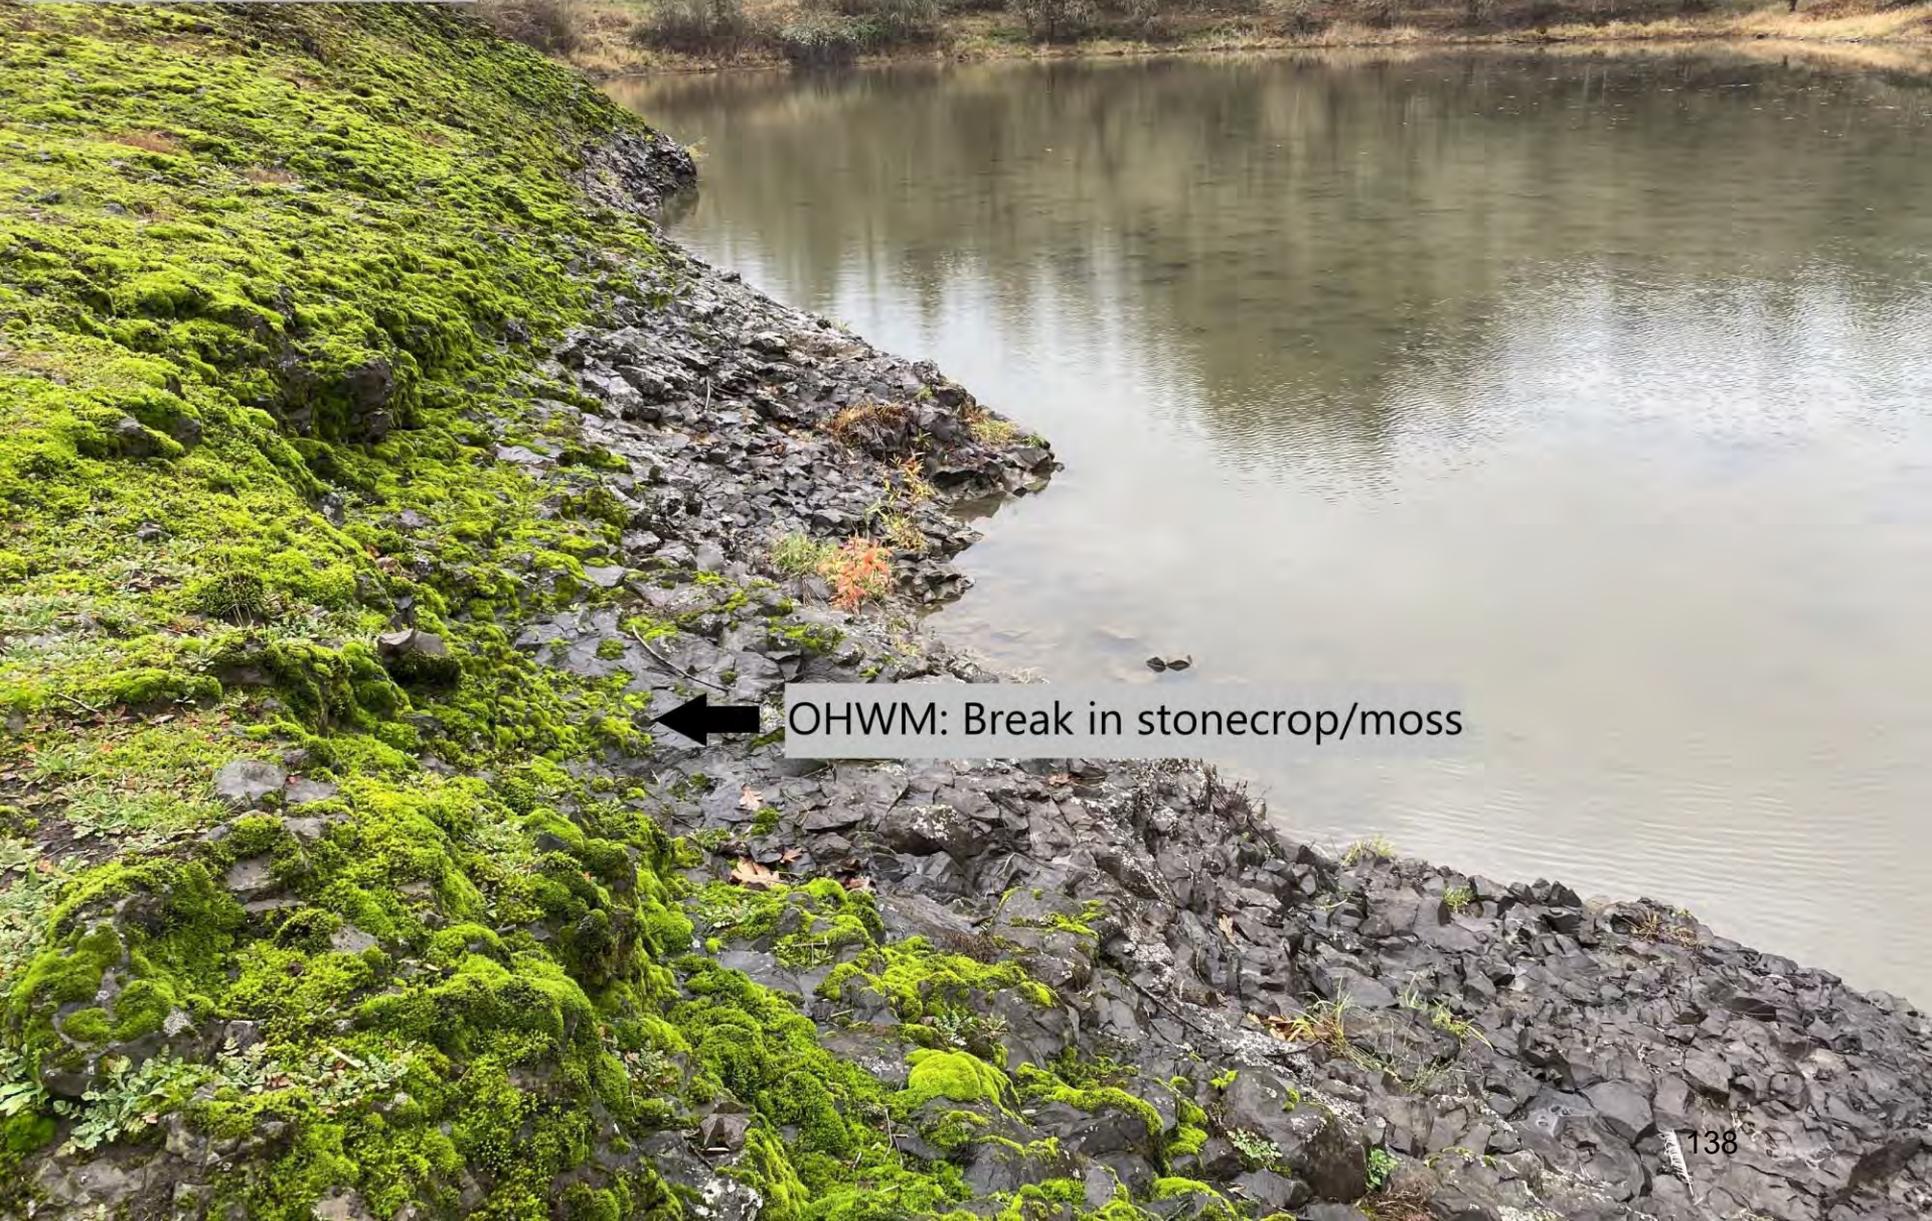
Exhibit 5  
66A-(1-9)

The basalt rocks below the OHWM have very little to no vegetation on them

← OHWM: Break in stonecrop/moss

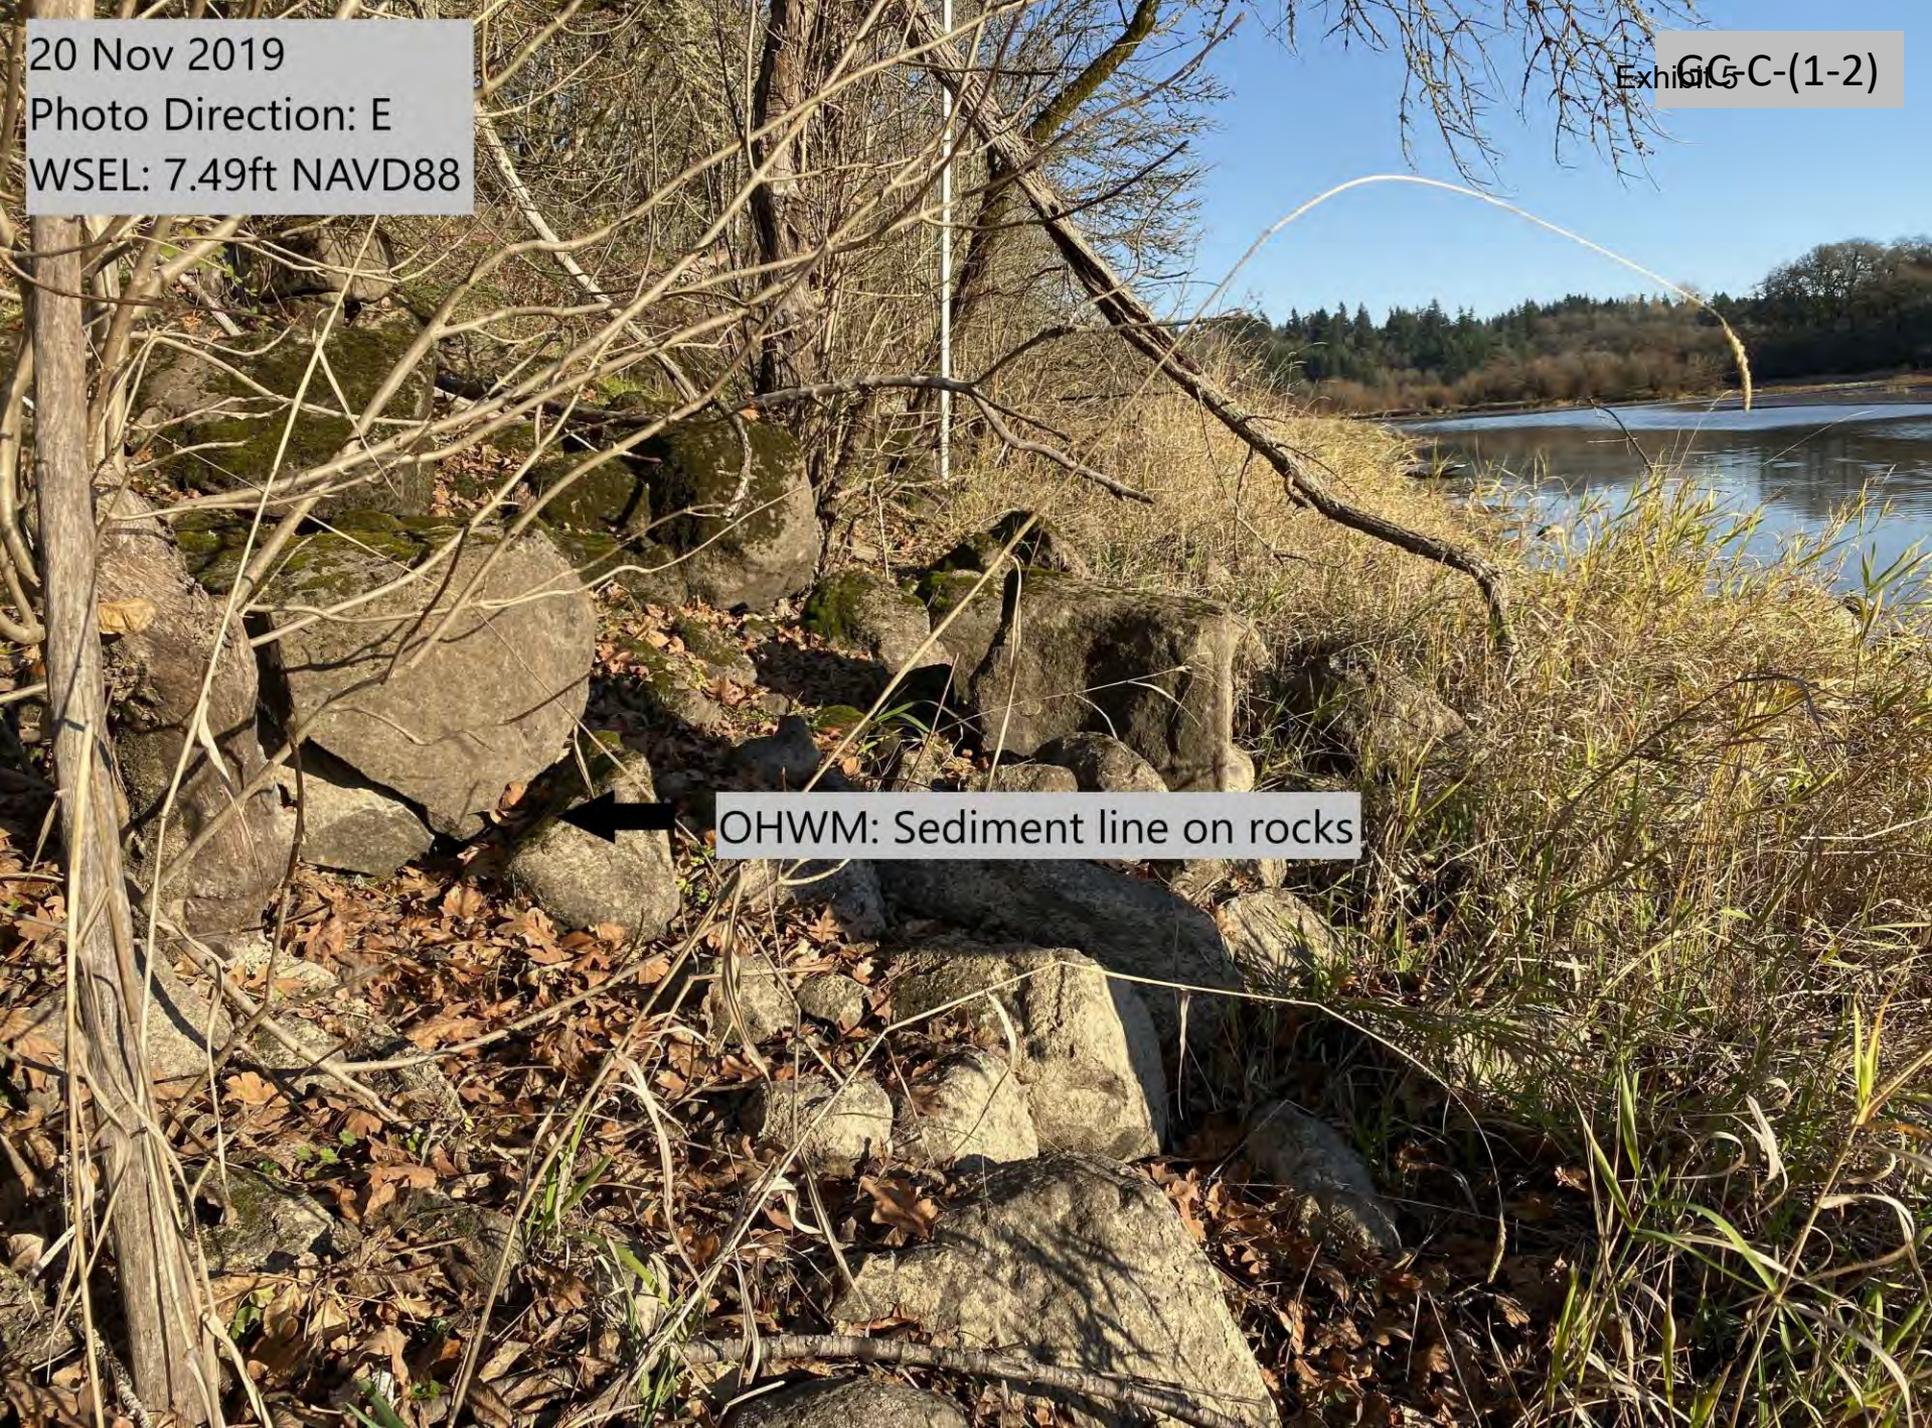
Exhibit 5  
66-C-(1-2)

← OHWM: Sediment line on rocks

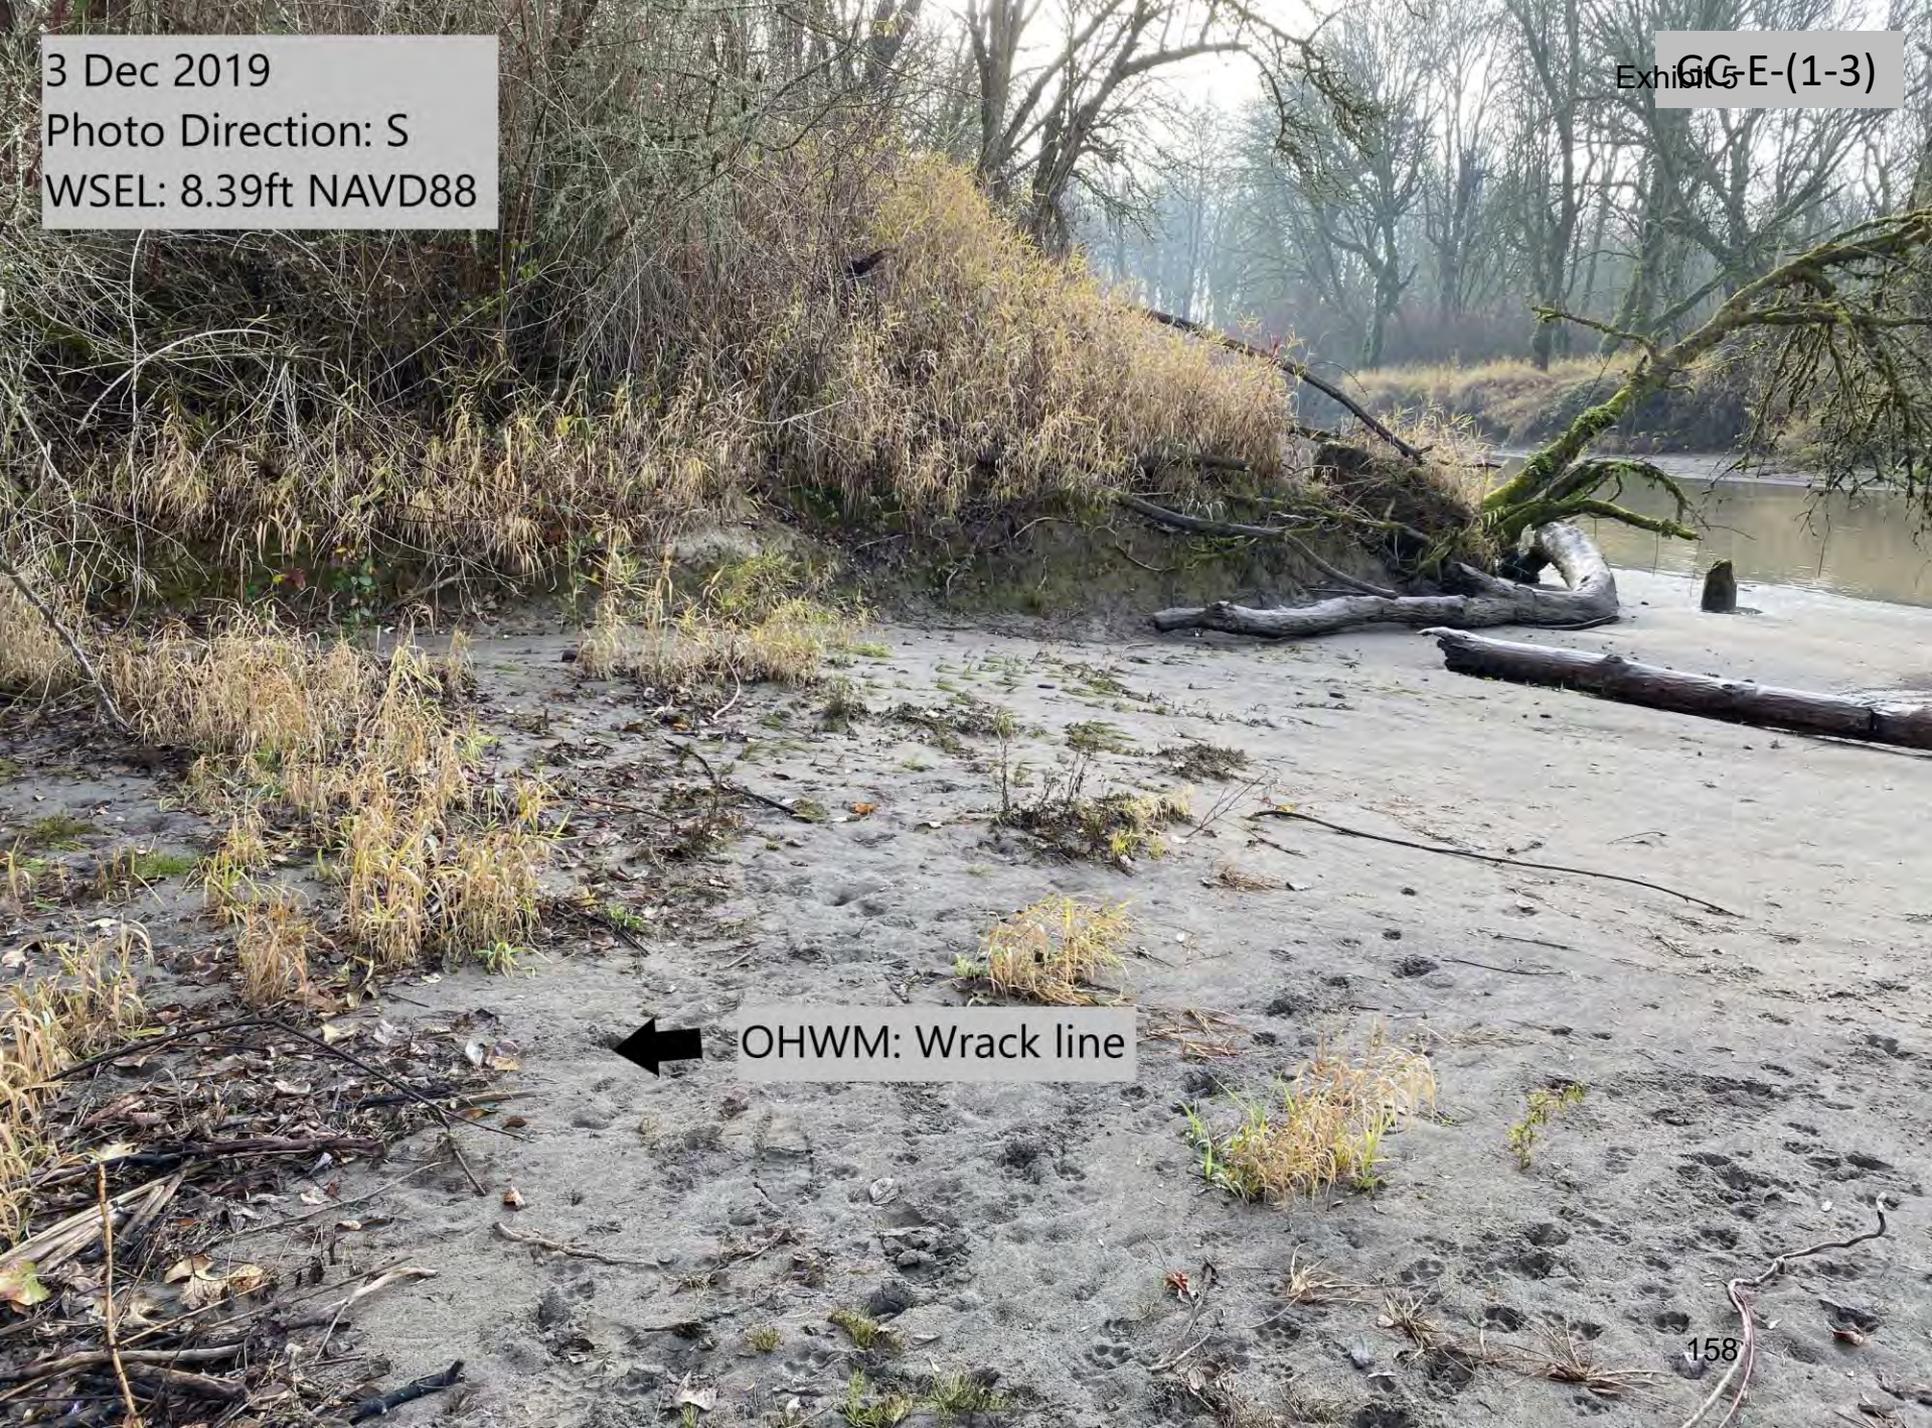
Exhibit 5  
CGE-(1-3)

← OHWM: Wrack line
