# SHORELINE MASTER PROGRAM PERIODIC REVIEW COMMENTS

WRITTEN COMMENTS

AUG 2019 – JUL 2020

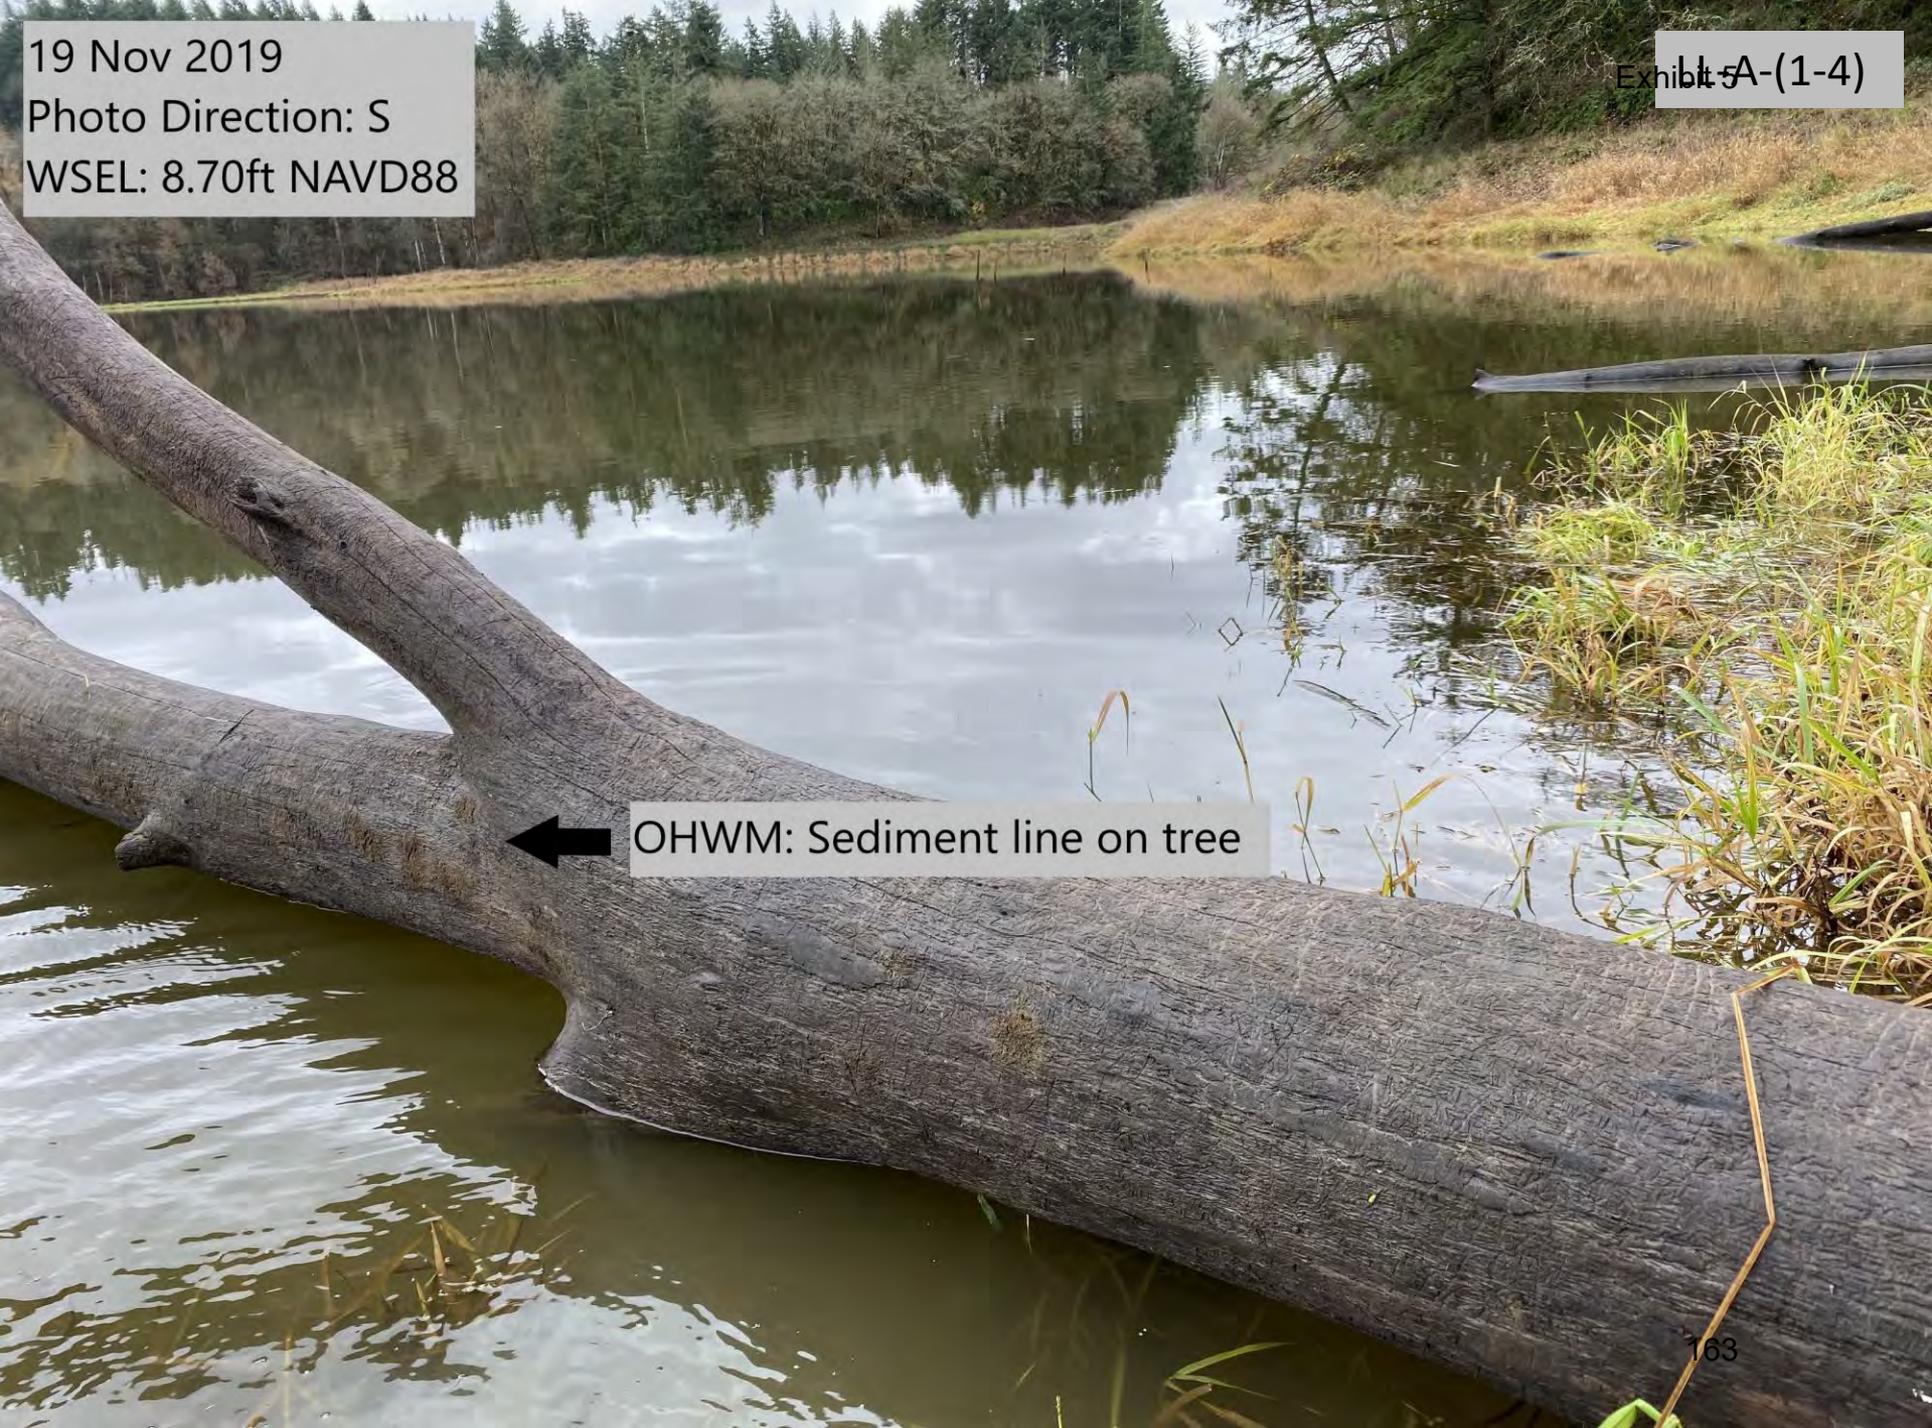
Exhibit A-(1-4)

Impounded lake. A tree fell over and there is sediment staining at OHWM. Vegetation consists of reed canary grass and bull rush

← OHWM: Sediment line on tree

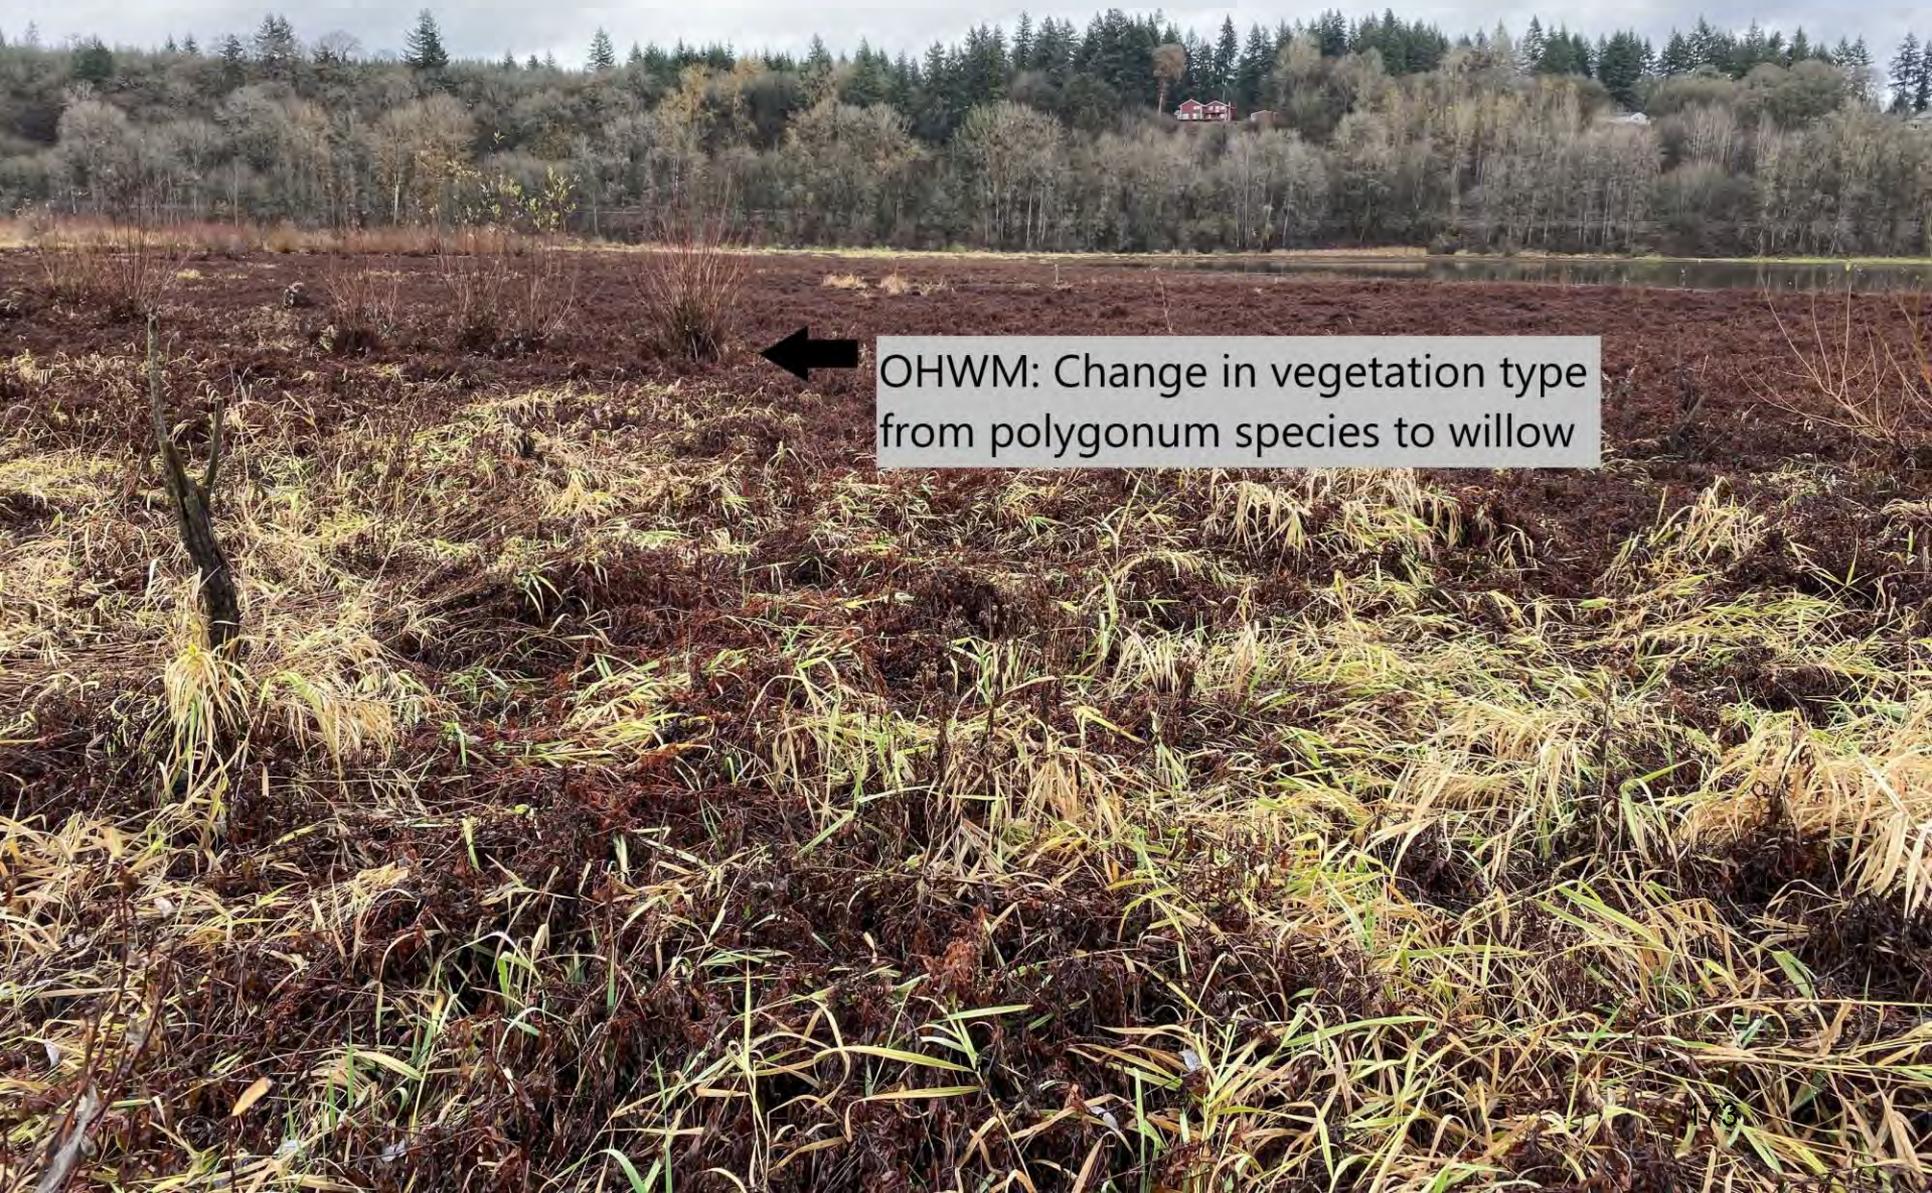
Exhibit C-(1-6)

← OHWM: Change in vegetation type  
from polygonum species to willow

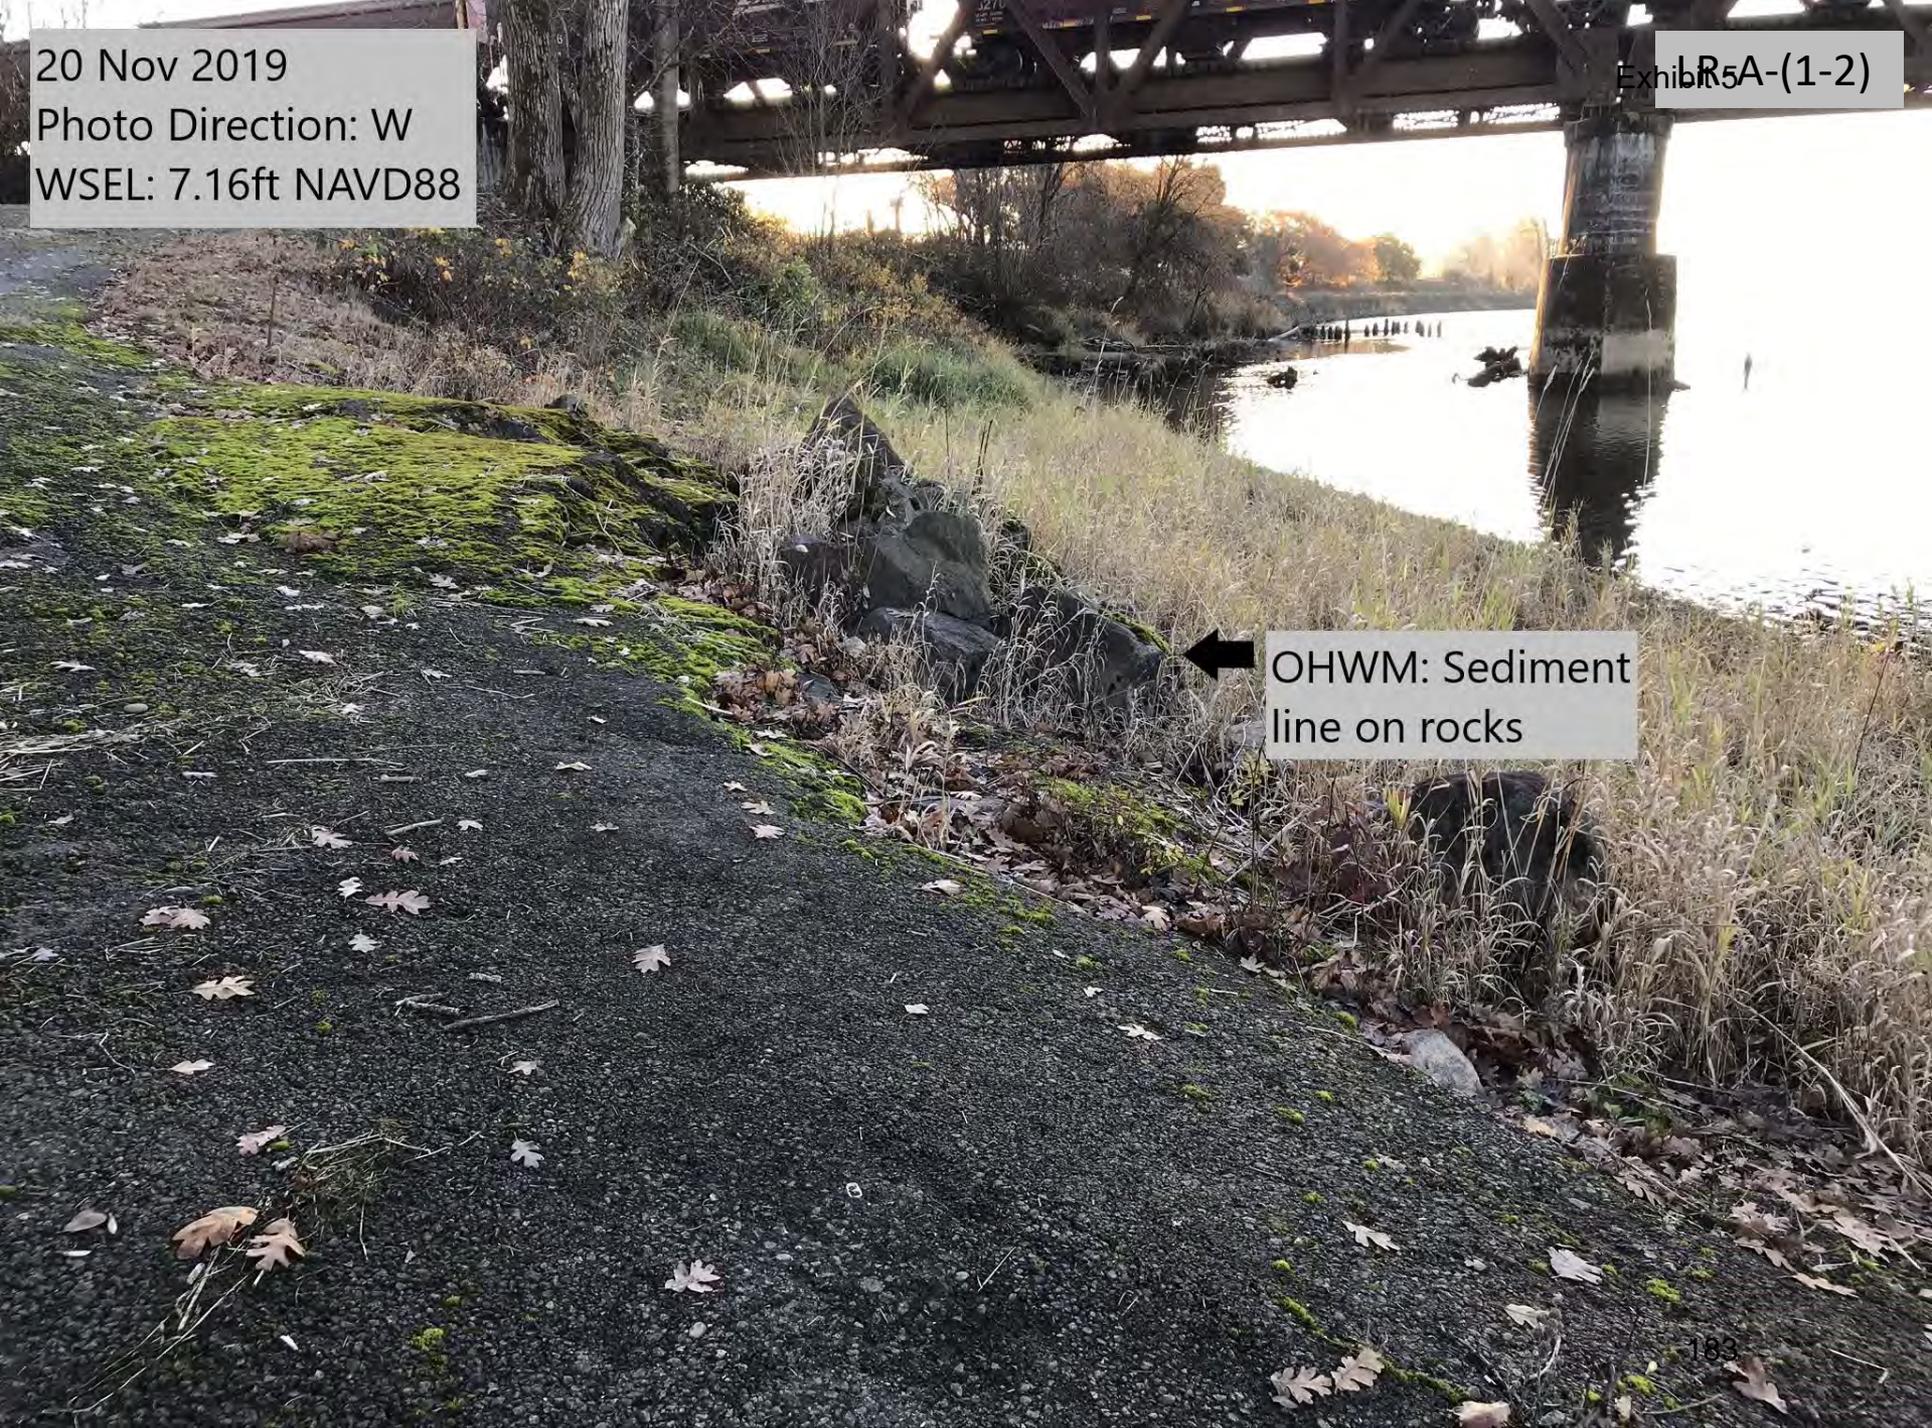
Exhibit R5A-(1-2)

← OHWM: Sediment line on rocks

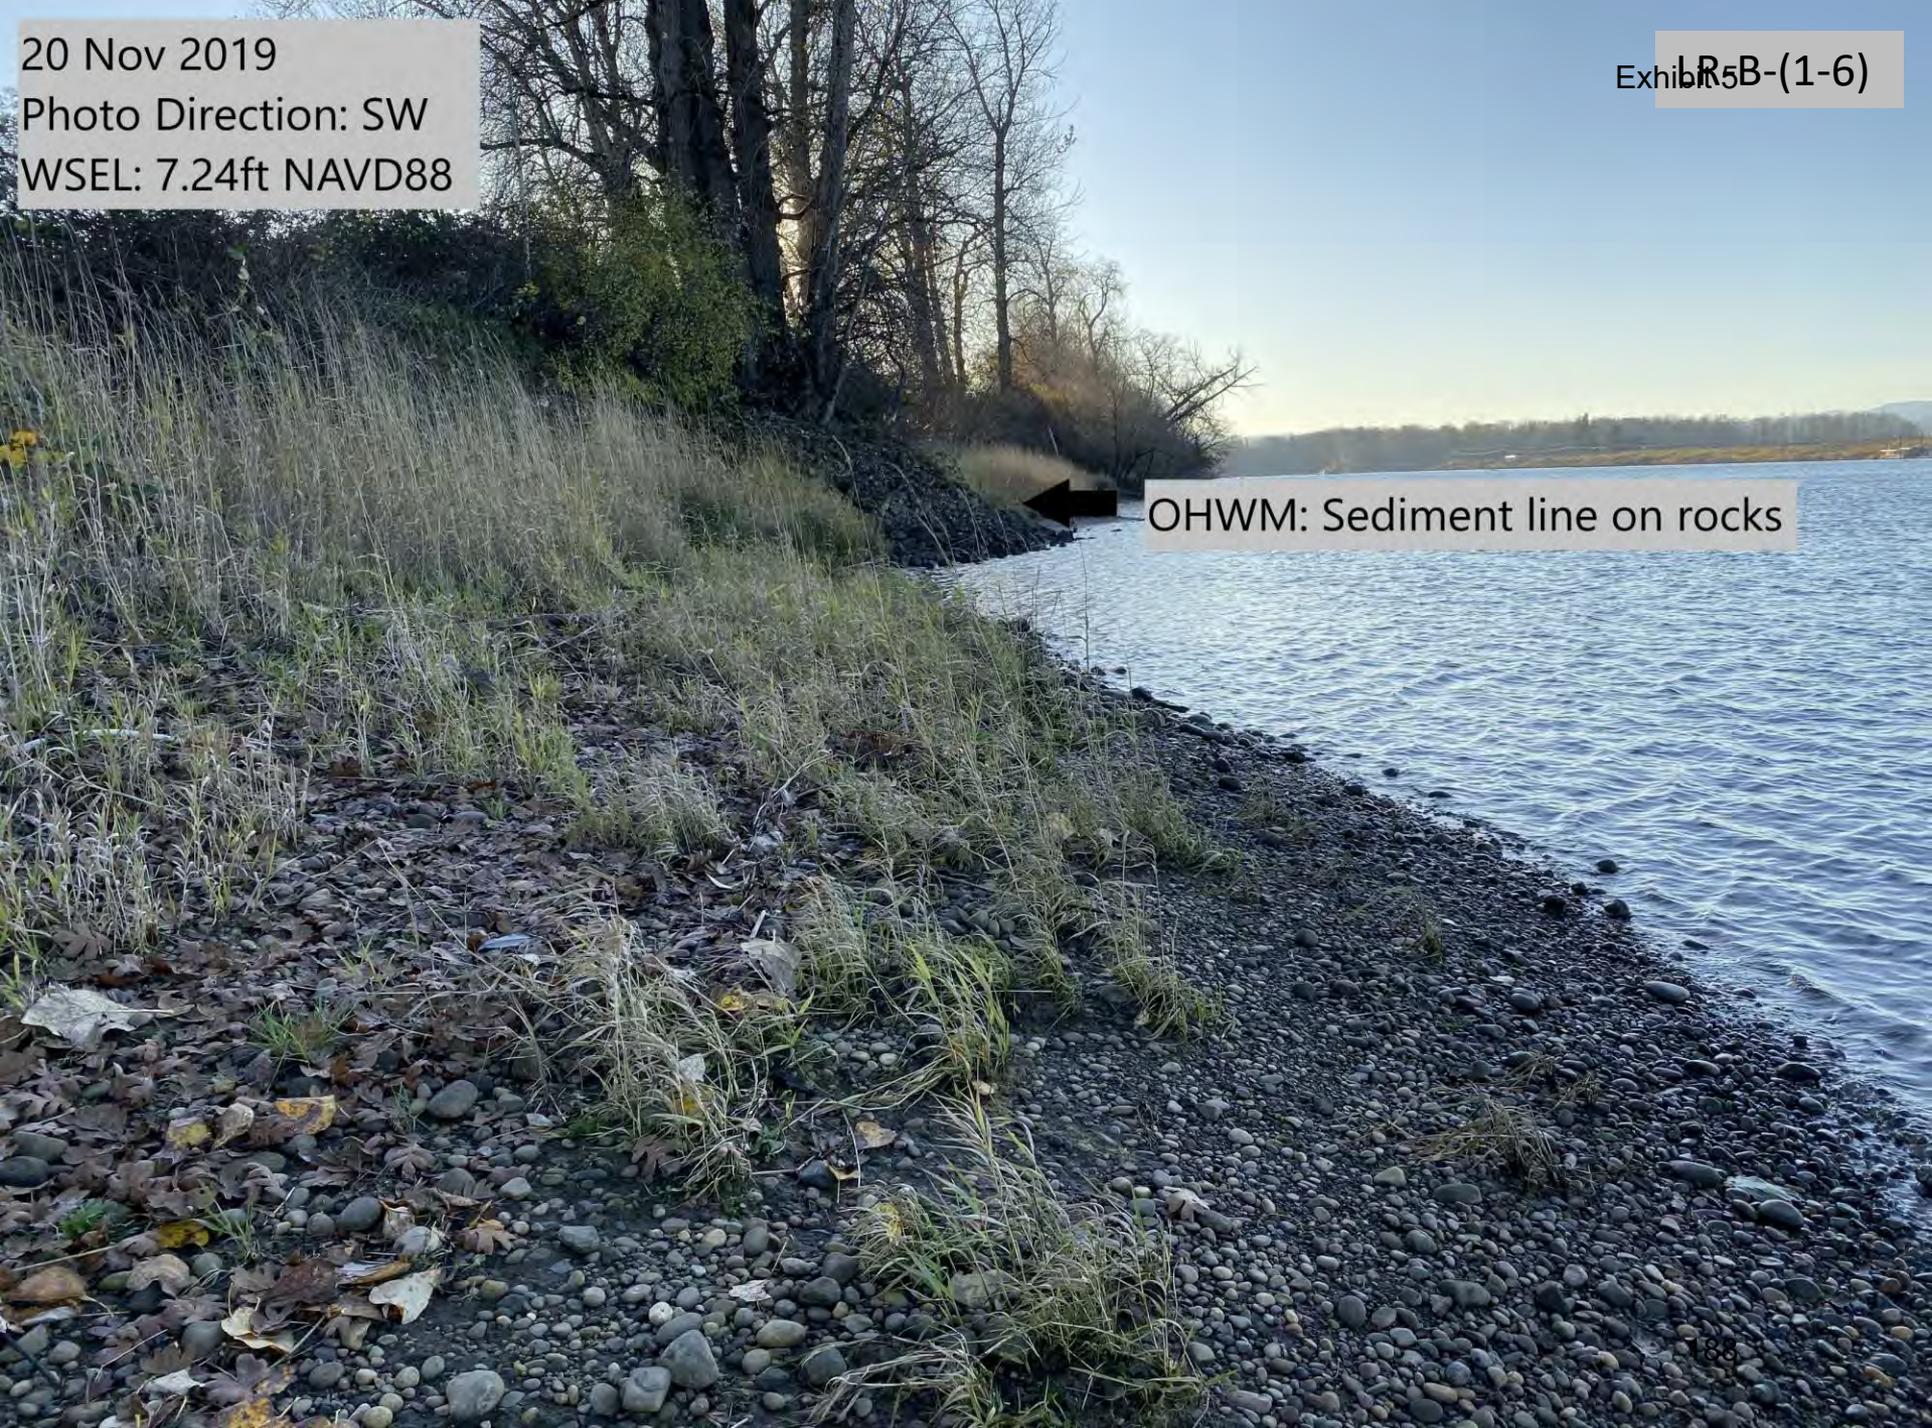
Exhibit R5B-(1-6)

OHWM: Sediment line on rocks

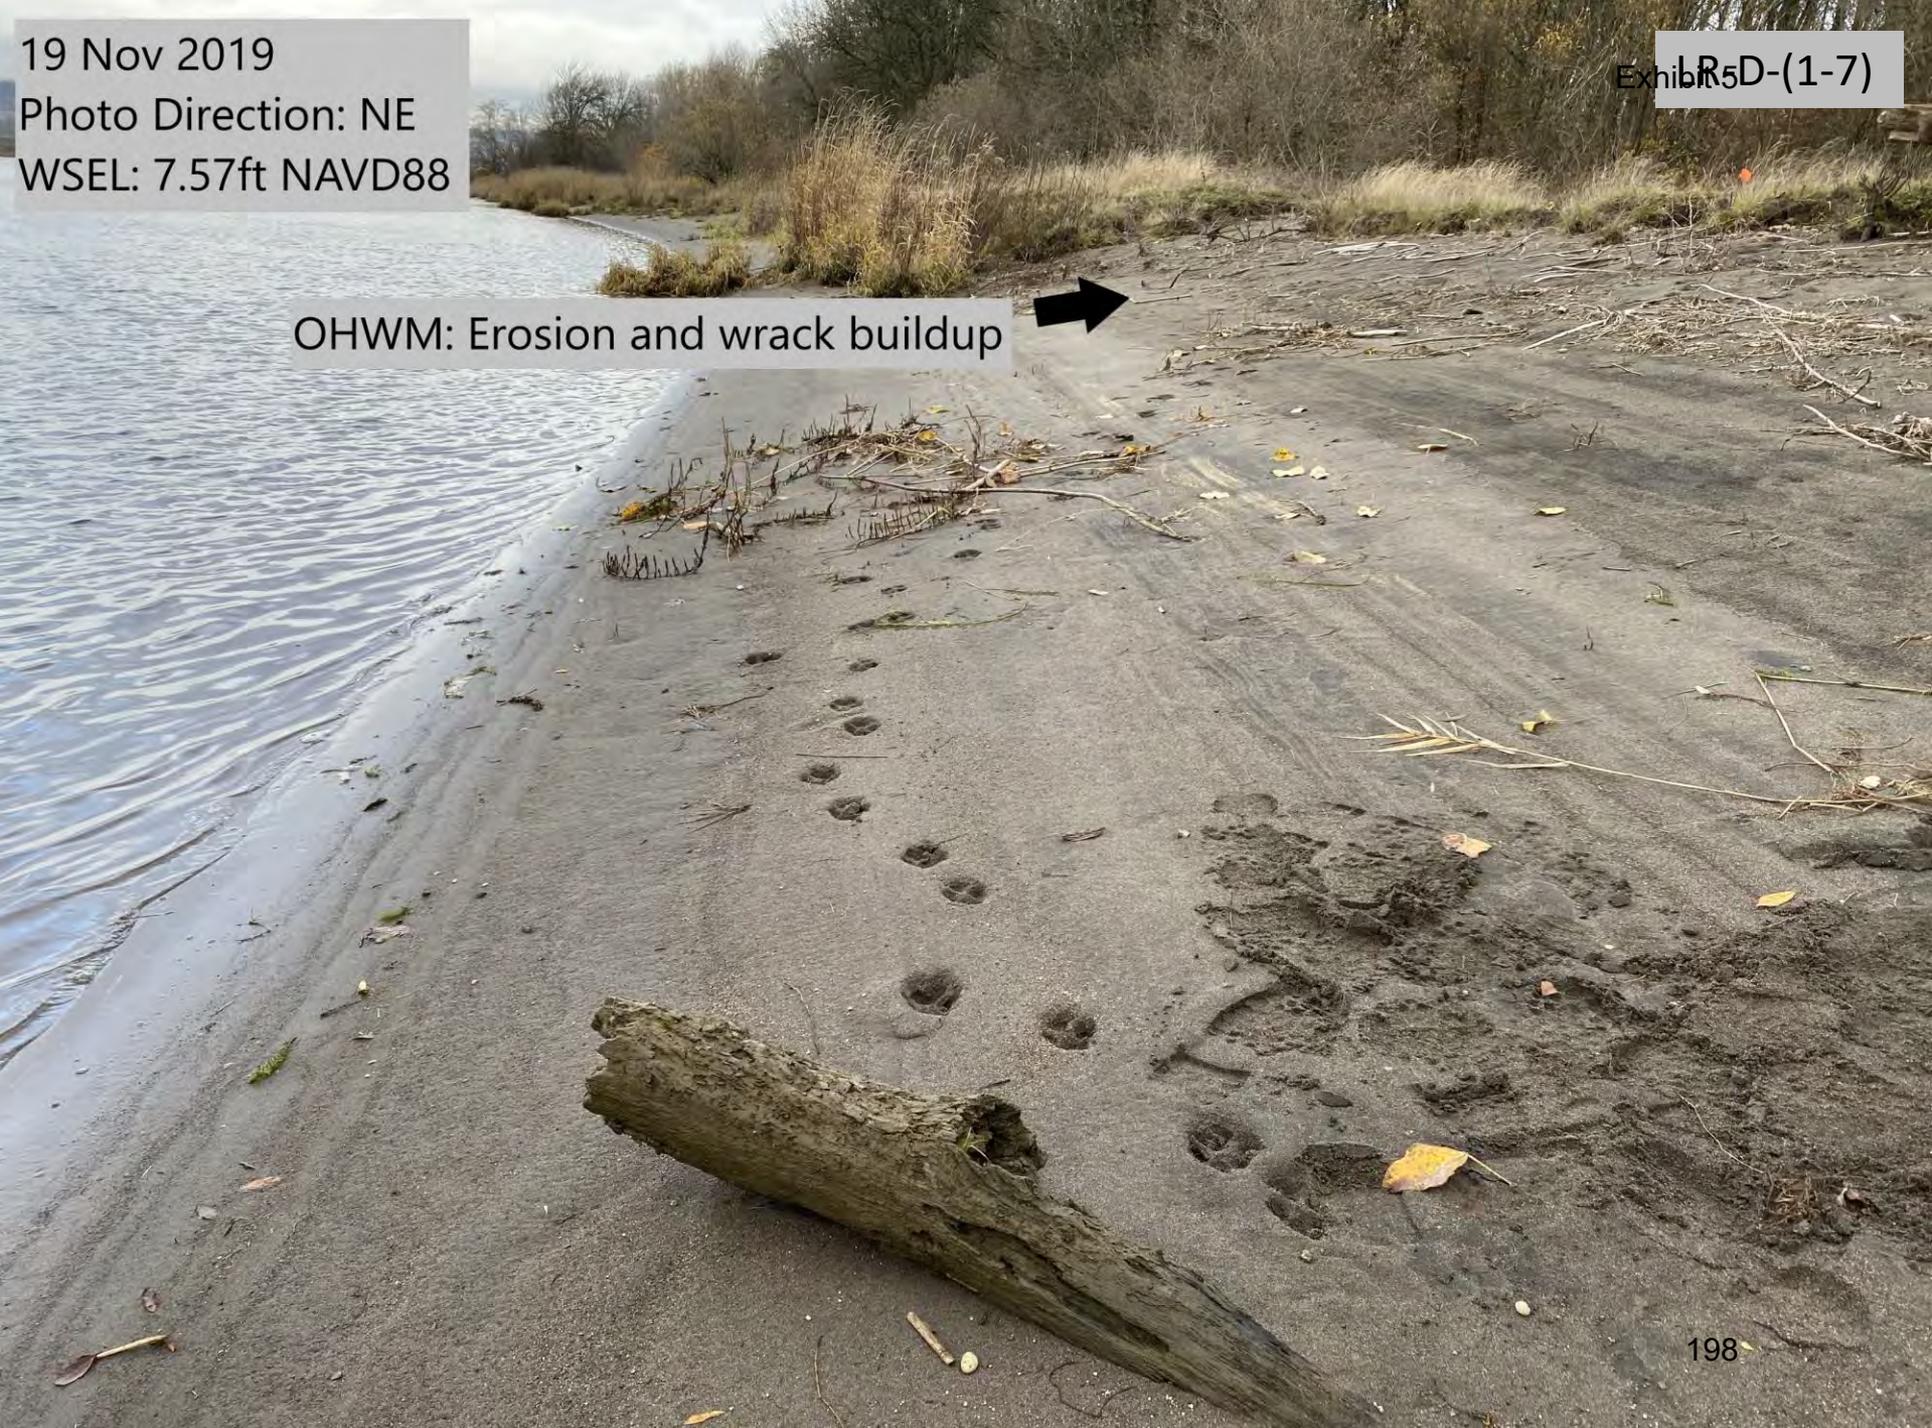
OHWM: Erosion and wrack buildup

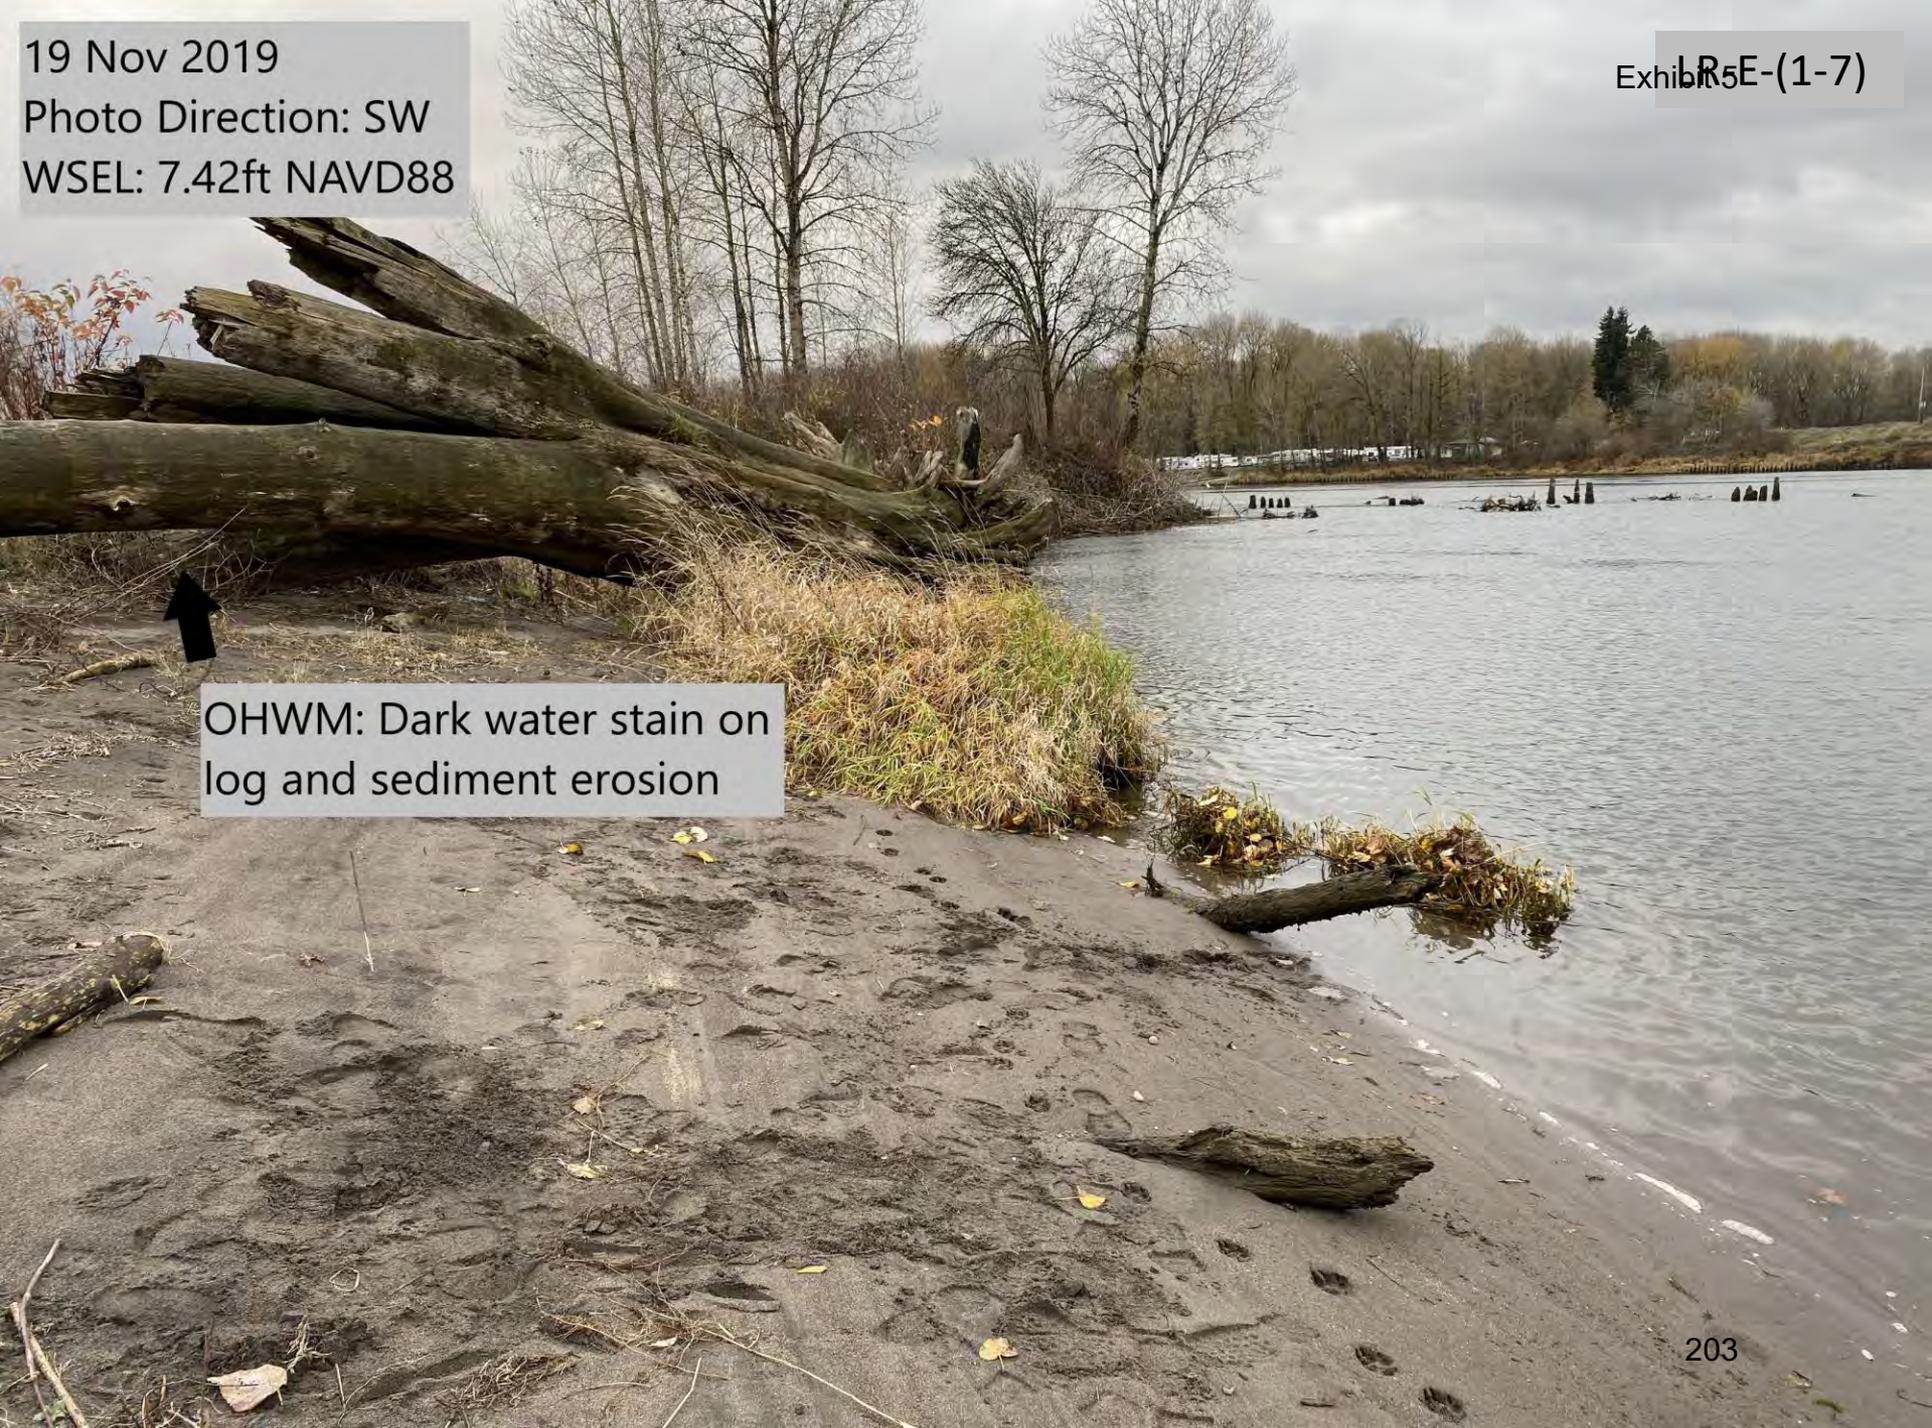
OHWL: Dark water stain on log and sediment erosion

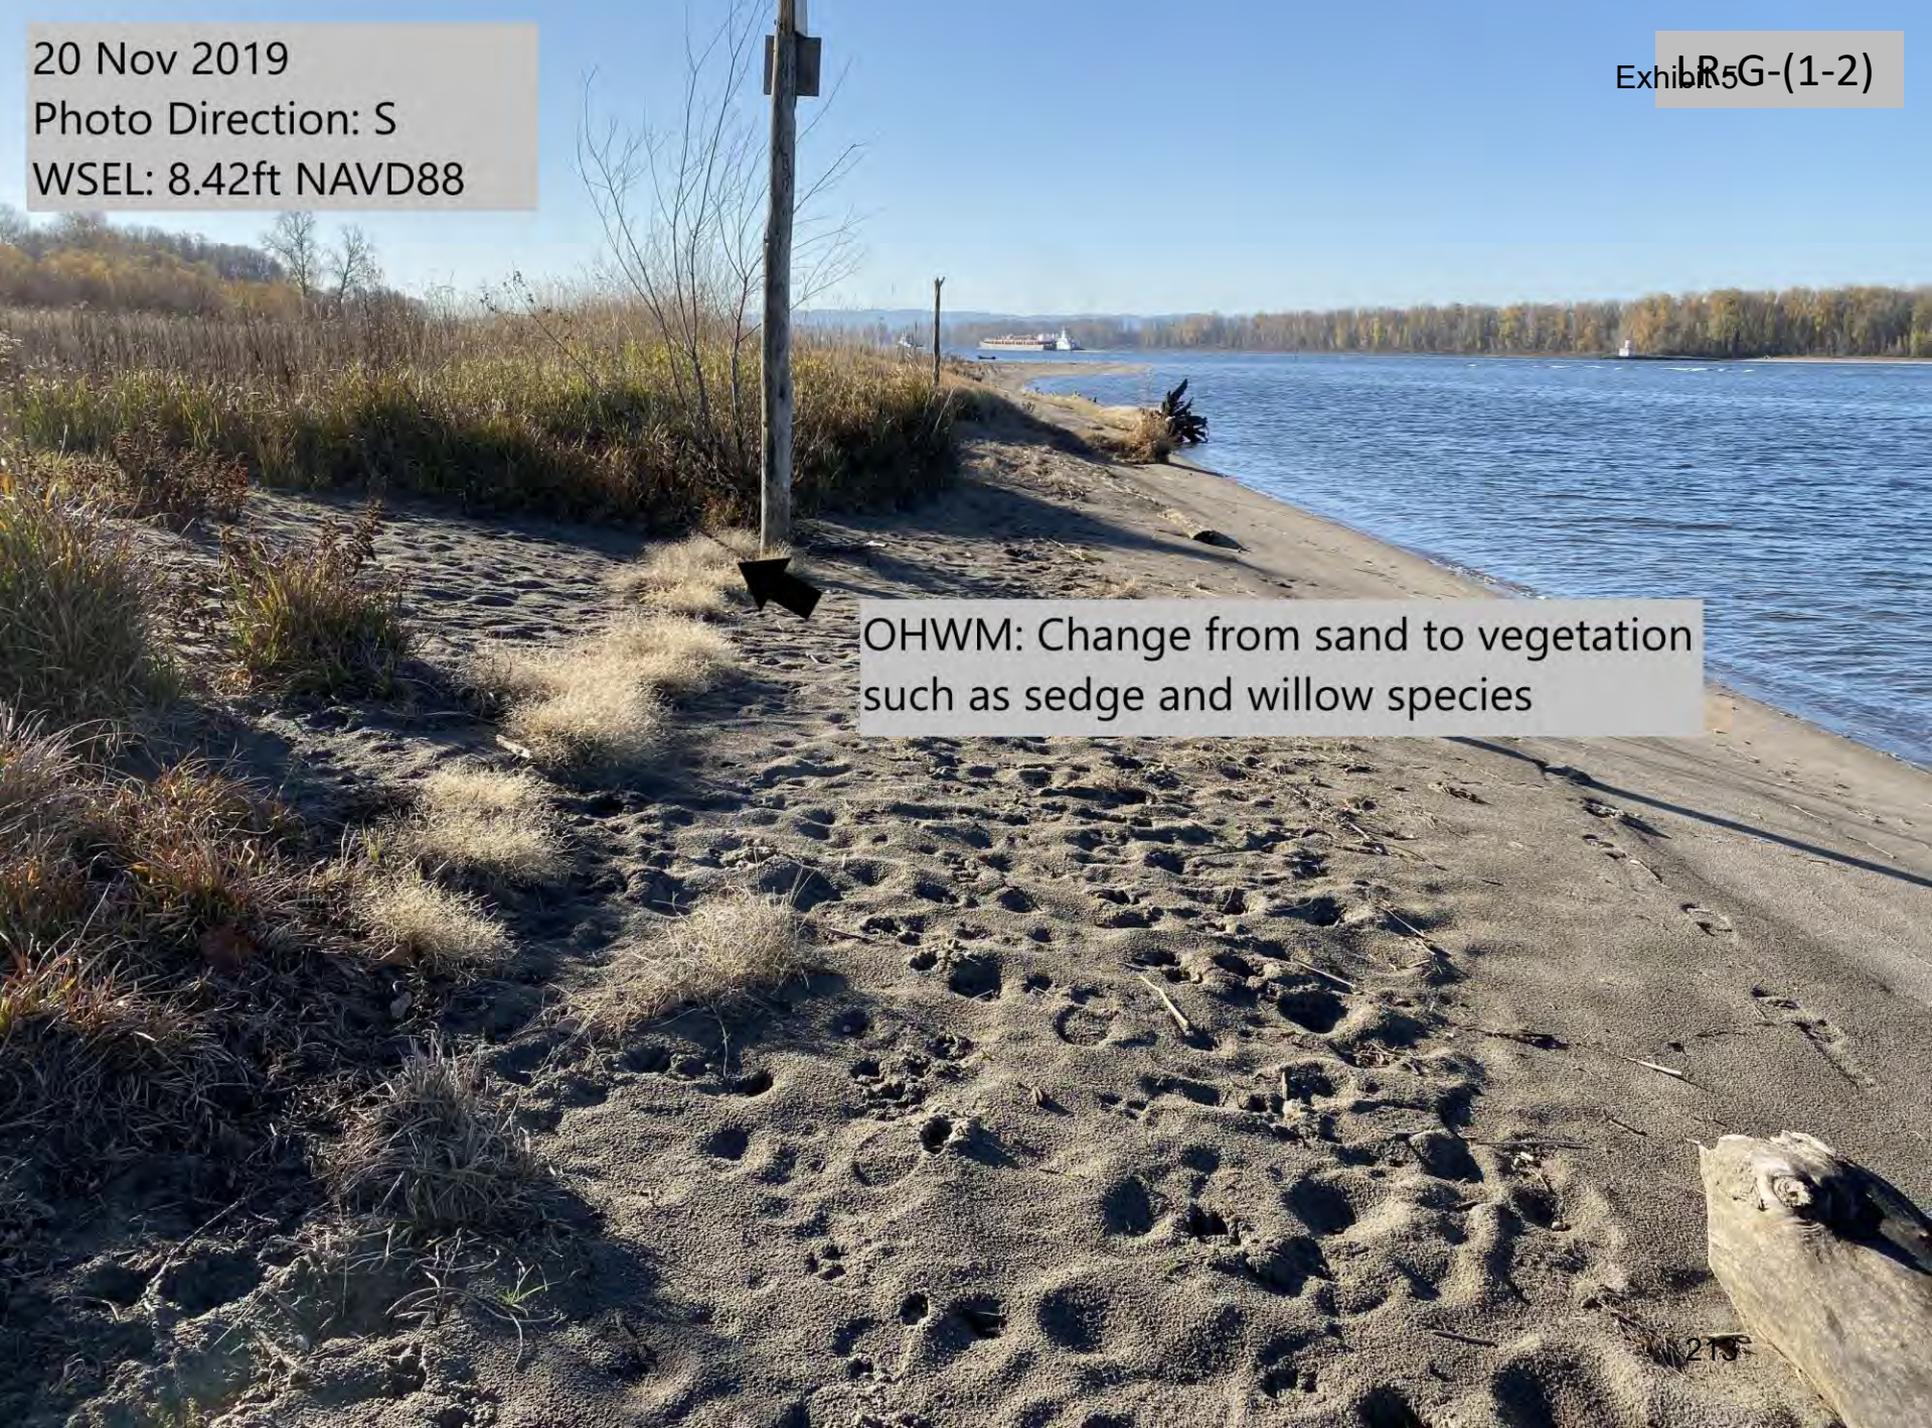
OHWM: Change from sand to vegetation  
such as sedge and willow species
