Exhibit 22 Part 4 LRE-(1-7)

Site/Project: Wapato Valley /
 Name/Owner: Plas Newydd Farm
 Location: Lewis River
 Description: 45.85357, -122.776643
points: LR-F-(1-3)

To: Jenna Kay, Planner II/Shoreline Master Program Coordinator
From: Brent Davis, Wetland and Habitat Review Manager/Shoreline Administrator *BD*
Date: January 10, 2019
Subject: REVISED Analysis to Support Proposed Shoreline Map Amendments in the Shanghai Creek Basin

**2020 Shoreline Master Program Update
Shanghai Creek Shoreline Map Revisions**

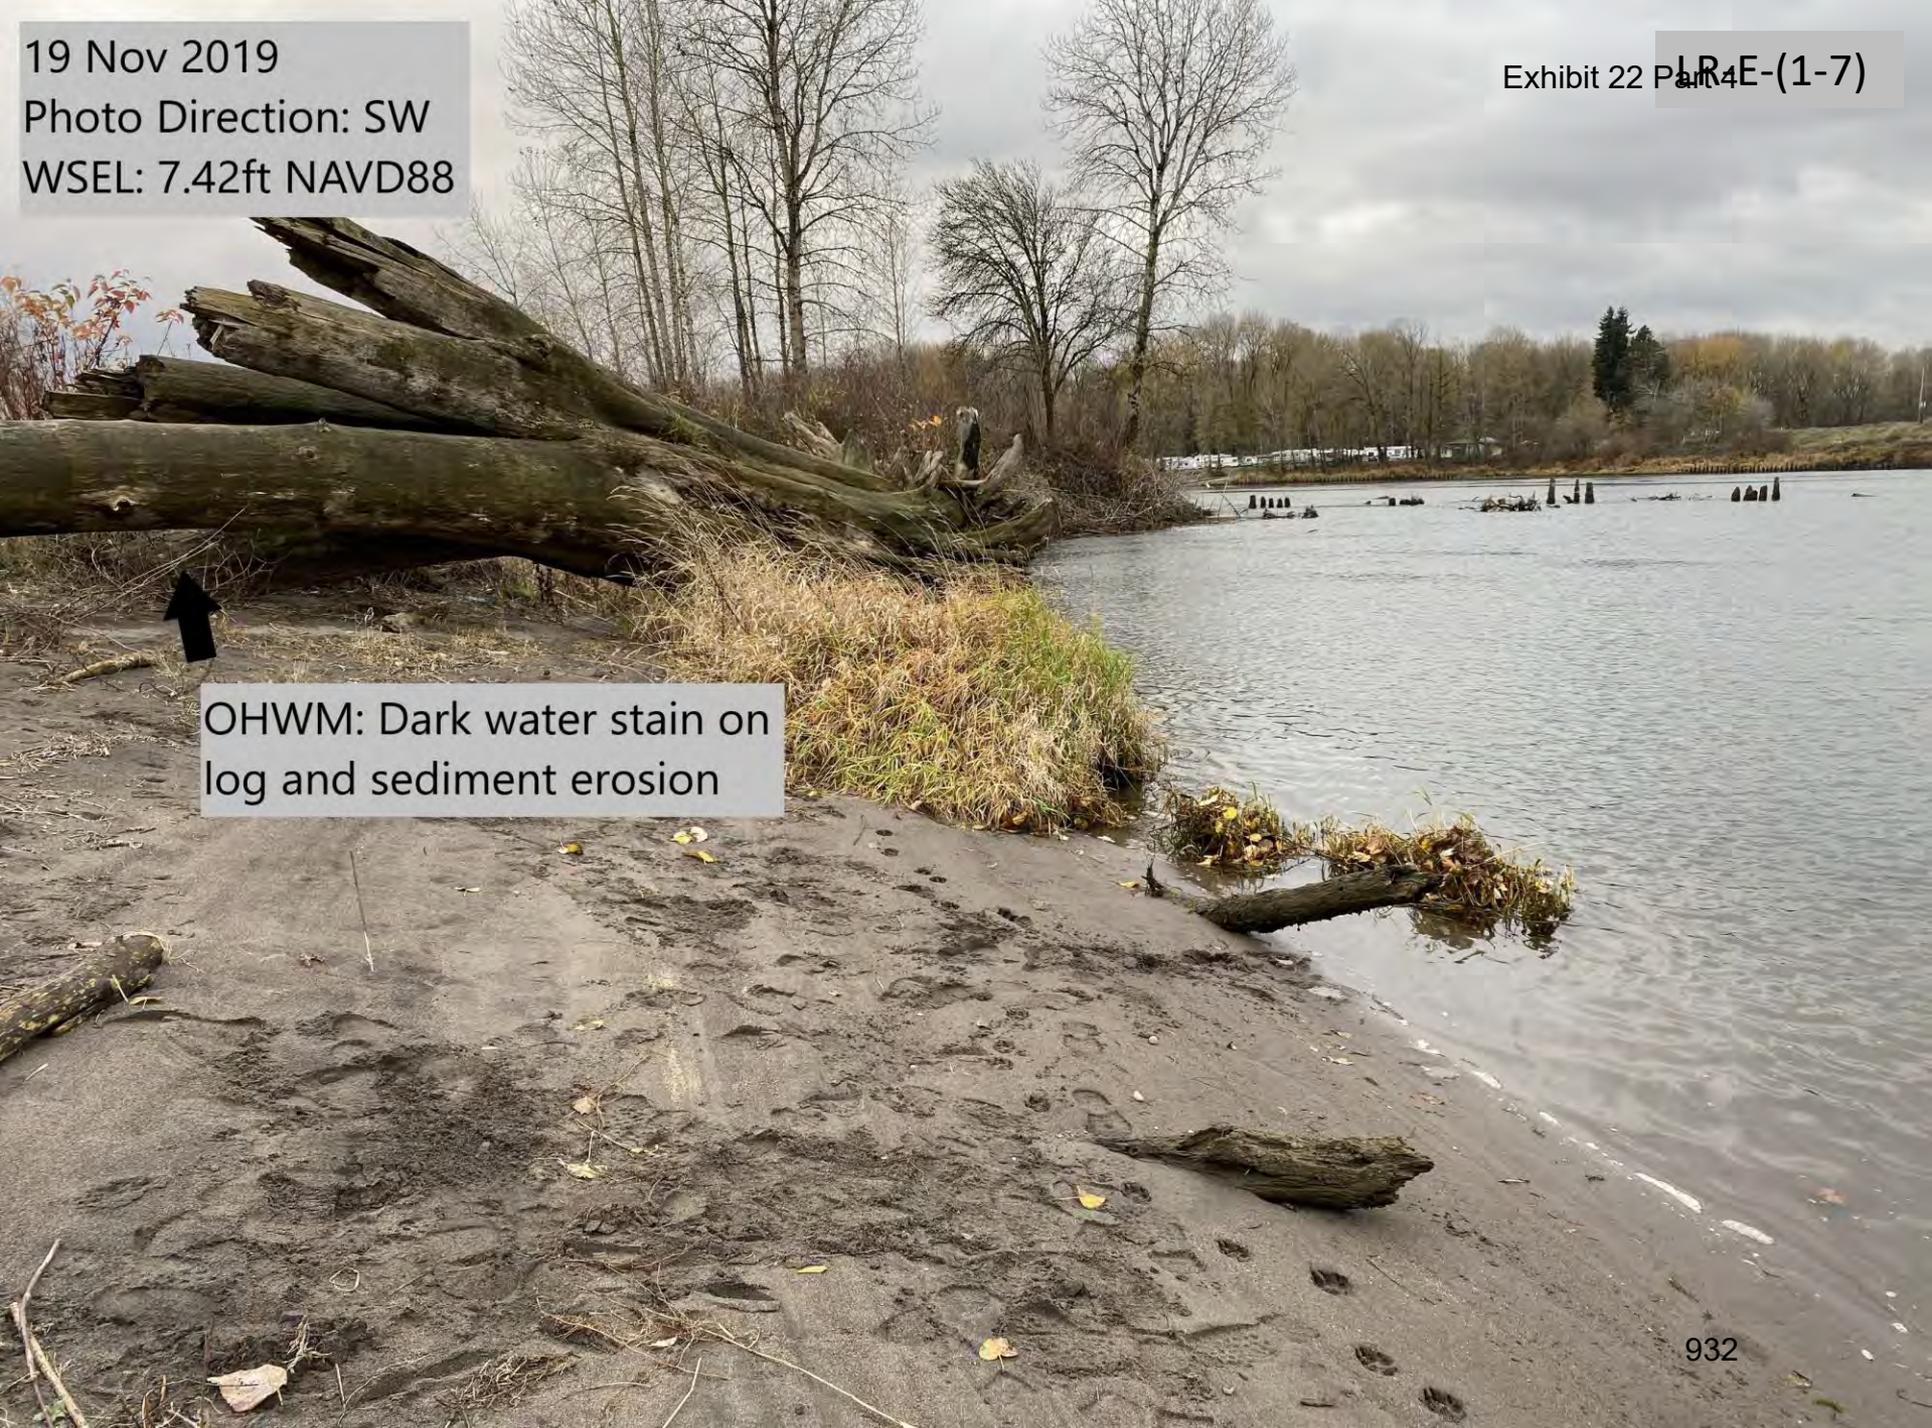
19 Nov 2019
Photo Direction: SW
WSEL: 7.42ft NAVD88

OHWL: Dark water stain on
log and sediment erosion

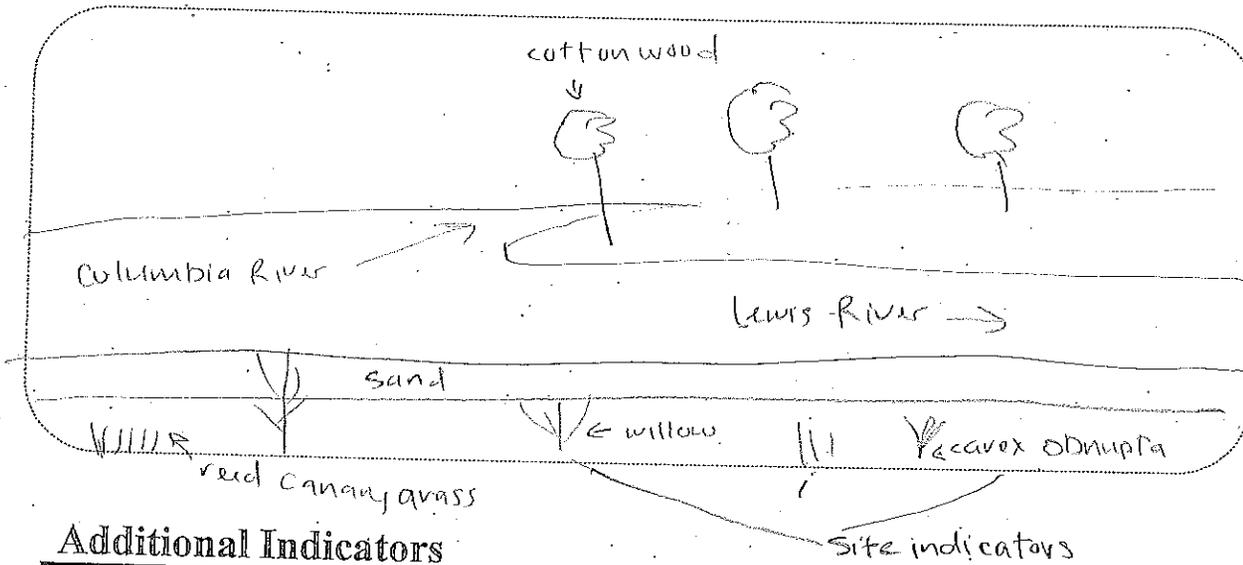
This survey site was at the confluence of the Lewis and Columbia Rivers. The OHWM here was not clear on any fixed objects so we used the lowest elevations of the native willows and slough sedge. Reed canarygrass was present but tolerates wet and dry conditions so it was not a useful indicator species.

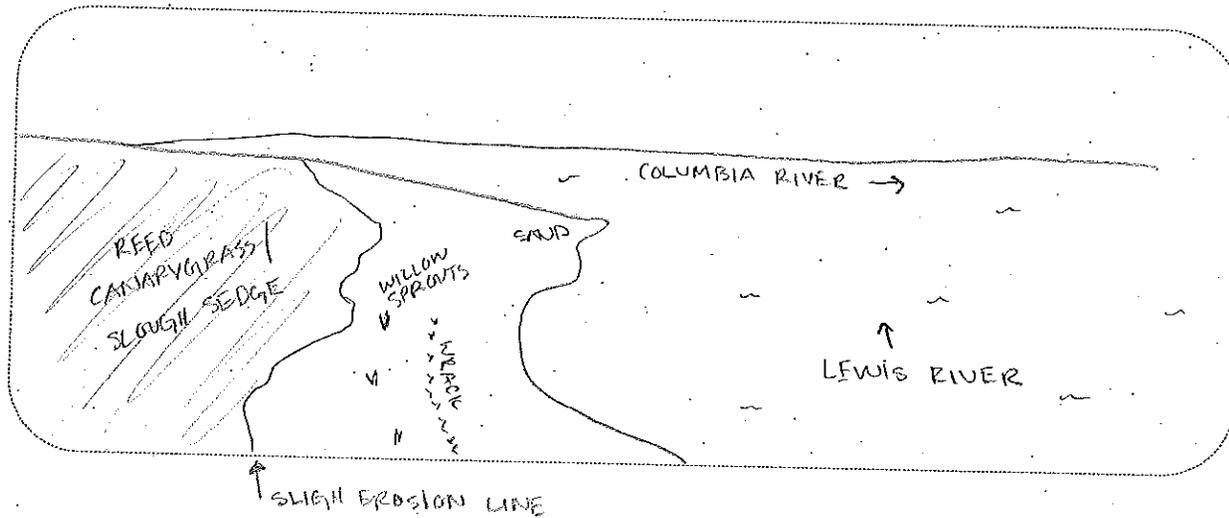
This survey site was at the confluence of the Lewis and Columbia Rivers. Water levels here are highly variable as evidenced by lines of washed up debris/wrack at multiple elevations on the beach. Elevations were taken at larger wrack lines and where willows were sprouting a little higher on the beach.

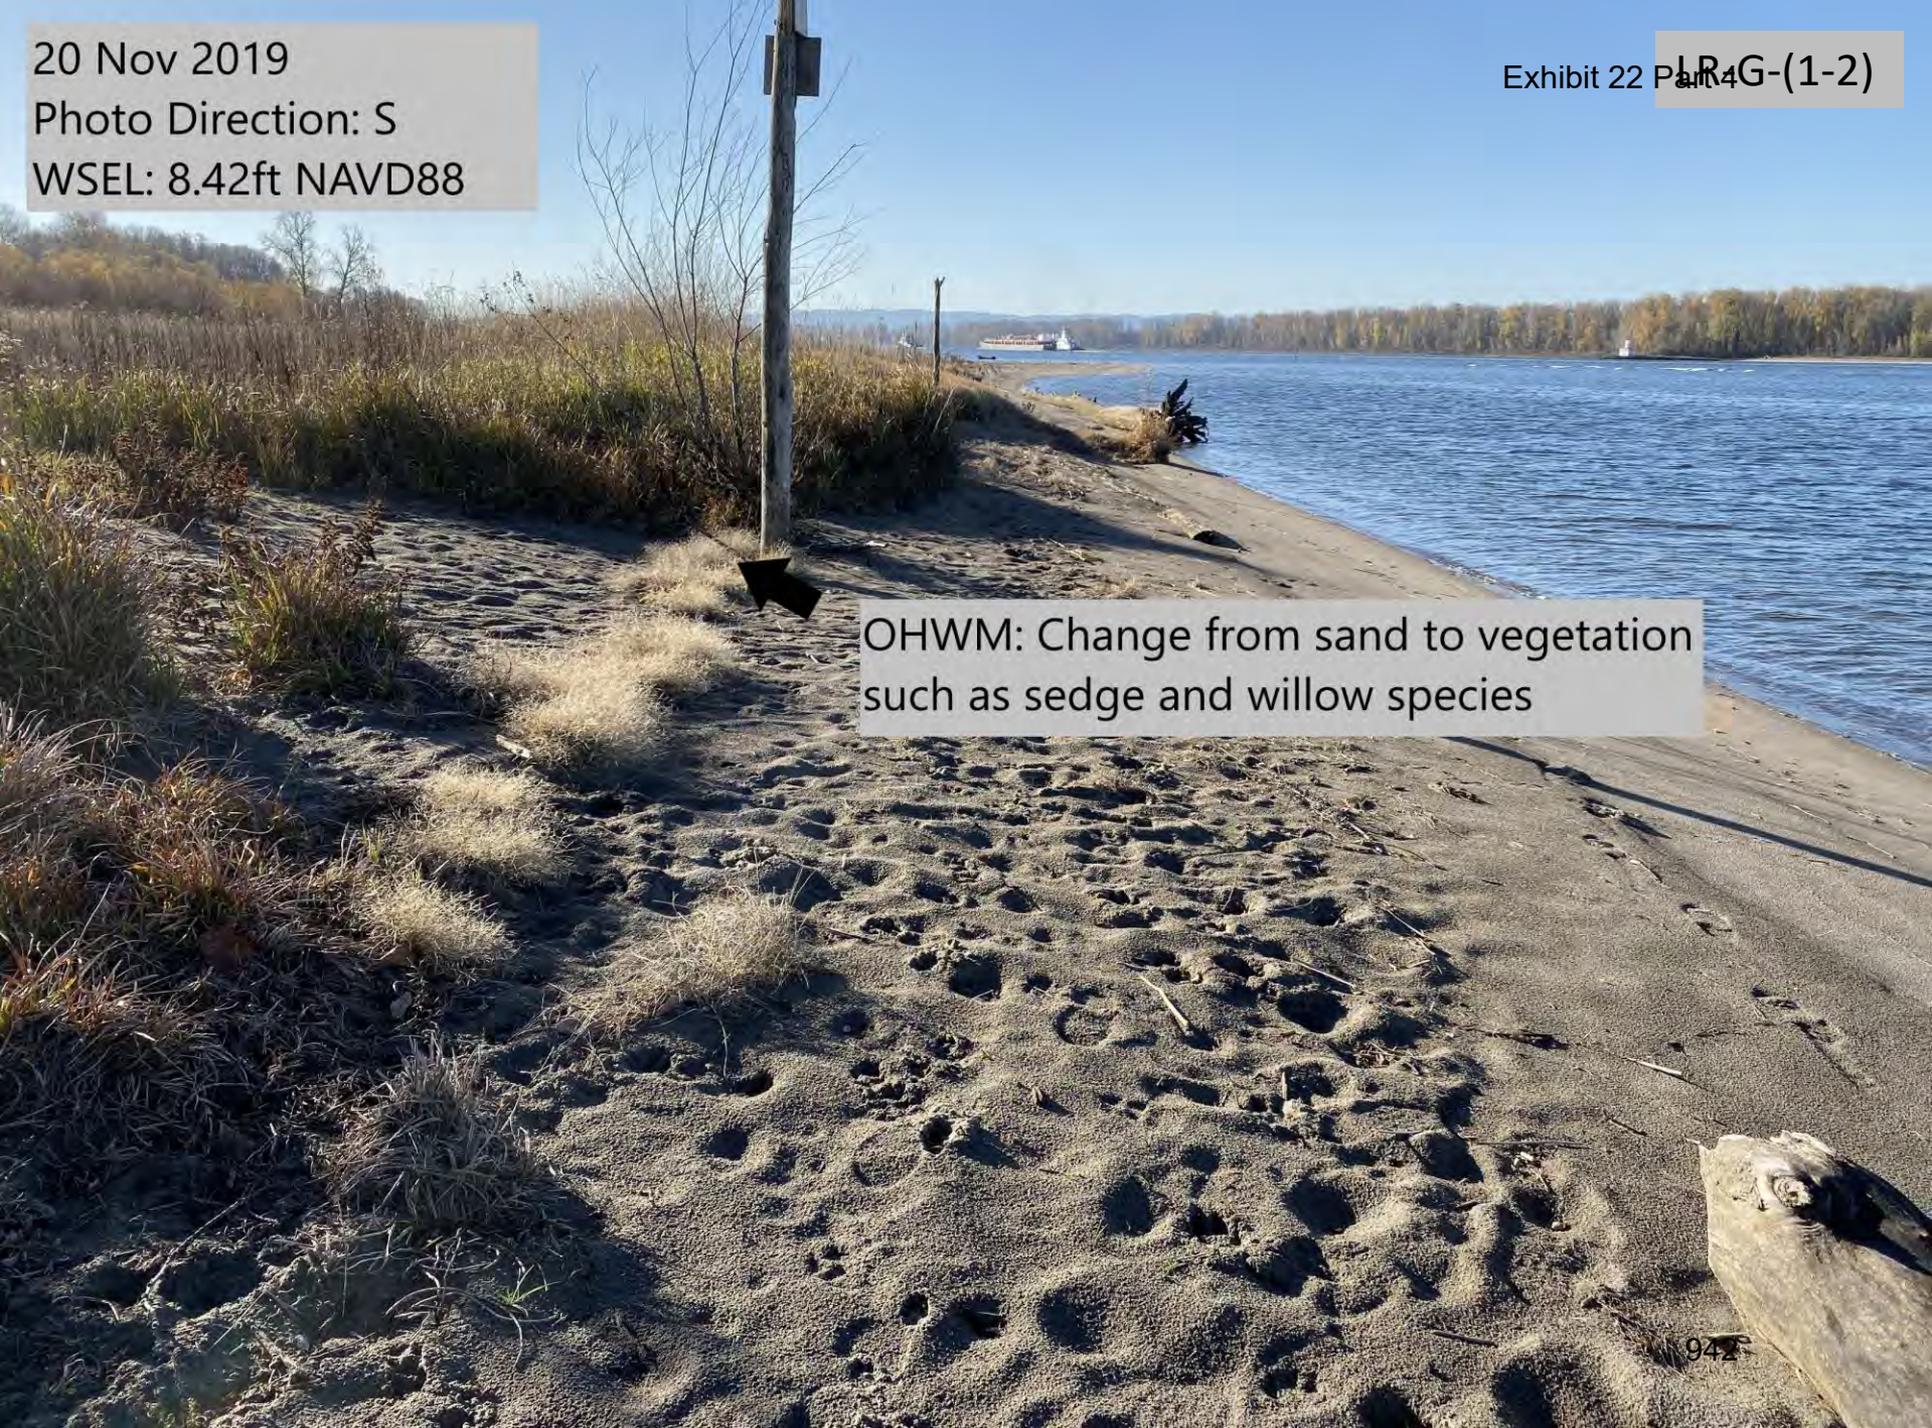
Exhibit 22 Part 4
LR4G-(1-2)

20 Nov 2019
Photo Direction: S
WSEL: 8.42ft NAVD88

OHWL: Change from sand to vegetation
such as sedge and willow species

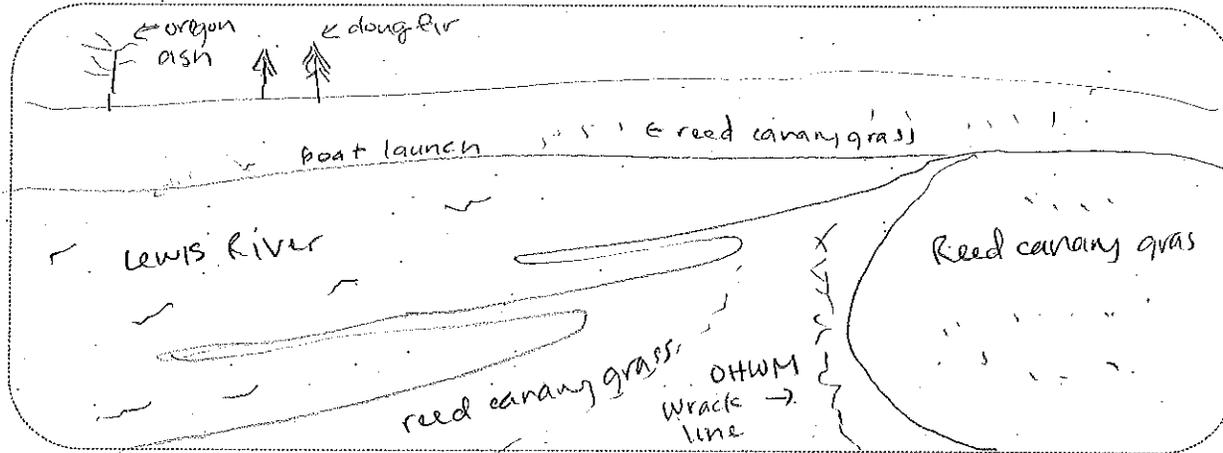
There is a wrack line that is an OHWM indicator.

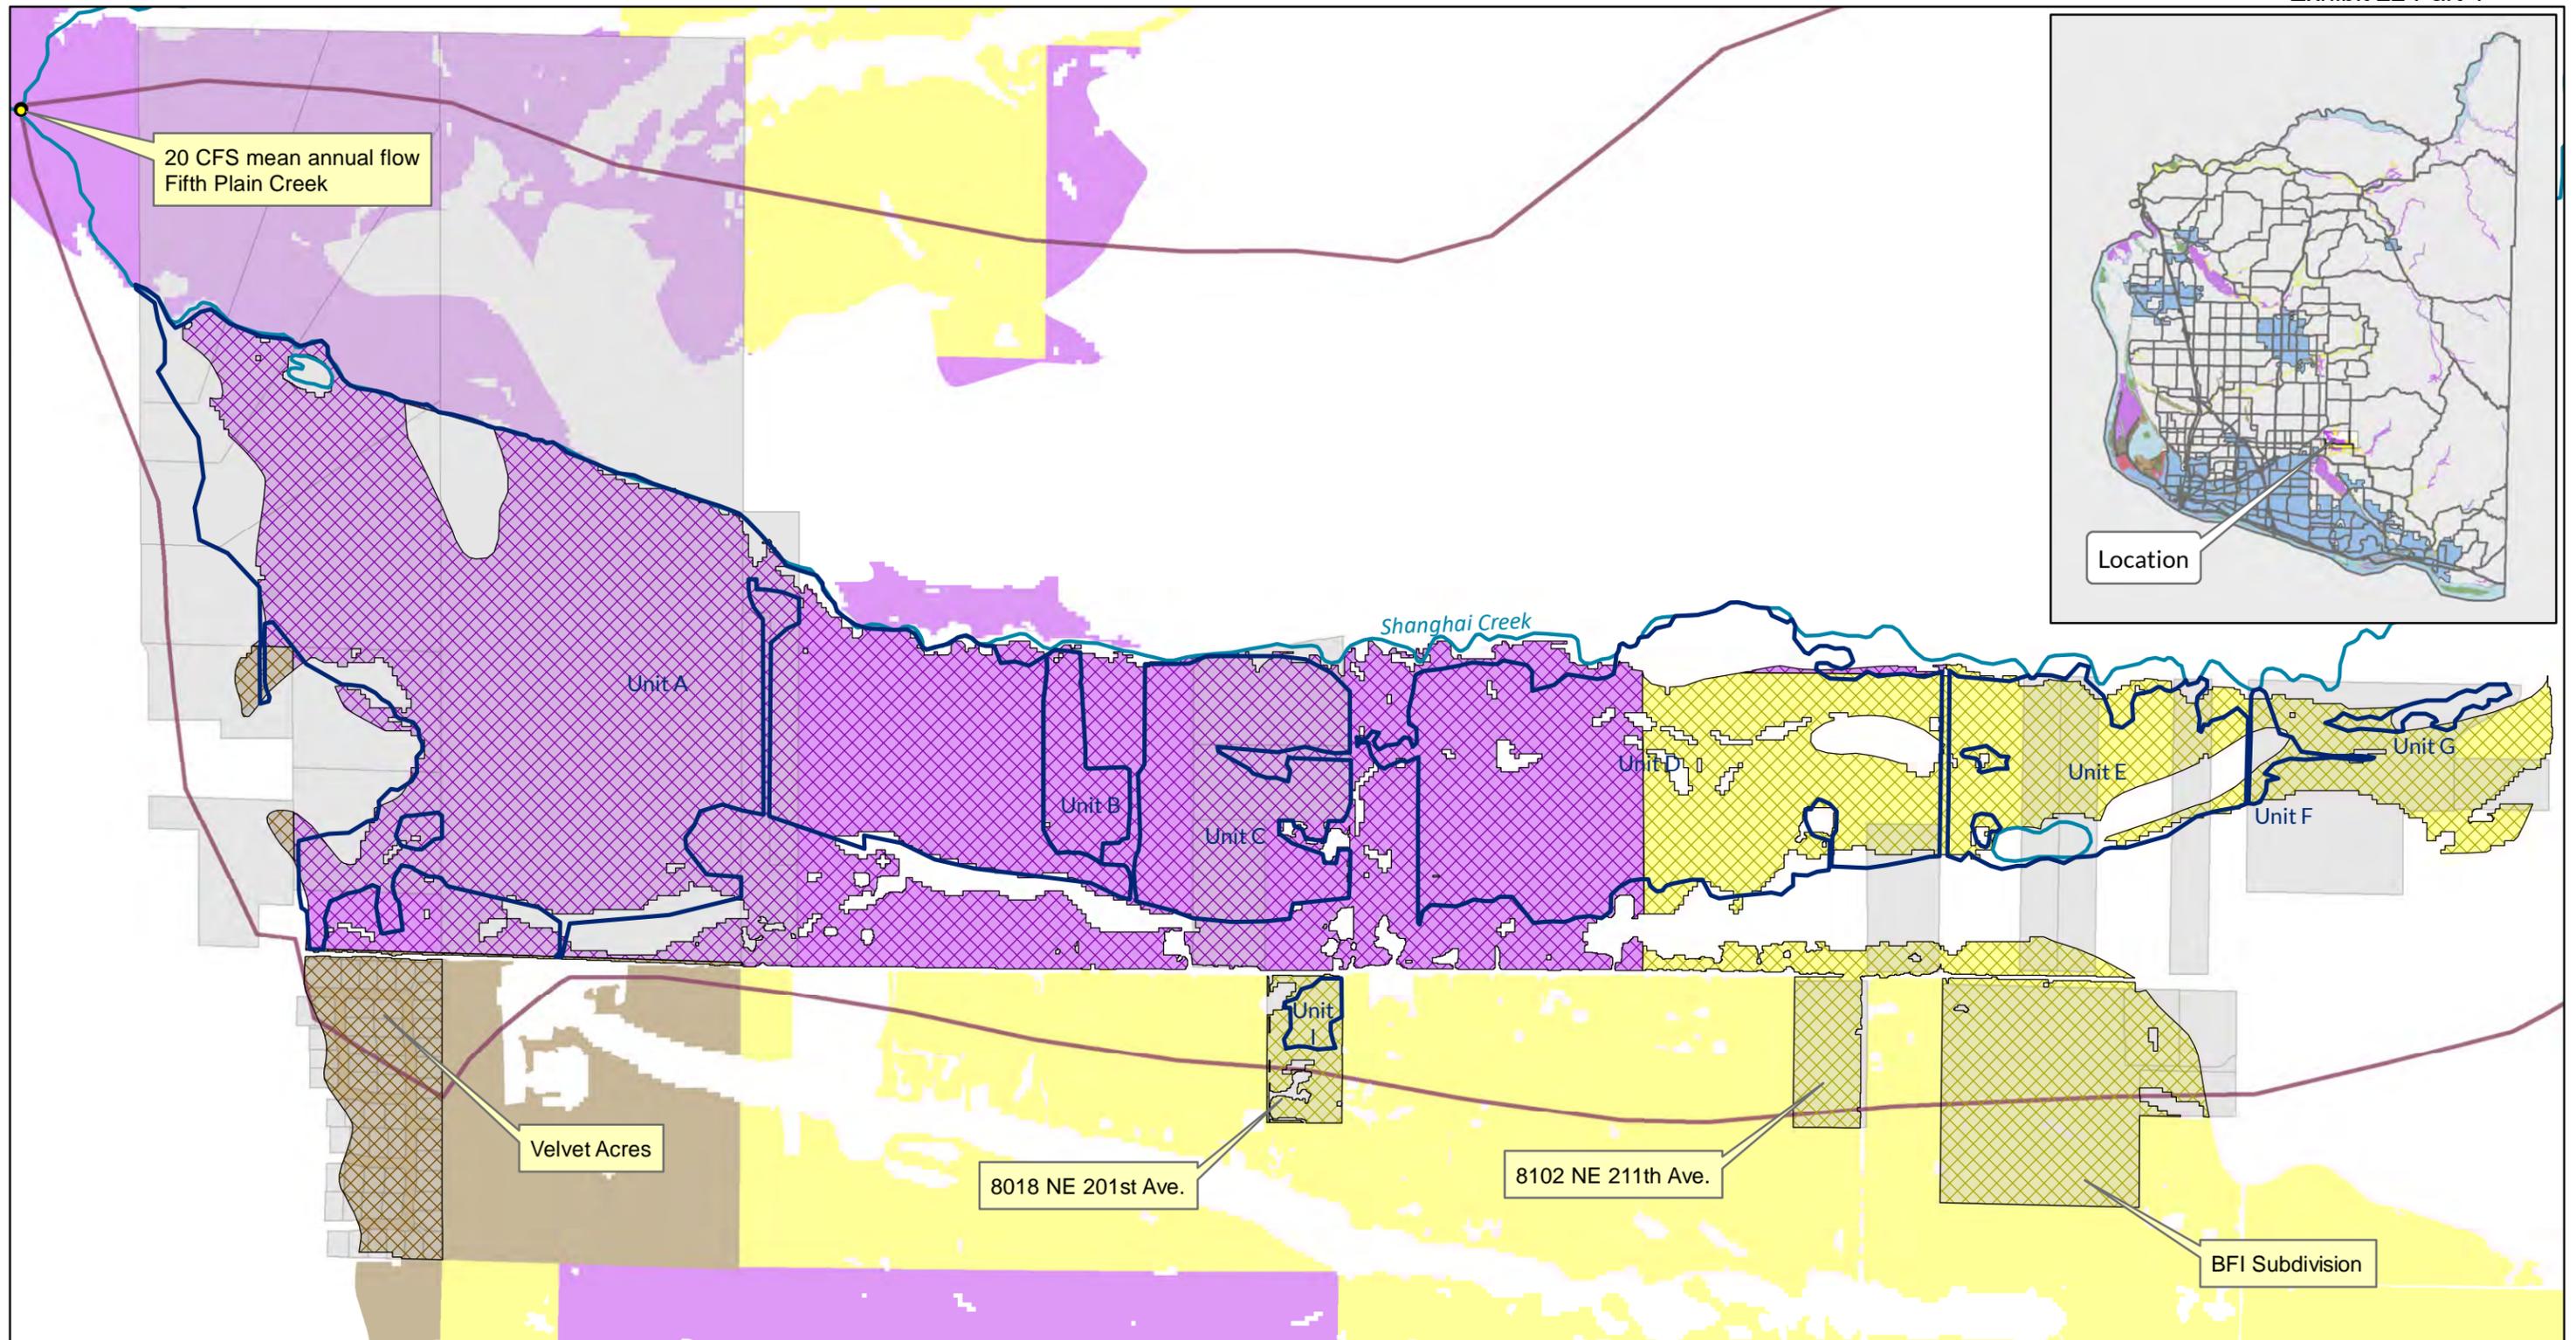
Figure 1
 Wetland Assessment Units and Proposed Map Revisions

Velvet Acres is a recently platted subdivision that spans the divide between Shanghai and Lamas Creeks at the western end of the study area. There are no wetlands in this subdivision (see Attachment C-1), therefore this area can be removed from the Shoreline Management Area map as proposed in Figure 1.

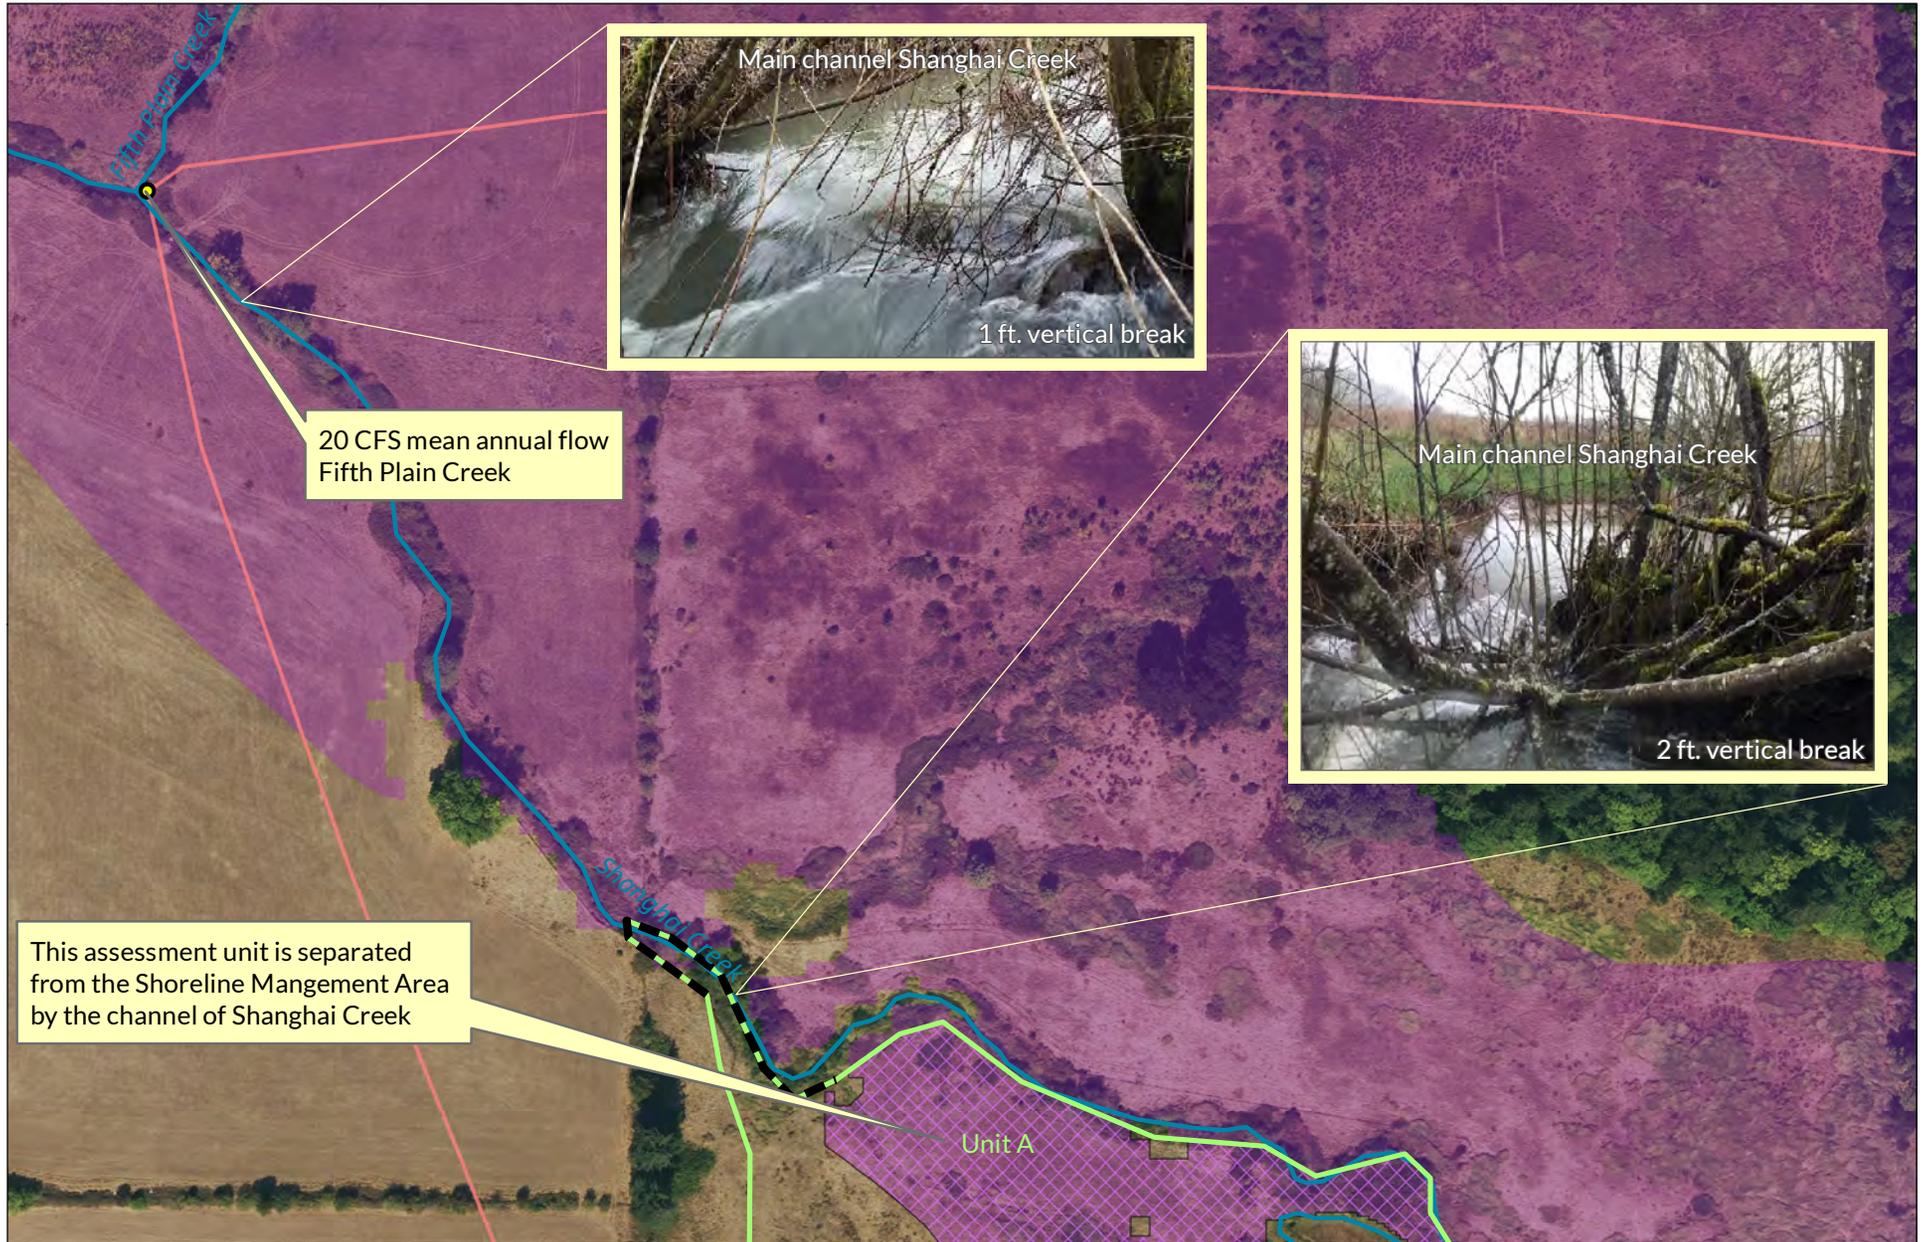
Figure 3A: Key Hydrologic Breaks - Detail

Unit A is the downstream most wetland in this review. The downstream hydrologic break (Figure 3A) was initially established in 2016 based on analysis prepared by a AKS Engineering & Forestry and reviewed on site by Clark County and Ecology (see Attachment A). This unit is a slope wetland isolated from influence by Shanghai Creek, except for during extreme flood events, due to vertical separation from the channel and from the SMA by vertical separation from Fifth Plain Creek and upland terrace elevated above the Flood Hazard Area (1% probability).

This assessment unit is separated from the Shoreline Mangement Area by the channel of Shanghai Creek

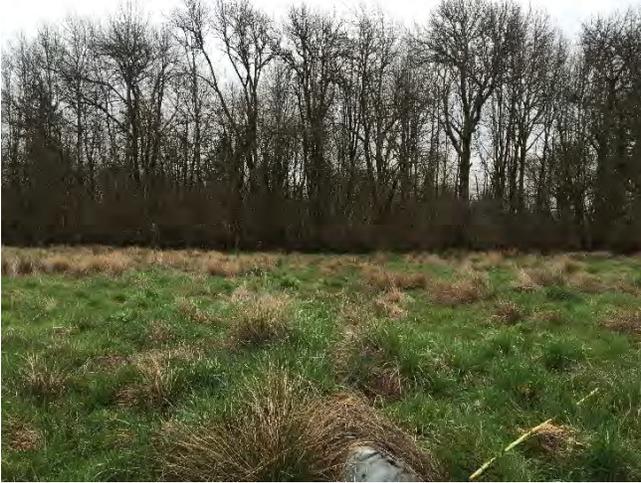
Photo 1.

View south of the forested wetland present on the northern portion of the 4K property. Photo taken from the field north and off site of the 4K property.

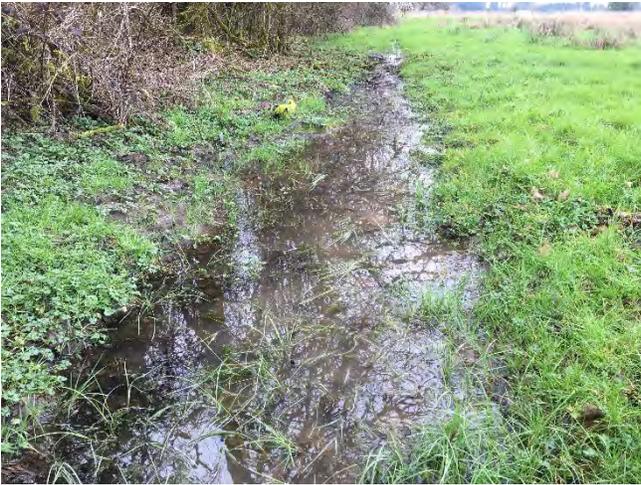
Photo 2.

View west across Ditch 3. Ditch 3 collects hydrology from the 4K wetland and conveys it north to Ditch 1.

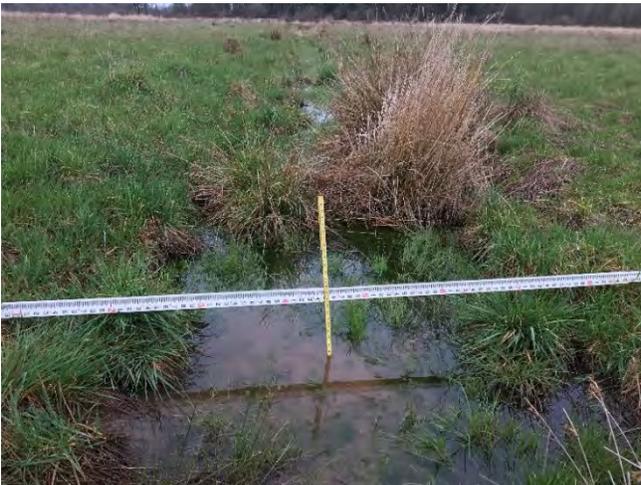
Photo 3.

Representative photo of hydrology present within Ditch 1, Data point 9.

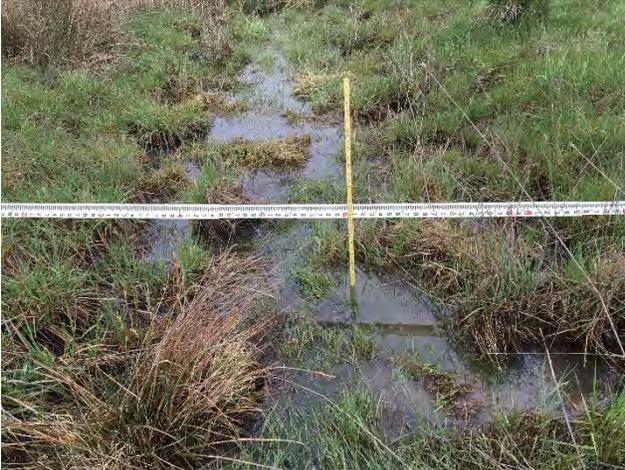
Photo 4.

Representative photo of hydrology present within Ditch 1, Data point 11. Approximate width of channel is 9 feet, and depth 12 inches.

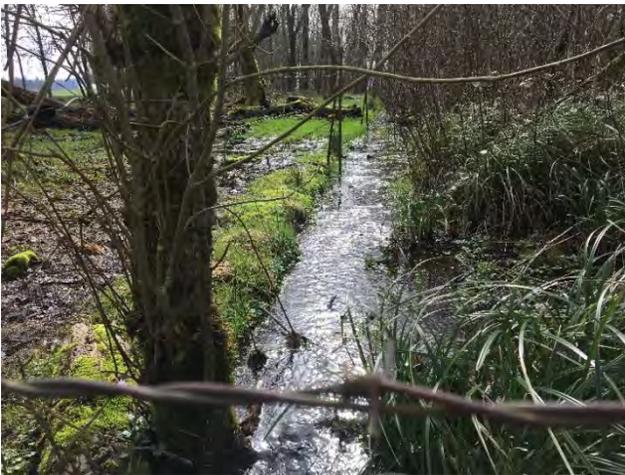
Photo 5.

View south down Ditch 2 from the northeast property corner associated with the northern 4K parcel. The E3 survey point was also at this location.

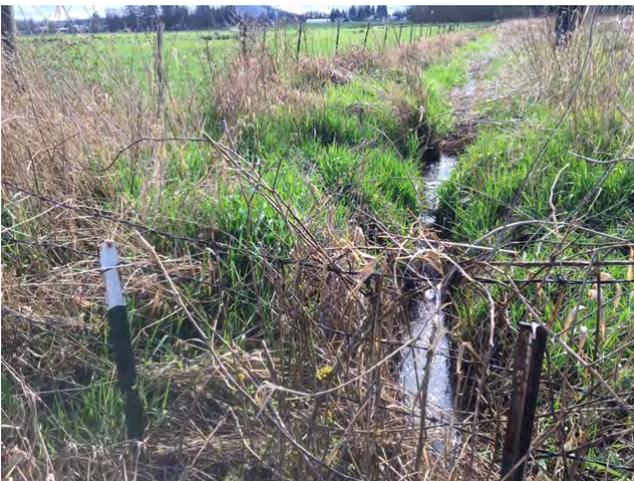
Photo 6.

View south down Ditch 2 from the fenceline near Shanghai Creek. Ditch 2 flows directly into Shanghai Creek north of this fenceline.

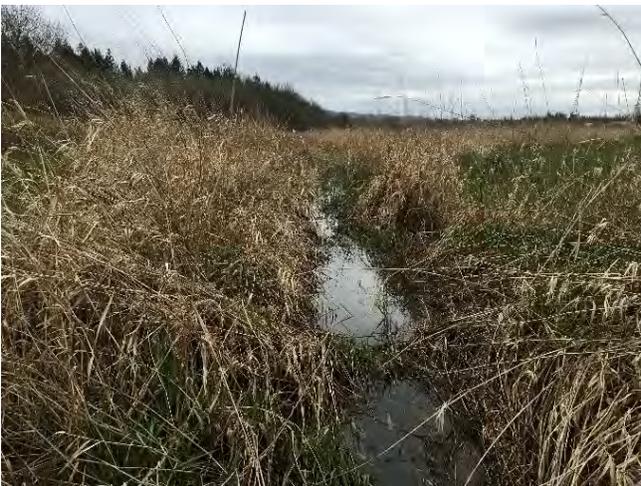
Photo 9.
View east down Ditch 4 from location just above AG Pond. Ditch 4 flows into AG Pond. Survey point E5 located just east of AG Pond. Location where Ditch 4 falls into AG Pond.

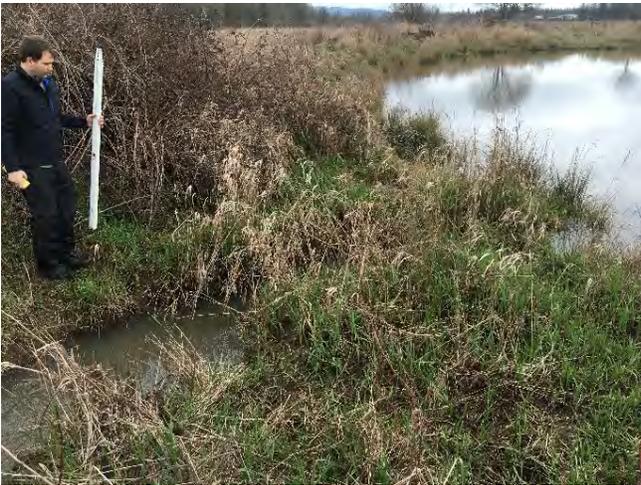
Photo 11.
Ditch 6 is visible in bottom left corner of photo. Ditch 6 connects the AG Pond to Shanghai Creek.

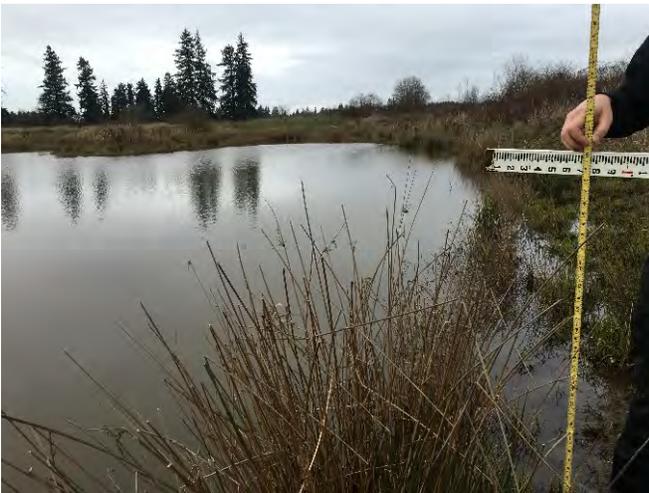
Photo 12.
View west across AG Pond. Measurement denotes the upland berm height (3' 9") associated with the north side of the AG Pond. The upland area continues west of the pond "Upland 1" on the site map.

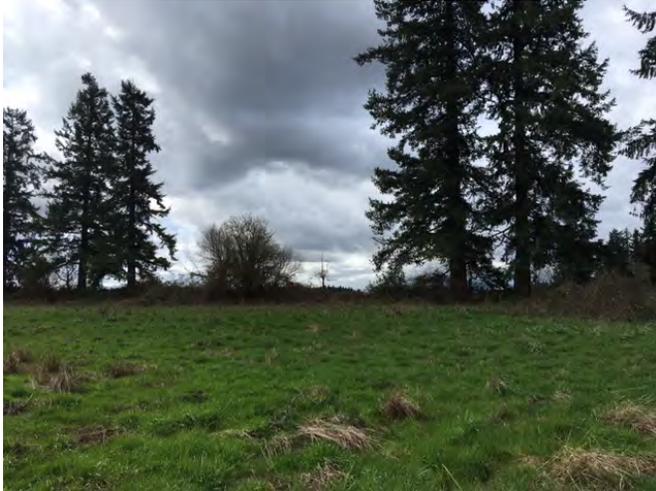
Photo 13.

View west of the Douglas-fir line present along the western boundary of the "Upland 2" area (See Figure 1). The Ditch 5 hydrology runs along the toe of this upland slope before flowing through a culvert and joining the bi-directional flow of Shanghai Creek.

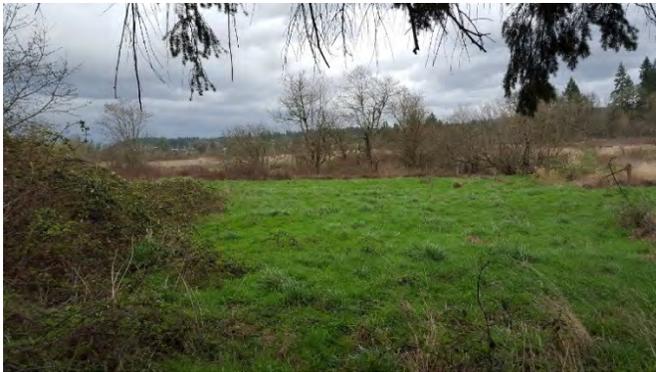
Photo 14.

View across the northern tip of the "Upland 2" area. The culvert that conveys the Ditch 5 hydrology is located just below the fence post visible in right side of photo.

The first drop over 2 feet in elevation within of Shanghai Creek ("Break 1") is located within the tall shrubs in the center of photo.

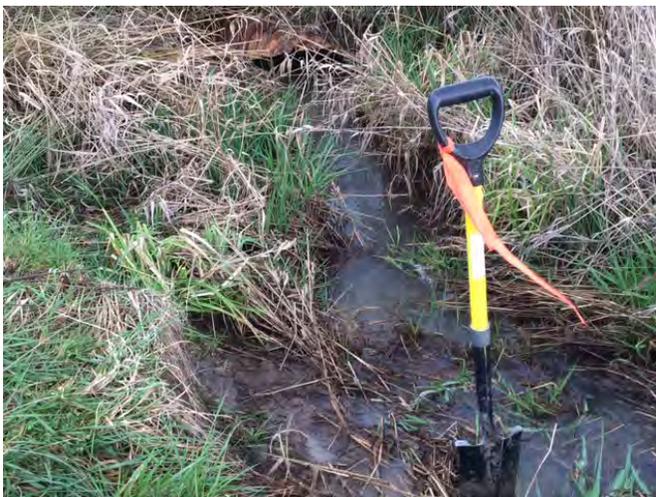
Photo 15.

View of the metal corrugated culvert (top of photo) present at the northern extent of Ditch 5. The wetland hydrology present within Ditch 5 is conveyed through this culvert to Shanghai Creek.

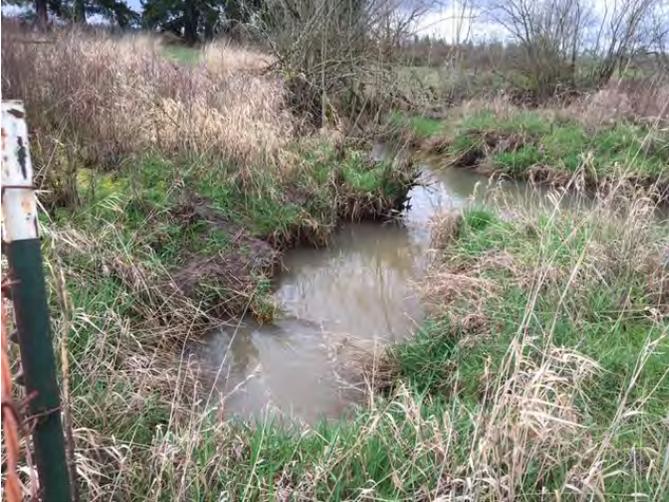
Photo 16.

View of the channel present directly north of the corrugated culvert associated with the northern extent of Ditch 5. The convergence of the Ditch 5 hydrology (side channel) and Shanghai Creek is visible in upper right of photo.

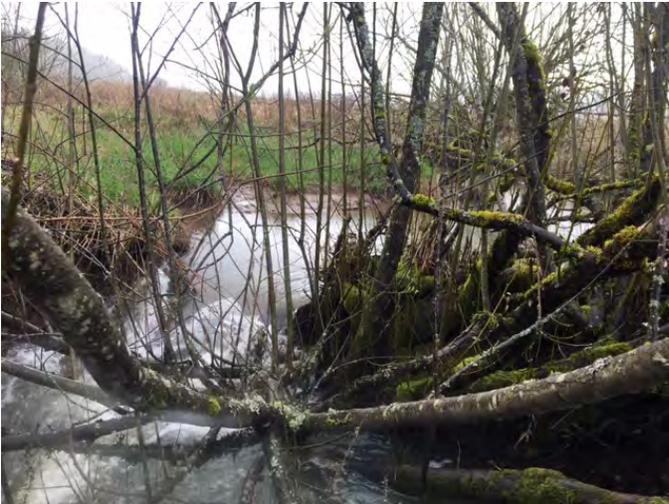
Photo 17.

Photo of "Break 1". Drop in elevation at this location was documented by laser level survey to be over 2 feet.

West of the AG Pond, two changes in elevation within the main channel of Shanghai Creek were observed and documented at survey points; E7 top/E7 bottom, and E8 top/E8 bottom. The change in elevation between the AG Pond (E6) and E7 top was -1.82 feet. From E7 top to E7 bottom the change in elevation was -2.02'. This change in the water elevation of over two feet was considered significant, and documented as "Break 1" (Figure 1)

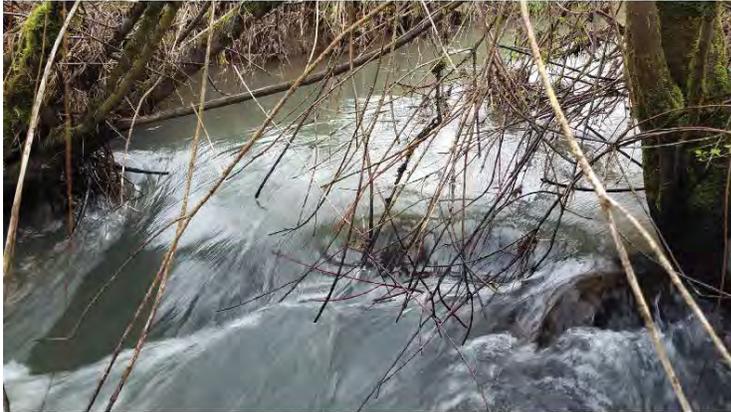
Photo 18.

Photo of "Break 2". Drop in elevation at this location was measured by laser level survey to be over 1-foot.

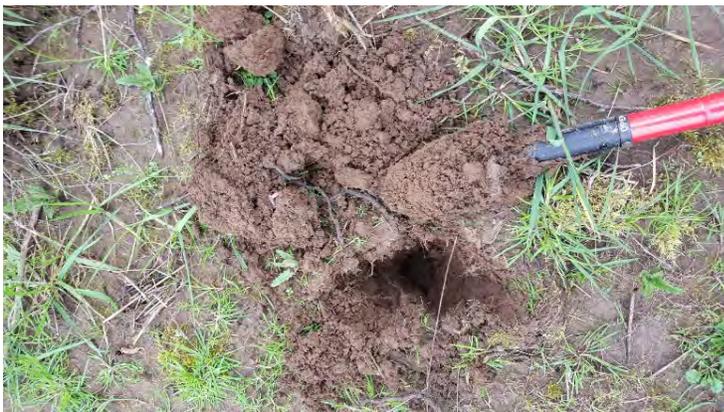
Photo 20.

Photo of soils documented at SP- 3 within agriculture fields that flank the "Break 2" location along Shanghai Creek.

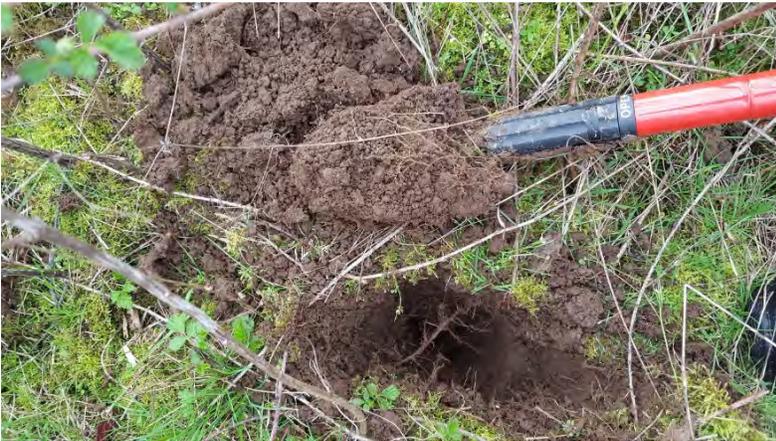
Photo 26.

Photo of soils documented at SP-4 within agriculture fields that flank the “Break 2” location along Shanghai Creek.
