CLARK COUNTY LAW ENFORCEMENT CENTER

FEASIBILITY STUDY | August 2016

Existing Building Facility Assessment Overview

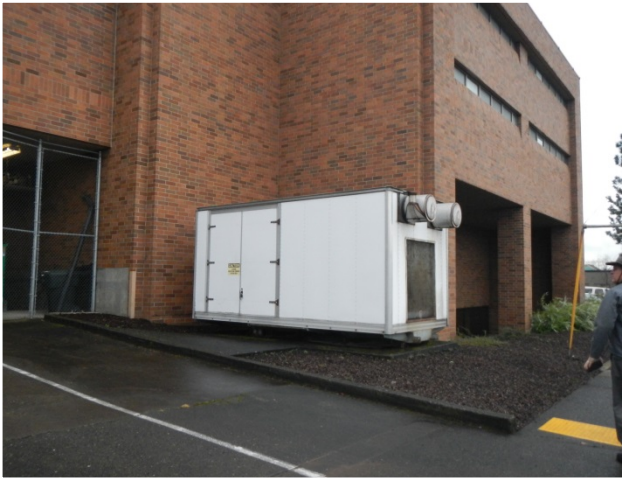
- A. West – Loading dock area
- B. East – Public entrance
- C. West – Steps to Level 0 from Level 1
- D. East – Public ADA entrance

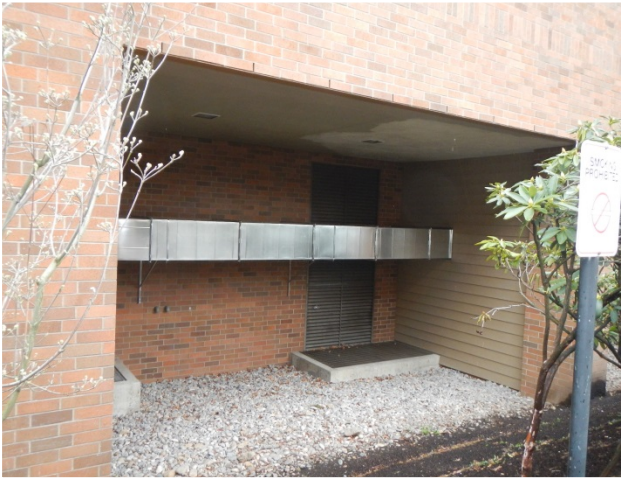
- A. East side
- B. East side
- C. West side
- D. North side

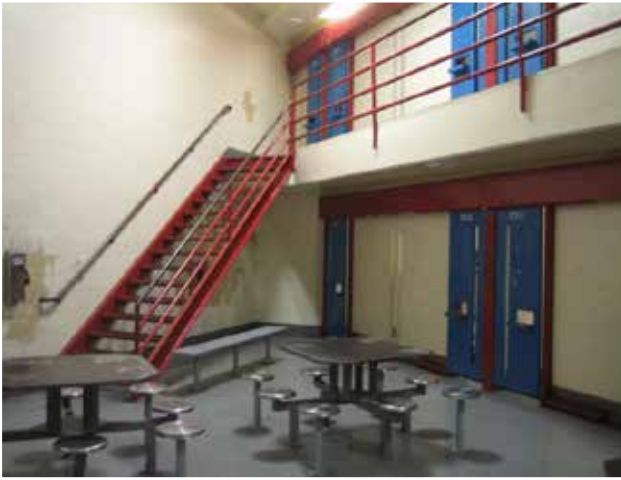
- A. Level 2 – Housing Pod mezzanine
- B. Level 2 – Expansion joint in Skybridge floor
- C. Level 2 – Expansion joint in Skybridge ceiling
- D. Level 0-1 – Main Lobby

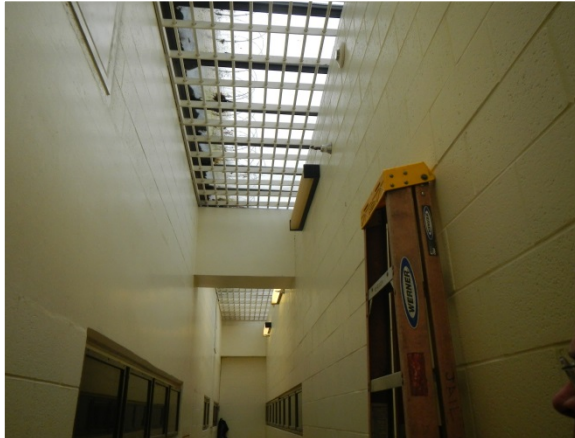
- A. Level 2 – Corridor
- B. Level 2 – Outdoor Recreation
- C. Level 2 – Mezzanine in Housing Pods
- D. Level 2 – Outdoor Recreation

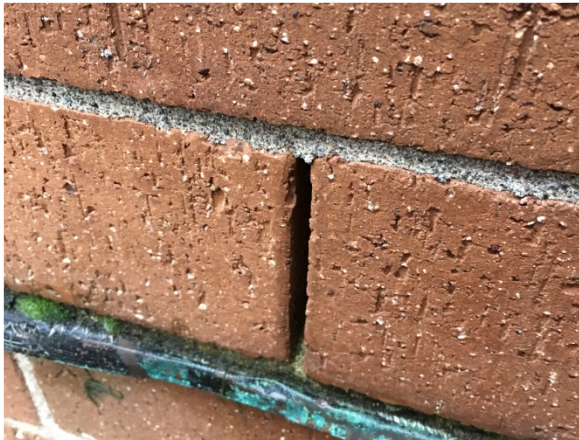
- A. Brick weep
- B. East side soffit
- C. South facade
- D. East - Skybridge

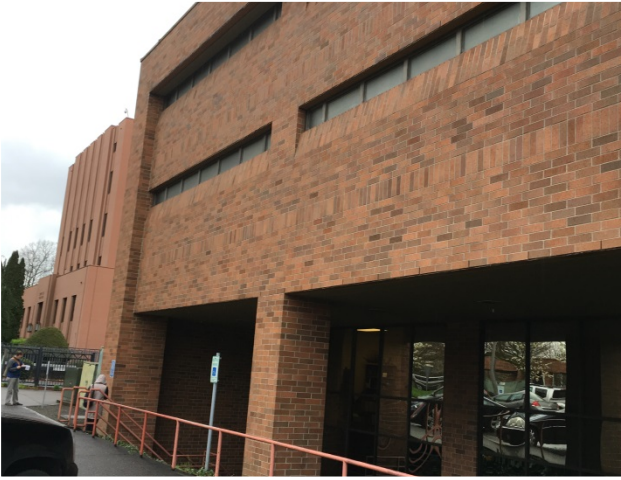
- A. North facade
- B. East facade
- C. North facade
- D. East/Skybridge

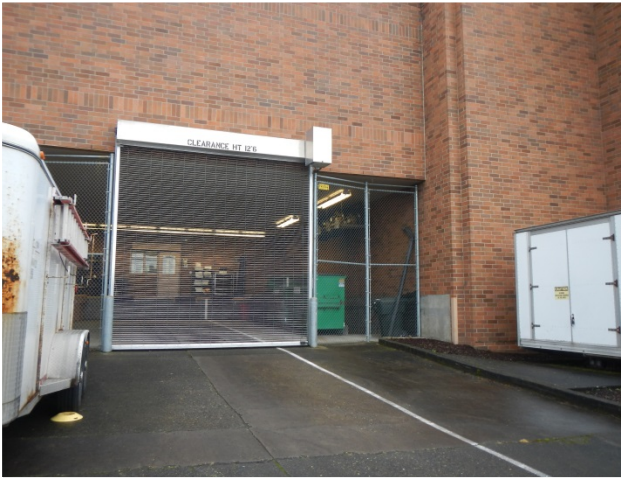
- A. West – Loading Dock
- B. South – Mechanical Room doors
- C. South – Vehicle Sallyport
- D. Skybridge

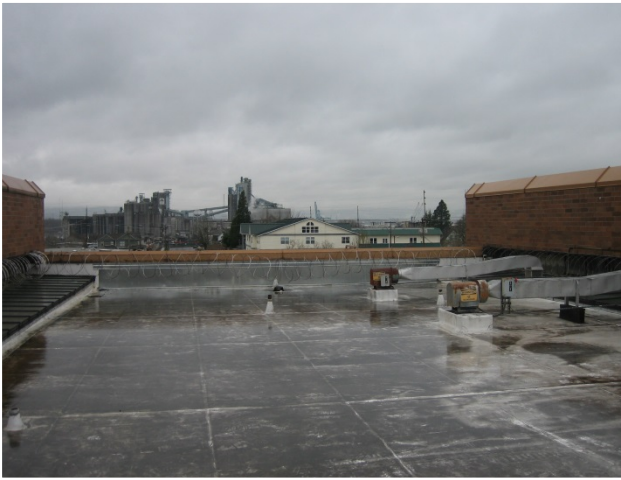
- A. Main roof, typical
- B. Flexible PV over main roof
- C. Main roof, typical
- D. Main roof, typical

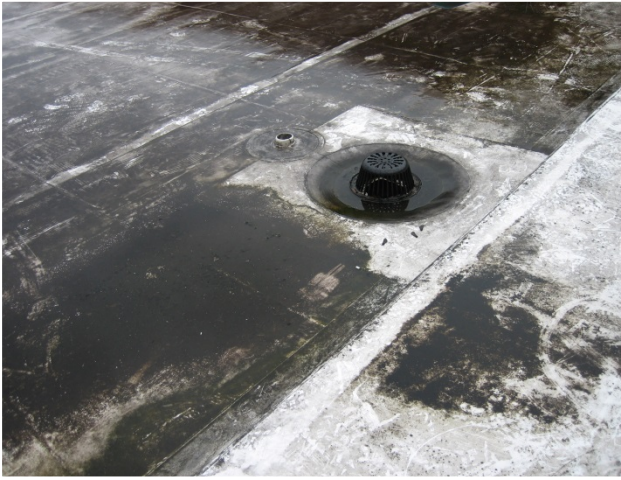
- A. Roof drain and overflow
- B. Venting and exhaust
- C. Curb around penthouse
- D. Curb around skylight

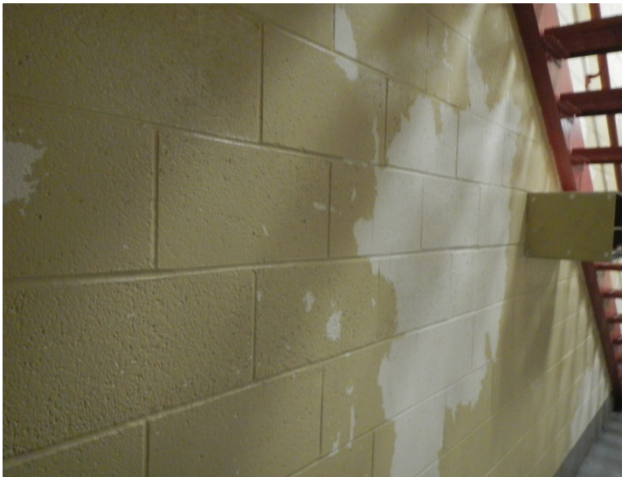
- A. Level 2 – Housing Pod, Dayroom
- B. Level 1 – North Foyer
- C. Level 0 – Lobby (Probation)
- D. Level 2 – Outdoor Recreation

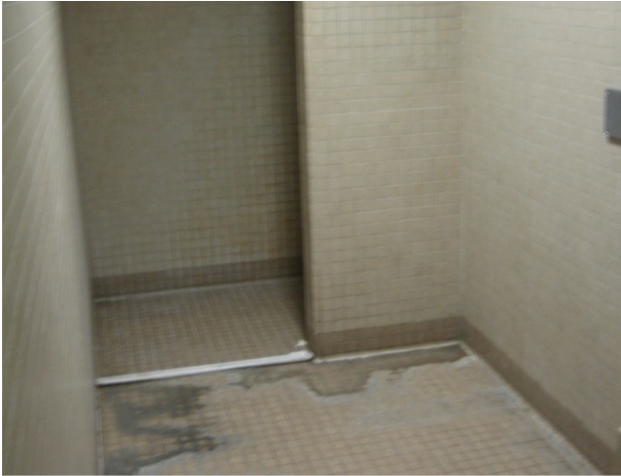
- A. Level 2 – Housing Shower
- B. Level 2 – Housing Pod, Dayroom
- C. Level 1 – A-Pod, Dayroom
- D. Level 1 – Inmate Property Storage

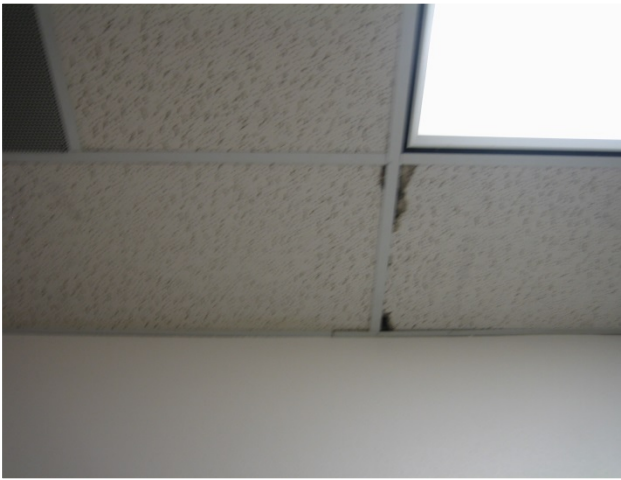
- A. Level 0 – Sheriff's Office
- B. Level 1 – Inmate Property Storage
- C. Level 0 – Women's Locker Room
- D. Level 1 – Loading Dock

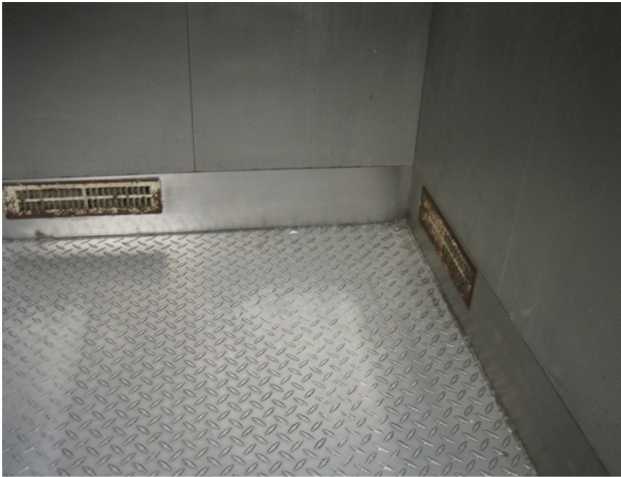
- A. Large jail elevator vents
- B. Small jail elevator
- C. Lobby elevator
- D. Cracked walls in Lobby elevator

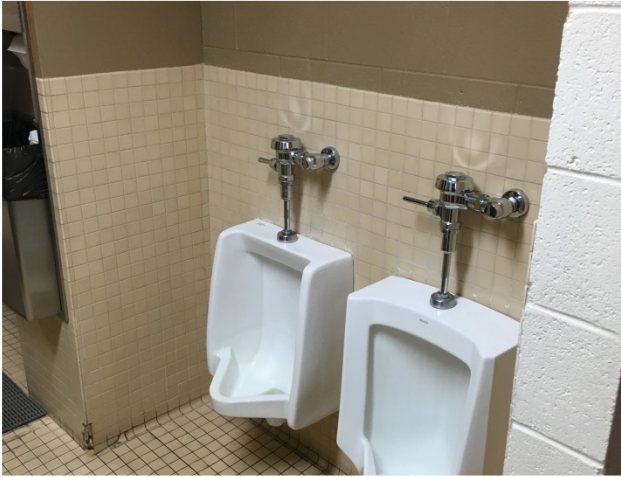
- A. Locker Room?
- B. Medical Area Inmate Bathroom
- C. Medical Area Inmate Bathroom
- D. Location Unknown?

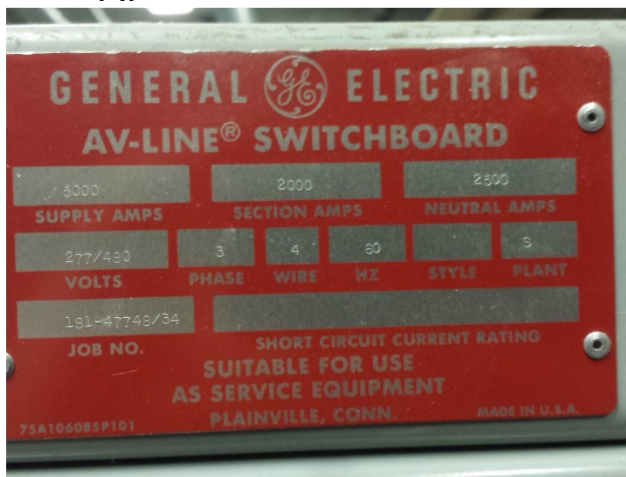
- A. 480V Service Nameplate
- B. 480V Service Main Switches
- C. 208V Service Nameplate
- D. 208V Service Main Switches

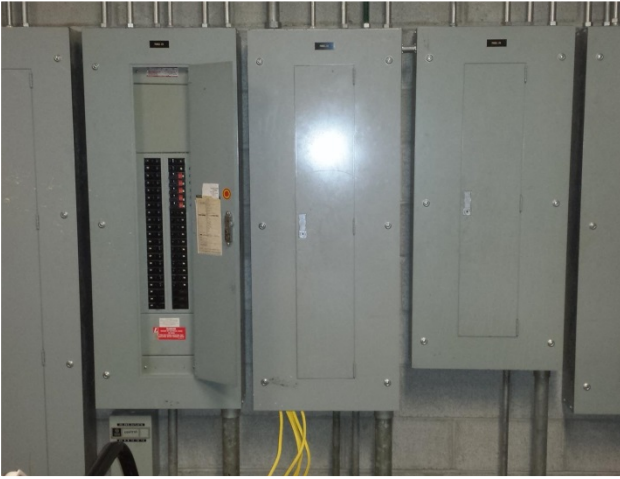
- A. Existing Distribution panelboards
- B. Close up of panelboard showing breakers, Normal and GFI (red)
- C. Receptacle showing burn marks from pencil lead shorting/cigarette lighting method
- D. VFD no longer in use.

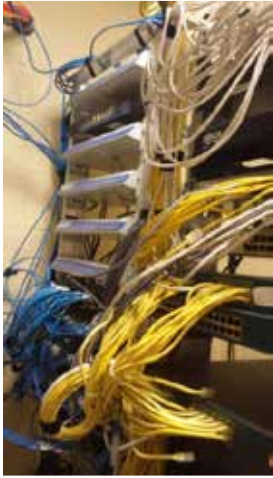
- A. IDF patch panel – Rooms are pretty tight and designed as afterthought.
- B. IDF Punch down wall – No spare room for growth
- C. Fire Alarm System – Hybrid of older analog and new digital.
- D. Network Video recorders and PLCs located behind central control.

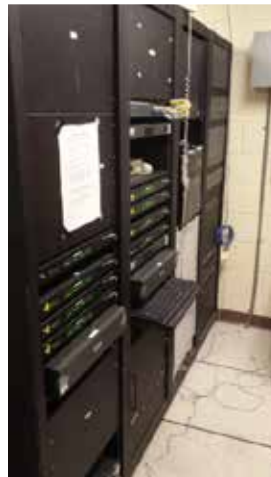
D.

The PLC system is the heart and brains of the entire security electronics system and was manufactured by General Electric. GE is still a viable manufacture of PLC equipment but the series of PLCs being used (Fanuc) is no longer being manufactured for general use. GE does however continue to provide support and replacement parts for this equipment.

Recommendation: HK recommends that this system be replaced with a new system. Also, consideration should be given to having the new system have redundant PLC processors and power supplies to lessen the likelihood of a catastrophic system-wide failure.

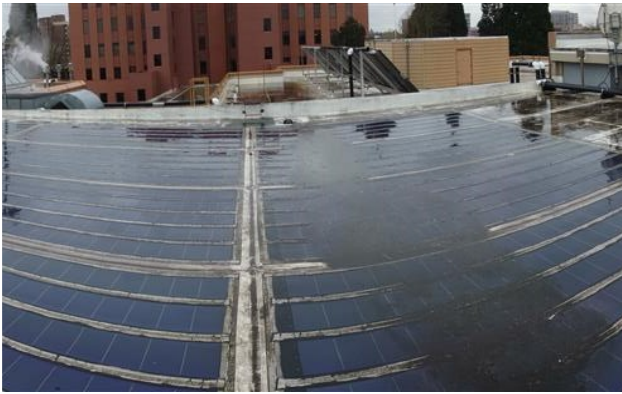
- A. Roof mounted Thin film photovoltaics (PVs) showing build-up of grime.
- B. SMA Sunny Boy inverters for PV system
- C. Utility PV Production meter.
- D. Customer metering for PV system.

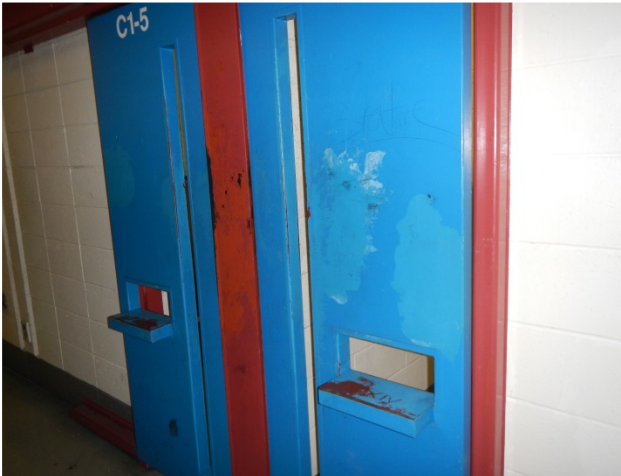
- A. Level 2 – Housing Pods, cell doors
- B. Level 2 – Jail Rover Station
- C. Level 2 – Medical Exam Room
- D. Level 1 – Loading Dock, secure door

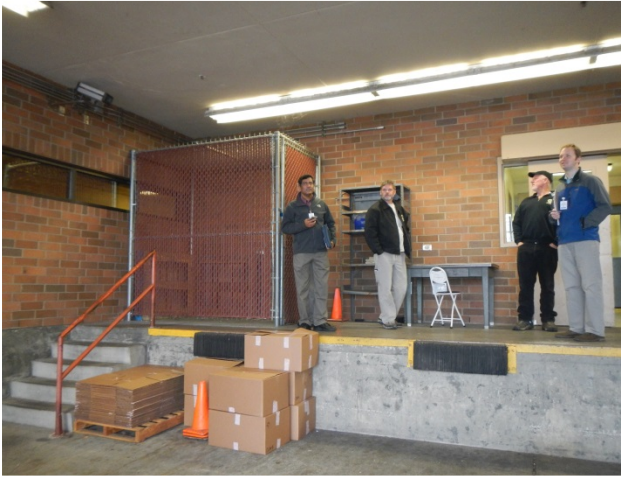
- A. Level 1 – Loading Dock
- B. Level 1 – Loading Dock
- C. Level 1 – Vehicle Sallyport
- D. Level 1 – Vehicle Sallyport

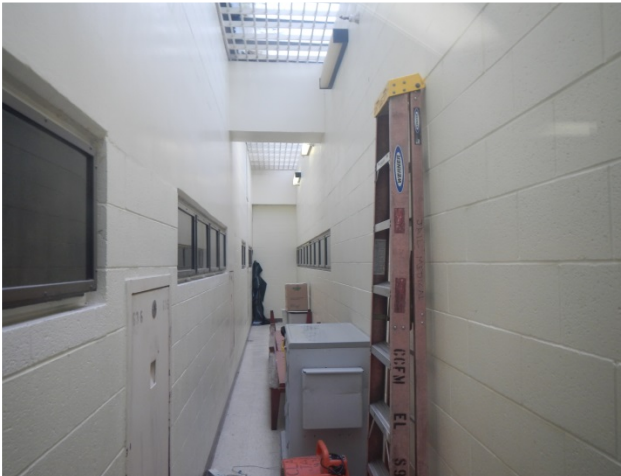
- A. Level 2 – Corridor with maintenance equipment
- B. Level 2 – Outdoor Recreation equipment
- C. Level 2 – Outdoor Recreation equipment
- D. Level 0 – Gym equipment

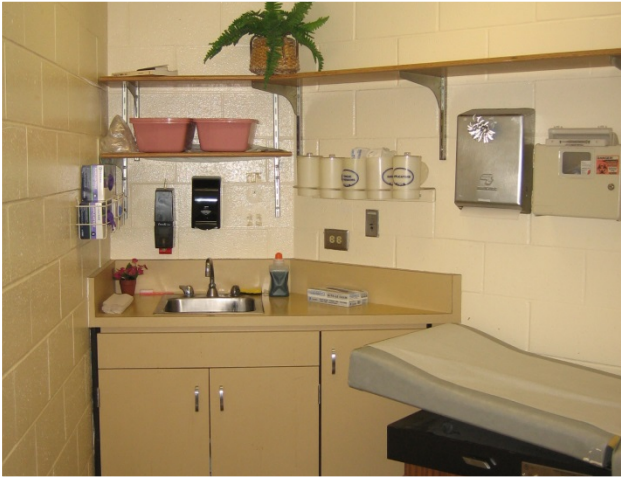
- A. Level 2 – Medical Exam Room casework
- B. Level 2 – Housing Pod, Dayroom tables
- C. Level 1 – Main Lobby seating
- D. Level 2 – Inmate Visit stools

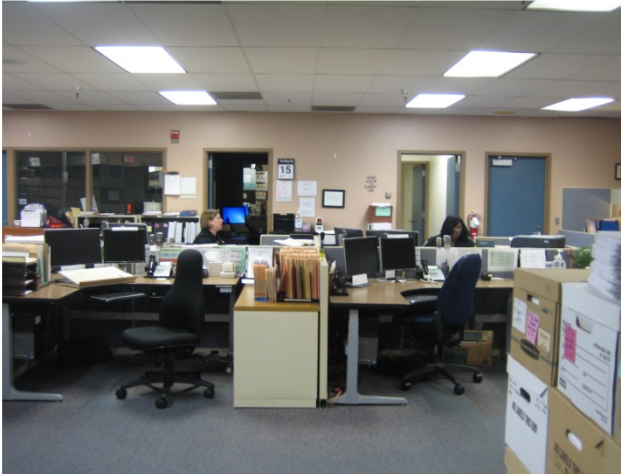
- A. Level 0 – Criminal Records Office
- B. Level 1 – Jail Admin Office
- C. Level 1 – H-pod Dorm
- D. Level 1 – Main Lobby/Foyer (north)

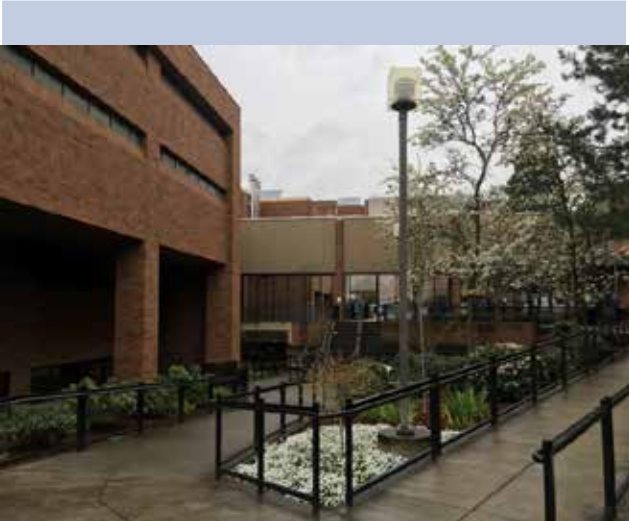
- A. Southeast
- B. West
- C. North
- D. Northeast

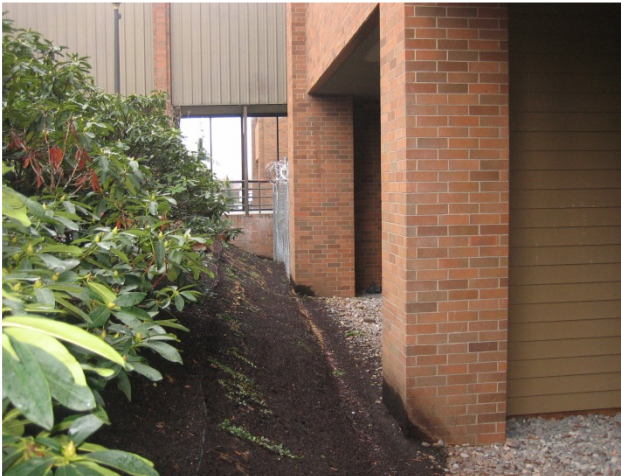
- A. Northeast
- B. Southeast
- C. North
- D. Southwest

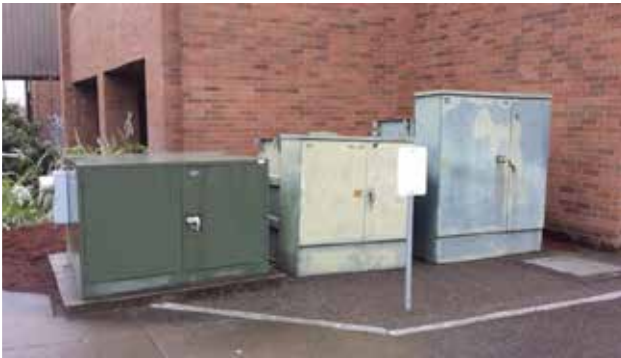
- A. Utility metering cabinet, 208V utility transformer, 480V utility transformer
- B. Utility Meter
- C. Nameplate from metering cabinet

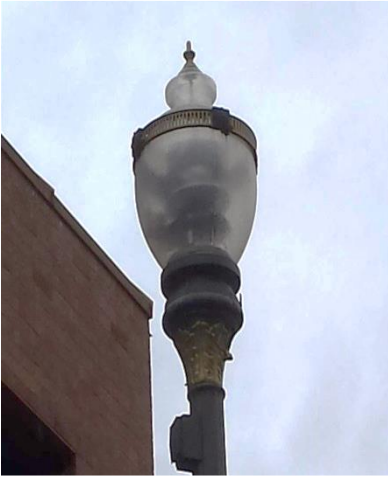
- A. Acorn Post Tops
- B. Cylinder Post tops
- C. Canopy lighting showing new LED retrofits
- D. Illuminated Bollards

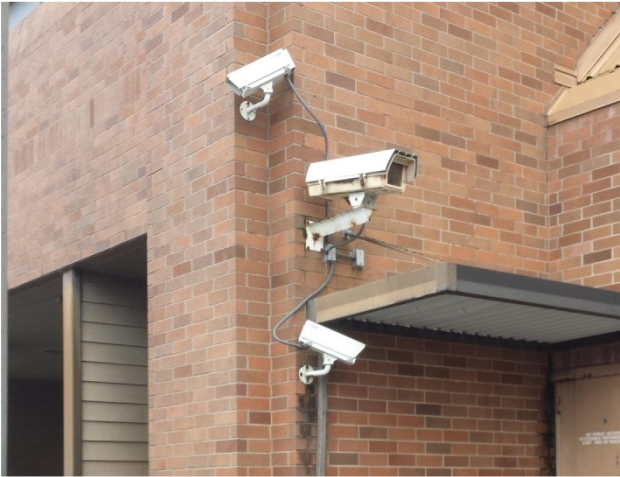
- A. Exterior CCTV camera housings
- B. Roof mounted Verizon receivers
- C. Verizon base station in penthouse
- D. Verizon base station in penthouse

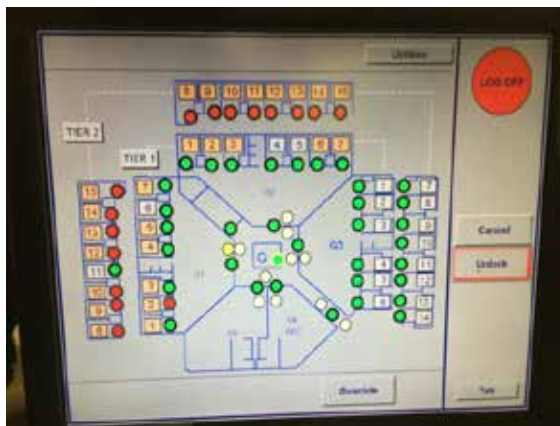
The topology of this system is server-based with remote workstations. This type of system is typically not considered appropriate for a detention application due to the fact that if the server fails the remote workstations will be nonfunctional and therefore without any redundancy build them, the system as a whole is at risk.

The software being used is manufactured by Cimplicity which is still a viable manufacturer.

Recommendations: The existing program appears to provide the intended operation but the server/client relationship of the network puts the County at risk as any failure within the server will cause a system wide failure. Providing new software would however be necessary to facilitate distribution of the program rather than its current centralization. This would also allow additional functionality not currently programmed into the system.

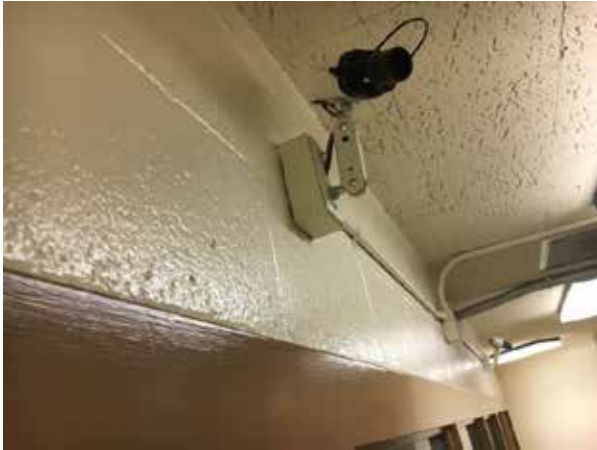
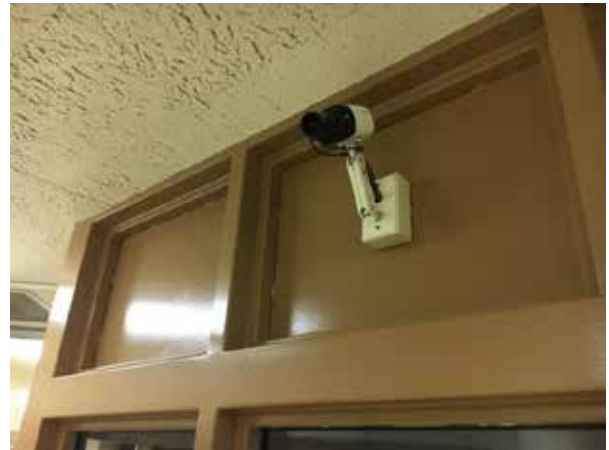
The video system is primarily an analog type system consisting of approximately 64 analog cameras. There are also approximately 10 IP cameras.

The analog cameras are a mixture of a variety of different manufacturers and model numbers. Few are mounted in housings or enclosures and are exposed and are on arm mounts fastened to the walls.

Recommendations: HK Recommends that the entire system be replaced with a new IP based system. This will eliminate the potential for a catastrophic system failure due to the video switcher failing and provide approximately 4 to 8 times better resolution. Several of the monitors can be retained, and the cabling can be reused.

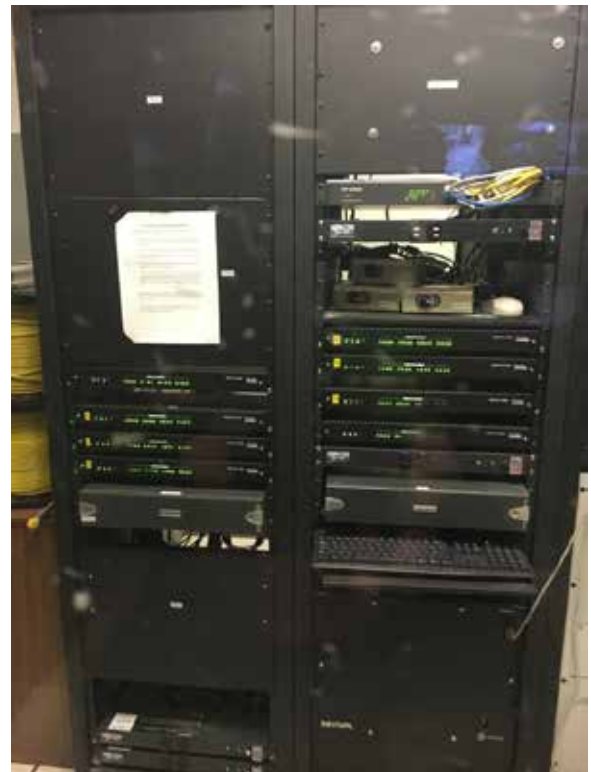
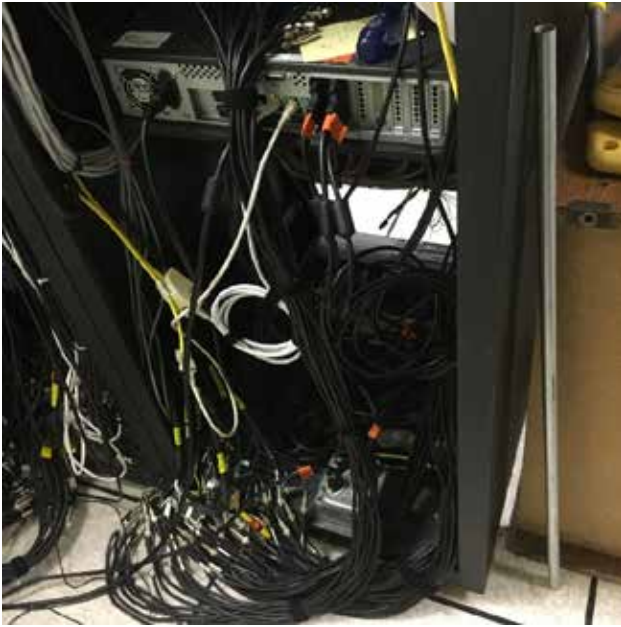
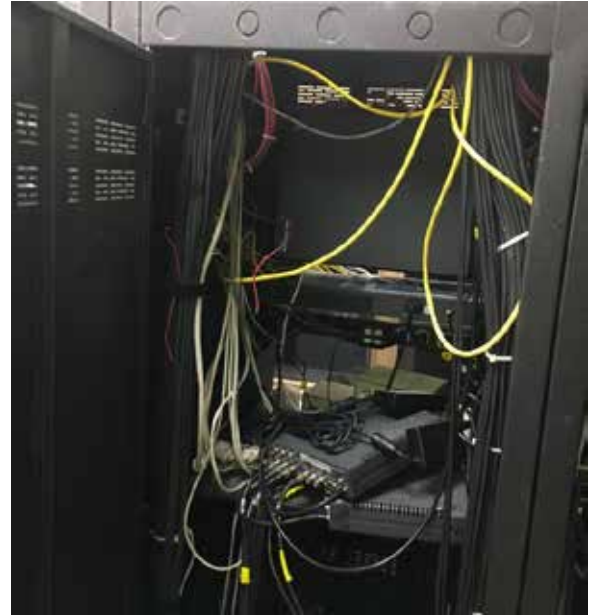
The analog cameras are routed through a video matrix switcher for switching active cameras to the various monitors throughout the facility. The video switcher is a Pelco, Nova system which has been obsolete by the manufacturer and new parts are no longer available. The video is being multiplexed in (8) 16-Channel PCI video multiplexers.

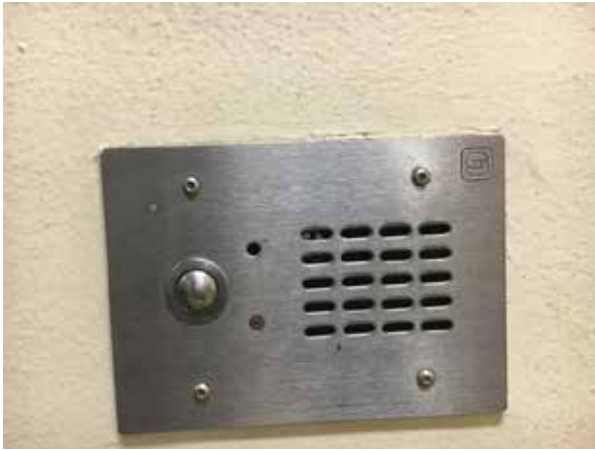
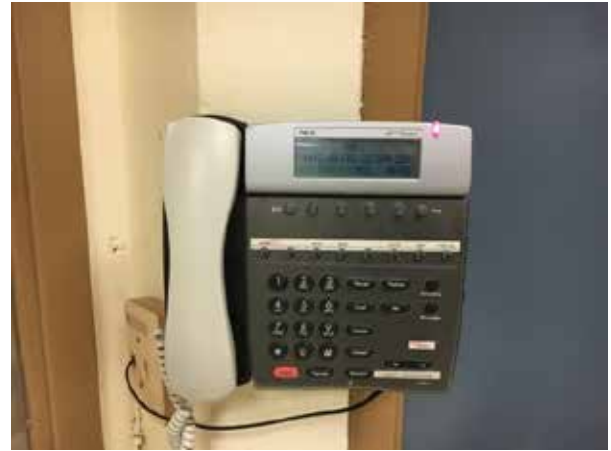
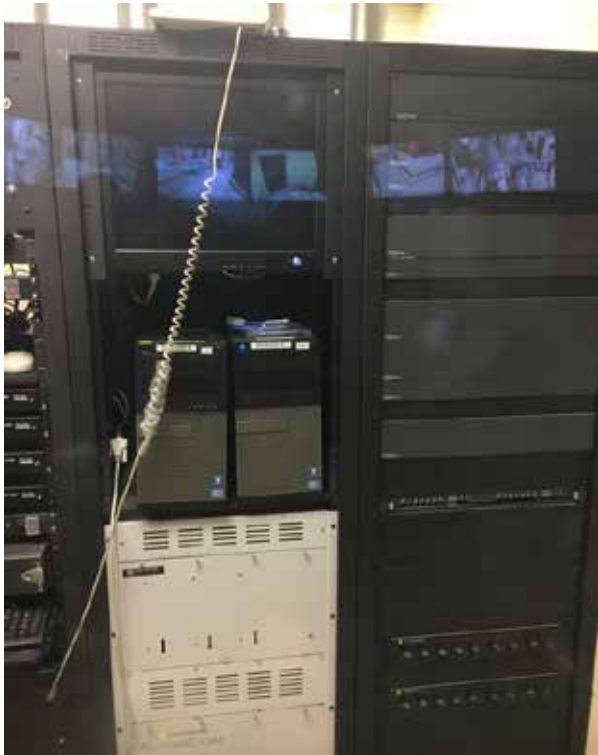
The existing intercom system is manufactured by Stentofon (Alpha-Com) and while the manufacturer is still viable, the specific exchange being used has been obsoleted and parts are no longer available.

Recommendations: HK Recommends that the entire Master intercom system and the Local intercom system be replaced with a new PBX based system capable of both functions. This will eliminate the potential for a catastrophic system failure due to the existing PBX that is no longer being supported by the manufacturer. Existing field cabling can be reused. Also, by combining both the Master and Local intercom systems and interfacing them with the PLC system, the master stations could still be used to call remote (Local) intercom stations through the use of the keypad thereby facilitating a level of redundancy if either the PLC or touch screen systems were to fail.

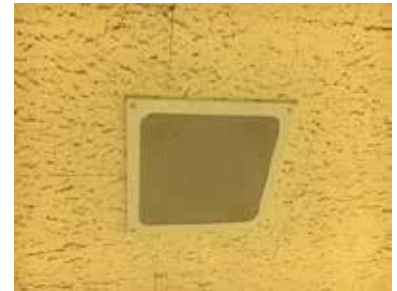
Ceiling mounted paging speakers have been provided and most appear functional, but they are not equipped with security baffles (grilles) and are subject to easy destruction.

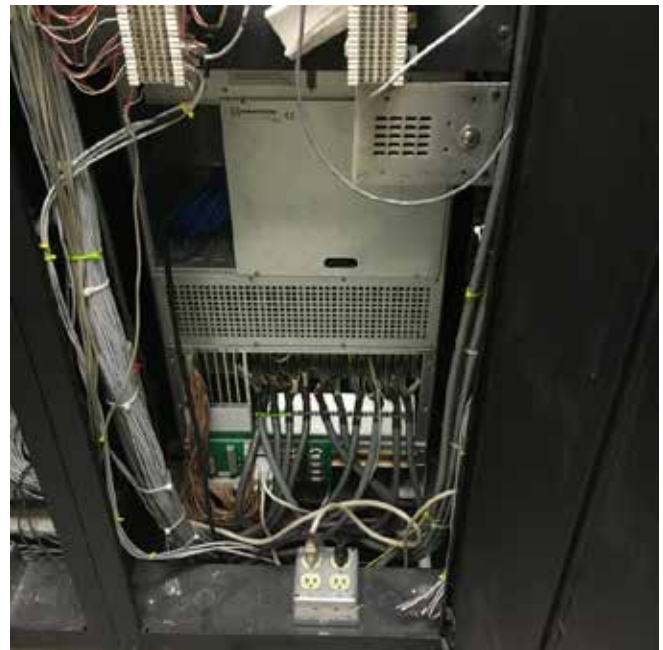
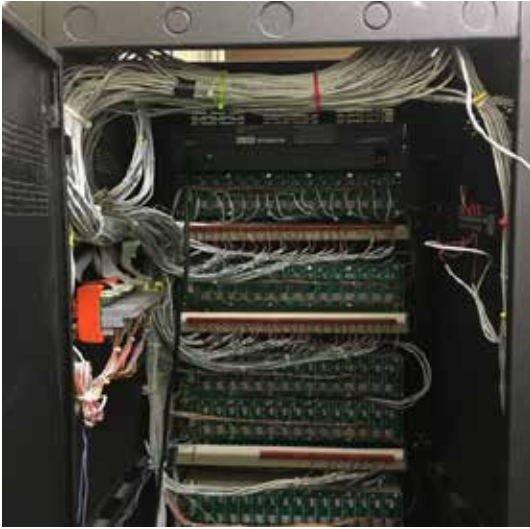
The remote intercom stations are still viable and the audio quality is good. The system also utilizes 6 Rauland, SDA-15 and (2) Communications Co, IC-28 bi-directional amplifiers, and (2) 5-Channel Pre-amp mixers for local intercom/paging.

The remote master stations are still available and the audio quality is good. Numerous master stations have been wall mounted for use as door stations. We noted that contrary to the IBC (UBC during original construction) no call request stations have been provided in the cells. HK feels that this puts the County at risk relative to both allowing a person who is in a lock-down condition to call for help, and with respect to the PREA guidelines.
