# **PROVIDENCE ACADEMY**

ADA AND DECK REPAIRS - 2020

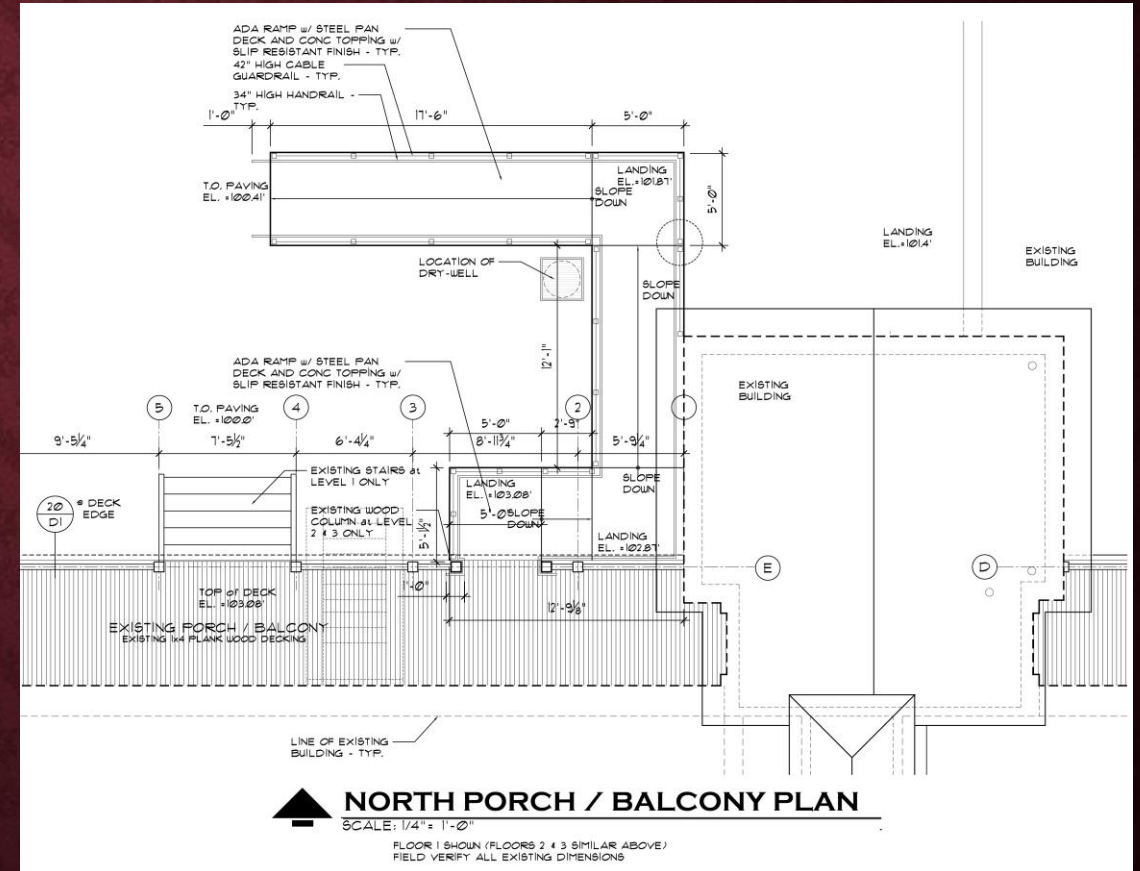
PROPOSED LOCATION OF NEW ADA RAMP

- COORDINATE RAMP WITH MASTER PLAN LAYOUT OF THE SITE.
- PROVIDE A NEW STEEL RAMP WITH CONC. TOPPING
- SIZED FOR ACCESSIBILITY AND SERVICE ACCESS.

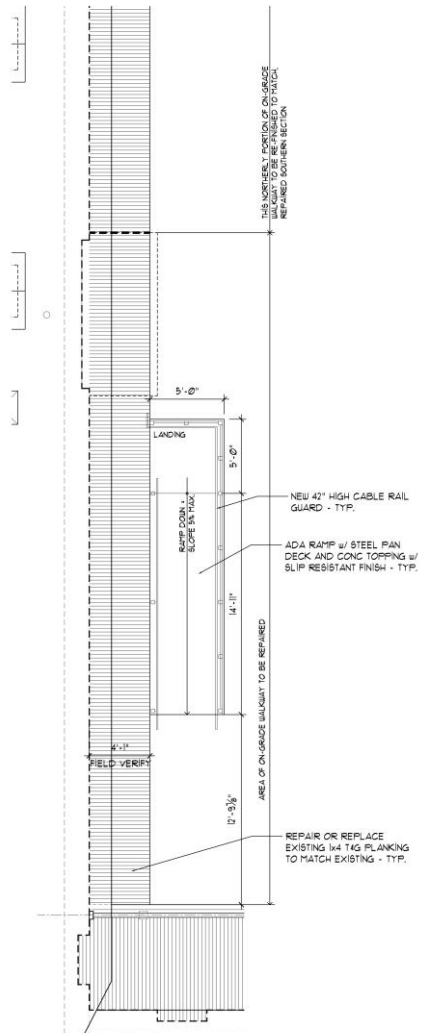
**NORTHEAST ENTRANCE RAMP PLAN**  
SCALE: 1/4" = 1'-0"

REMOVE DECK. ADD ADA RAMP BESIDE BUILDING

- COORDINATE WITH MASTER PLAN FOR THIS AREA SO RAMP INTEGRATES WITH PEDESTRIAN CIRCULATION AREAS.
- NEW STEEL RAMP WITH CONCRTE TOPPING.
