CLARK COUNTY LAW ENFORCEMENT CENTER

FEASIBILITY STUDY | August 2016

Existing Building Facility Assessment Overview

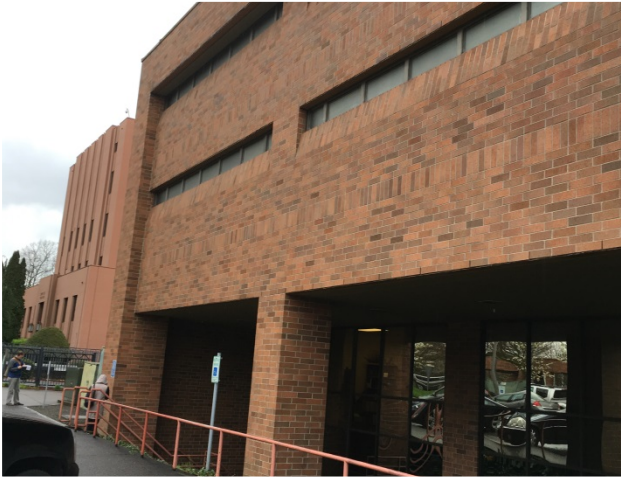
- A. North facade
- B. East facade
- C. North facade
- D. East/Skybridge

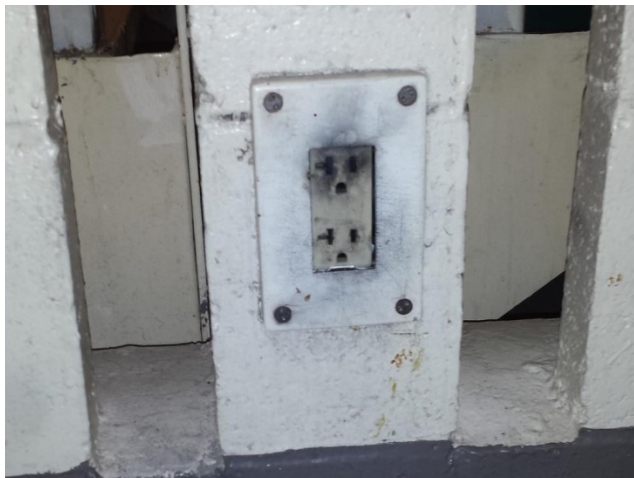
- A. Existing Distribution panelboards
- B. Close up of panelboard showing breakers, Normal and GFI (red)
- C. Receptacle showing burn marks from pencil lead shorting/cigarette lighting method
- D. VFD no longer in use.

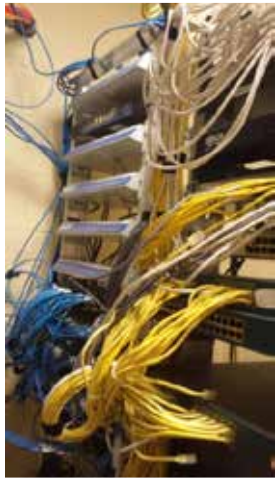
- A. IDF patch panel – Rooms are pretty tight and designed as afterthought.
- B. IDF Punch down wall – No spare room for growth
- C. Fire Alarm System – Hybrid of older analog and new digital.
- D. Network Video recorders and PLCs located behind central control.

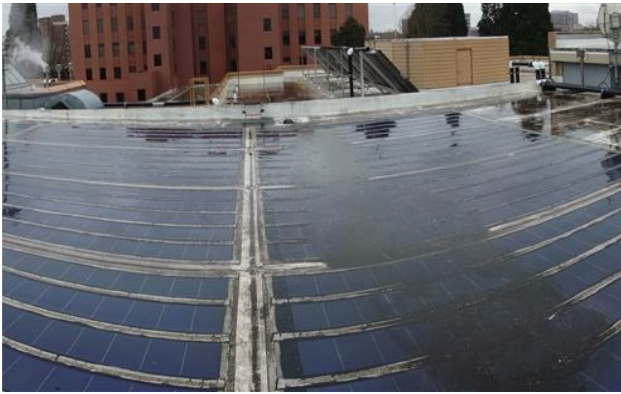
- A. Roof mounted Thin film photovoltaics (PVs) showing build-up of grime.
- B. SMA Sunny Boy inverters for PV system
- C. Utility PV Production meter.
- D. Customer metering for PV system.

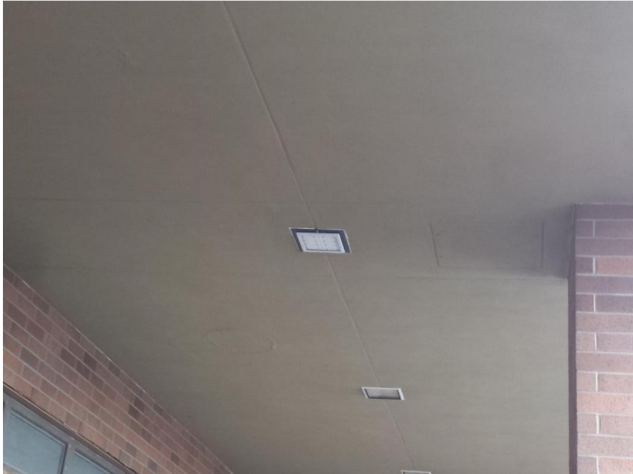
- A. Acorn Post Tops
- B. Cylinder Post tops
- C. Canopy lighting showing new LED retrofits
- D. Illuminated Bollards

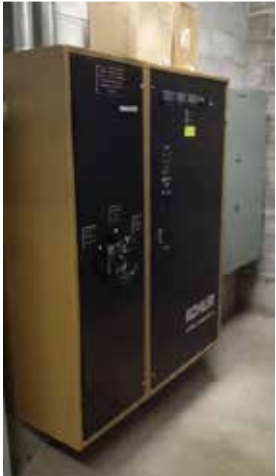
- A. Generator and fuel tank at loading dock
- B. Generator in enclosure
- C. Automatic Transfer Switch in main electrical room
- D. Emergency switchboard in main electrical room

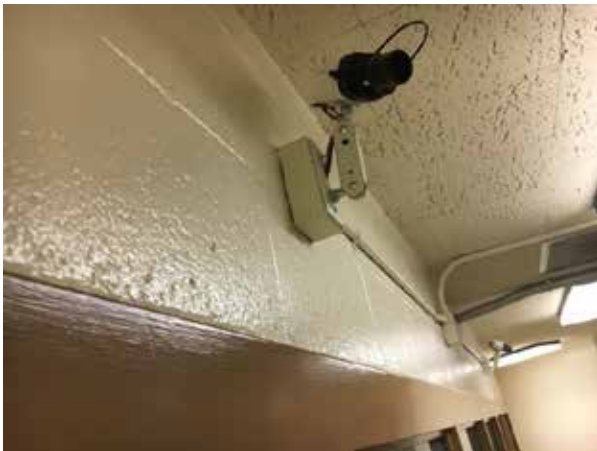
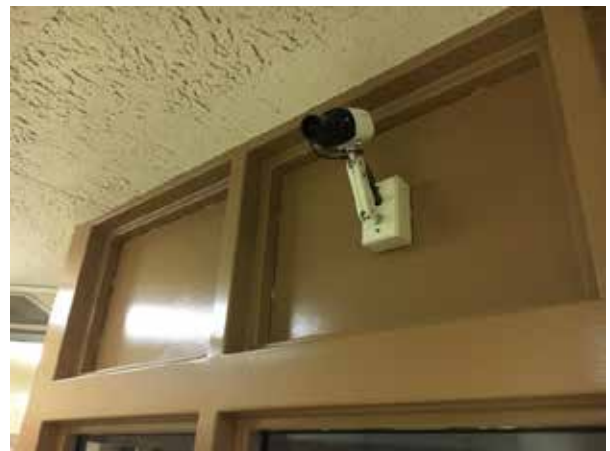
The video system is primarily an analog type system consisting of approximately 64 analog cameras. There are also approximately 10 IP cameras.

All of the cameras are connected to one of 3 DVRs manufactured by Pelco (Digital Sentry) used for recording both analog and IP video.

The analog cameras are a mixture of a variety of different manufacturers and model numbers. Few are mounted in housings or enclosures and are exposed and are on arm mounts fastened to the walls.

Recommendations: HK Recommends that the entire system be replaced with a new IP based system. This will eliminate the potential for a catastrophic system failure due to the video switcher failing and provide approximately 4 to 8 times better resolution. Several of the monitors can be retained, and the cabling can be reused.

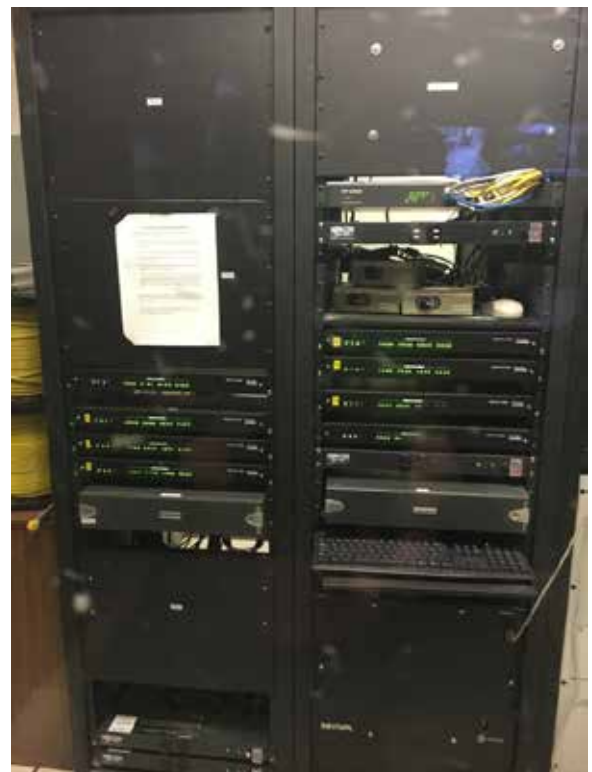
The analog cameras are routed through a video matrix switcher for switching active cameras to the various monitors throughout the facility. The video switcher is a Pelco, Nova system which has been obsoleted by the manufacturer and new parts are no longer available. The video is being multiplexed in (8) 16-Channel PCI video multiplexers.

The video switcher is connected through an RS-232C interface to the touchscreen system server to facilitate automatic switching upon door selection from a touch screen computers. The IP cameras have not been equipped with decoders to allow them to be interfaced to either the video switcher or touch screen systems.

The video monitors are a mix of CRT and LCD units. The Central Control Room monitors are primarily CRT based.

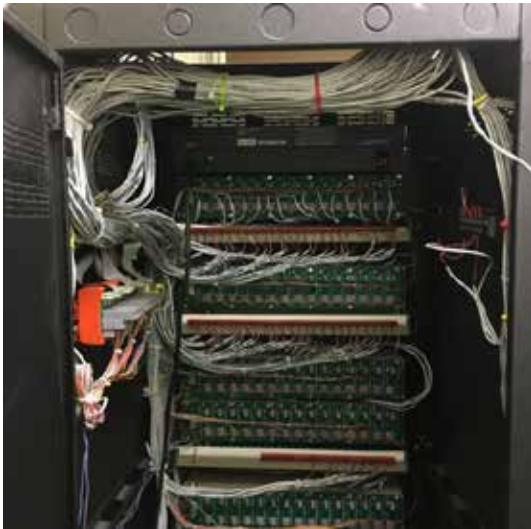
The remote intercom stations are still viable and the audio quality is good. The system also utilizes 6 Rauland, SDA-15 and (2) Communications Co, IC-28 bi-directional amplifiers, and (2) 5-Channel Pre-amp mixers for local intercom/paging.

The remote master stations are still available and the audio quality is good. Numerous master stations have been wall mounted for use as door stations. We noted that contrary to the IBC (UBC during original construction) no call request stations have been provided in the cells. HK feels that this puts the County at risk relative to both allowing a person who is in a lock-down condition to call for help, and with respect to the PREA guidelines.

Recommendations: HK Recommends that the entire Master intercom system and the Local intercom system be replaced with a new PBX based system capable of both functions. This will eliminate the potential for a catastrophic system failure due to the existing PBX that is no longer being supported by the manufacturer. Existing field cabling can be reused. Also, by combining both the Master and Local intercom systems and interfacing them with the PLC system, the master stations could still be used to call remote (Local) intercom stations through the use of the keypad thereby facilitating a level of redundancy if either the PLC or touch screen systems were to fail.
