SCHOFIELD BLOCK

HISTORIC PRESERVATION OPTIONS DISCUSSION

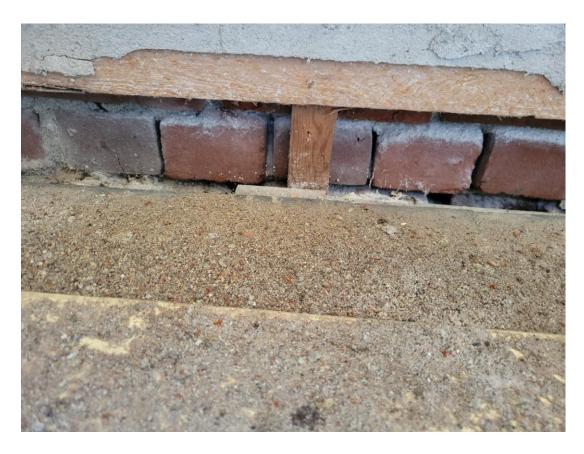
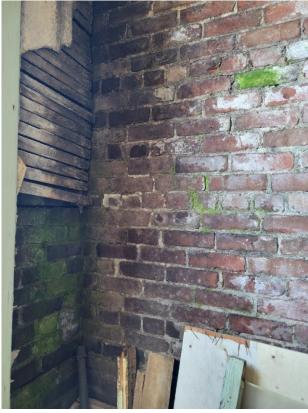
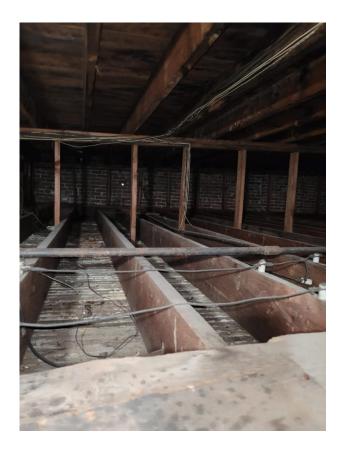
STRUCTURAL CONDITION – SIGNIFCANT ISSUES

- Roof joists and supporting ceiling construction have very long spans, and are more than 1.5 times the working stress allowed by the building codes.
- Basement beams and posts are not secured with positive connections.
- Some parapets are not braced.
- Insufficient foundation.

- Second floor joists supporting discontinuous wood bearing walls at long spans.
- The ground floor storefront on the east side of the building is composed of a brick façade supported by a wood beam.
- Stucco is failing and falling off the building.

CONCLUSION: The building is unfit for occupation as-is, and would pose a danger to the occupants. A change of occupancy will require full seismic upgrade to meet current building code, or the Existing Building Code at a minimum.
