General Surface Seal Repair Description:

A 2" thick bentonite seal, extending from grade to at least 18' below grade, is installed around the well casing during well construction. The 2" thick seal is damaged when the pitless adaptor style pump connection is made below grade. Seal repair is *required* prior to WAVE release.

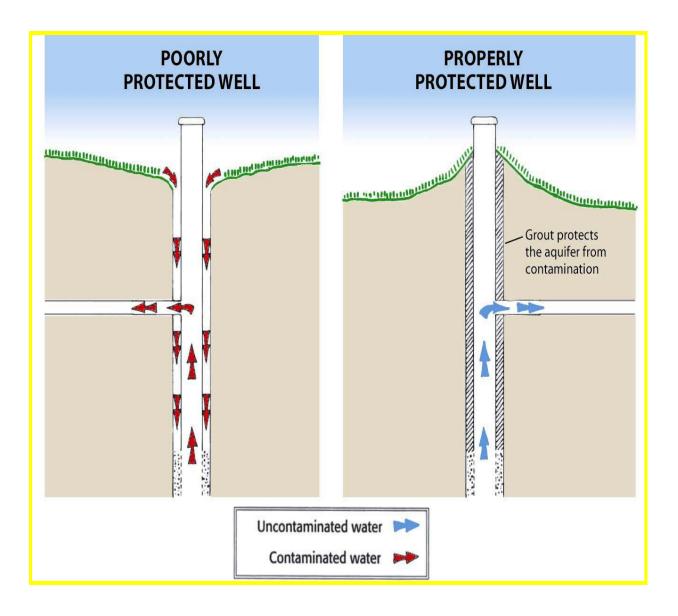
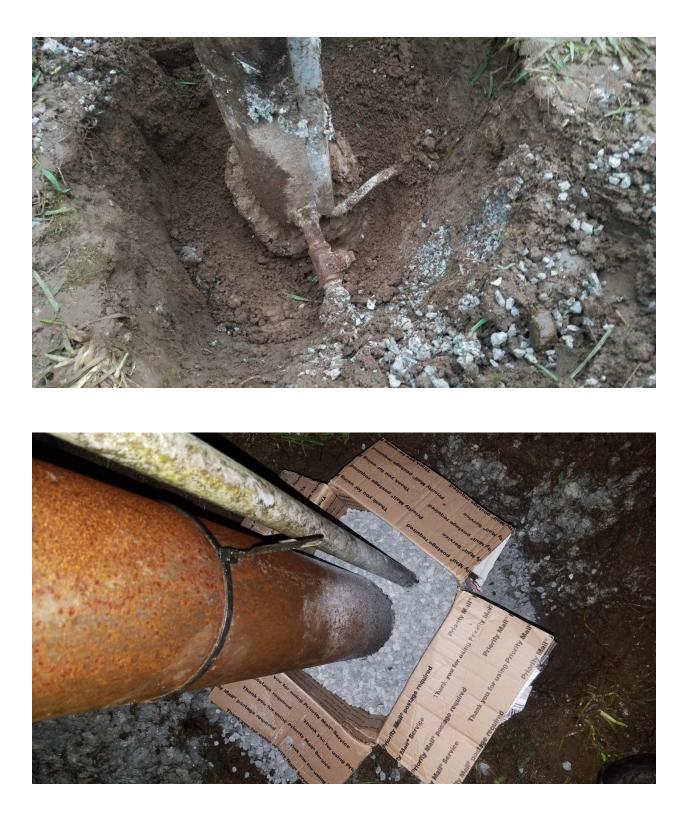
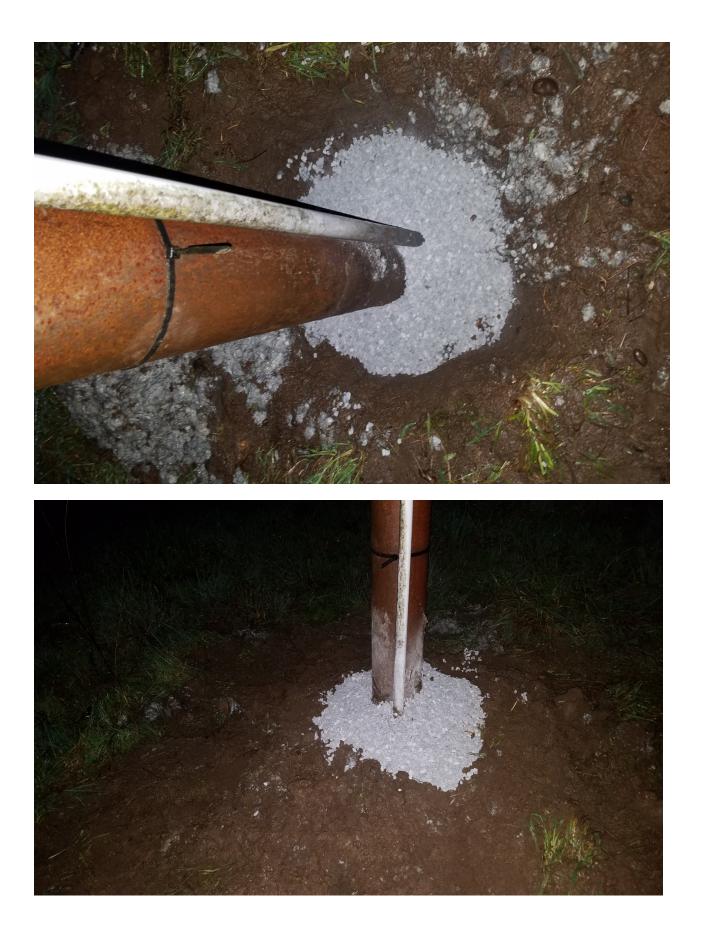
The repair itself if fairly simple; the attachments are examples of good seal repairs. The basic steps are as follows:
