2010

Clark County Stream Health Report

Department of
Environmental
Services

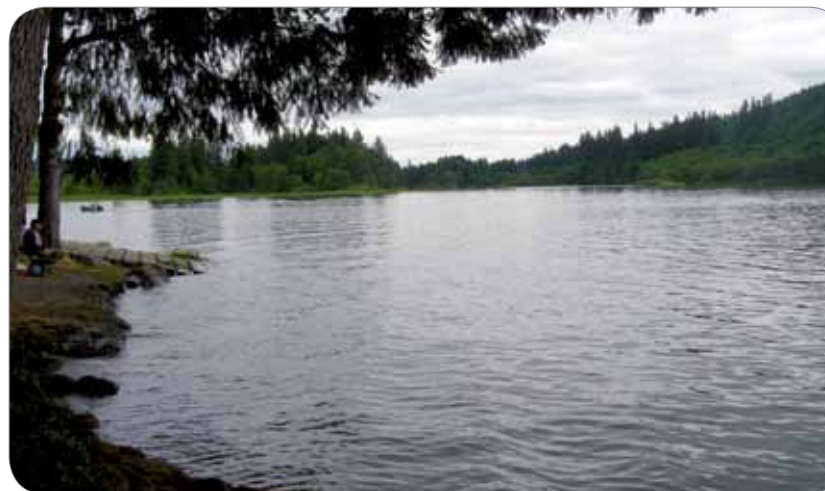
Watershed and Subwatershed

A watershed is an area of land that drains (sheds water) from its highest points to its lowest points, which is usually a stream or lake. Watersheds are made up of smaller drainage areas called subwatersheds. For this report, Clark County has been divided into 78 subwatersheds that make up 10 watershed areas.

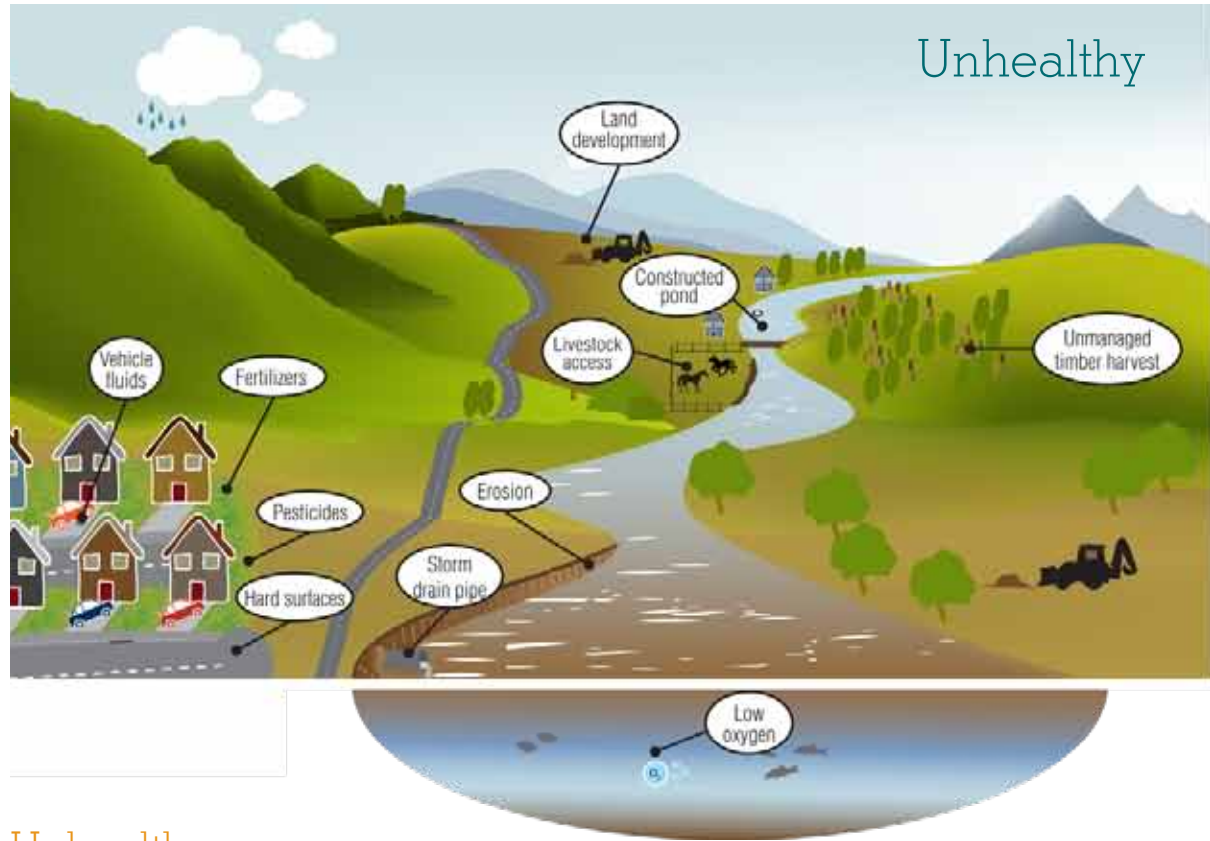
Unhealthy

In-channel ponds change stream flows and absorb heat, which harms stream life.

Livestock access adds bacteria and causes bank erosion.

Land development without effective stormwater management increases runoff, which causes erosion and affects water quality.

Unmanaged timber harvest increases runoff and causes erosion.

Fertilizers are plant nutrients that cause algae blooms downstream, which can harm stream life, pets and people.

Hard surfaces such as roads and roofs, and pipes that remove stormwater, increase runoff and cause stream levels to rise quickly. Hard surfaces are especially harmful next to streams.

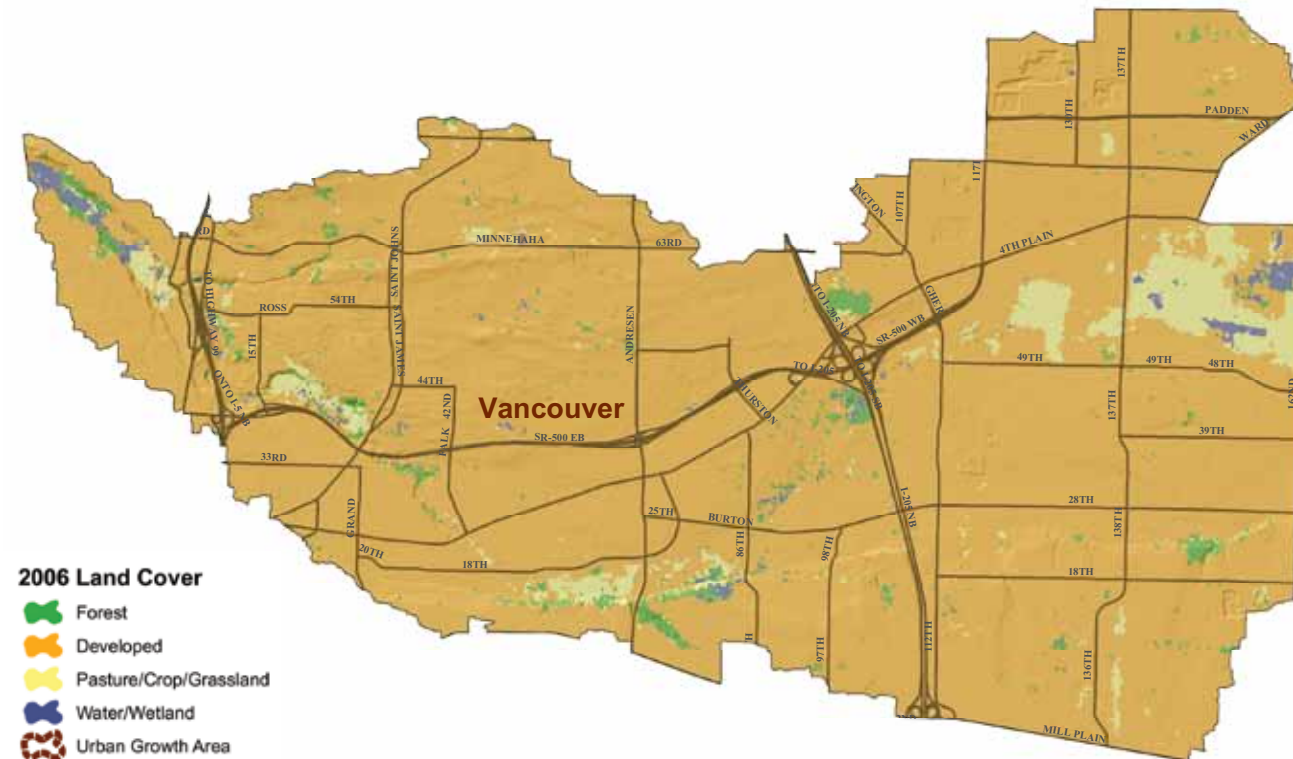
Burnt Bridge Watershed: Stream Health

Burnt Bridge Steam Health Score Card

Subwatershed	Water Quality	Biological Health	Flow	Subwatershed Rating
Lower Burnt Bridge Creek	●	--	--	●
Middle Burnt Bridge Creek	●	--	--	●
Indicator Rating	●			
Overall Watershed Rating:				Poor ●

Data were not collected from the following subwatersheds: Burton Sink and Upper Burnt Bridge Creek

- There are no good or fair ratings
- Historical data suggest Burnt Bridge Creek is the least healthy stream in Clark County
- Washington Department of Ecology is developing a state Water Cleanup Plan for bacteria, temperature, dissolved oxygen, and pH

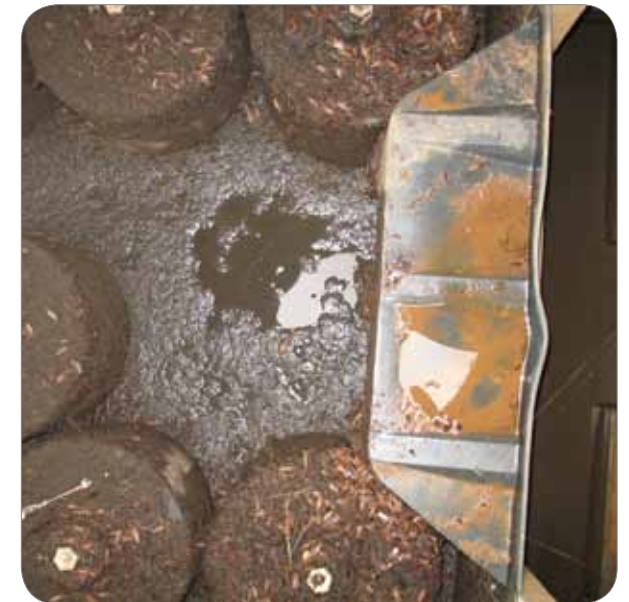
A sediment-filled stormwater vault
