2010

# Clark County Stream Health Report

Department of  
Environmental  
Services

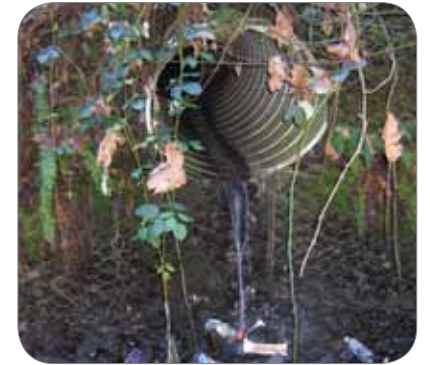
Untreated runoff and trash

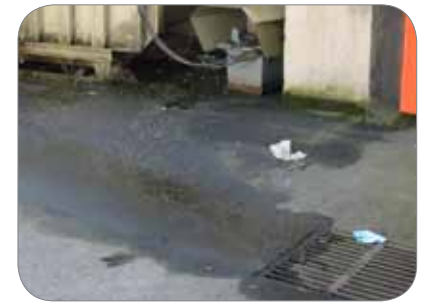
Pollution draining to stormwater system

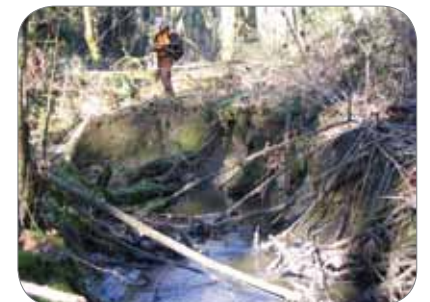
Urban streambank erosion

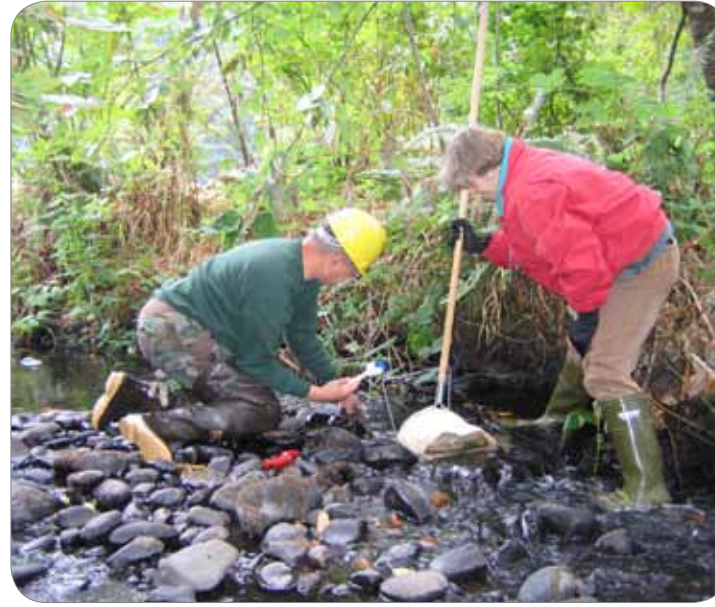
*Collecting data about biological health*

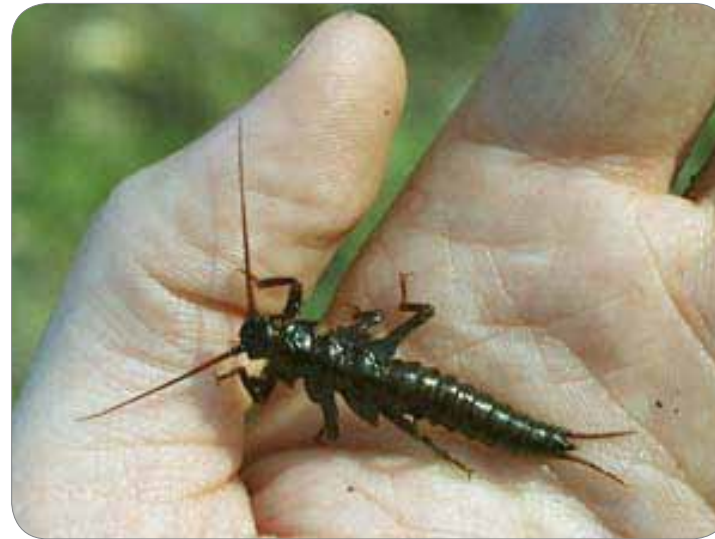
*Macroinvertebrate bug*

Biological health is scored based on the number and kinds of macroinvertebrates found in the stream (Karr 1998). Macroinvertebrates are insects, or bugs, large enough to be seen by the unaided eye and which spend a large part of their life-cycle in streams. Because they are exposed to in-stream conditions for lengthy time periods during their development, macroinvertebrates are an excellent way to measure the combined effects of stream degradation.

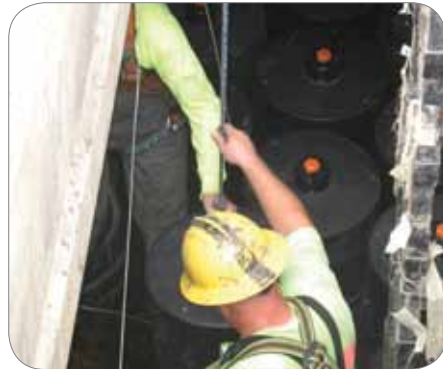
Replacing stormwater filters
