CLARK COUNTY
WASHINGTON

BMP C23 I

Brush Barrier

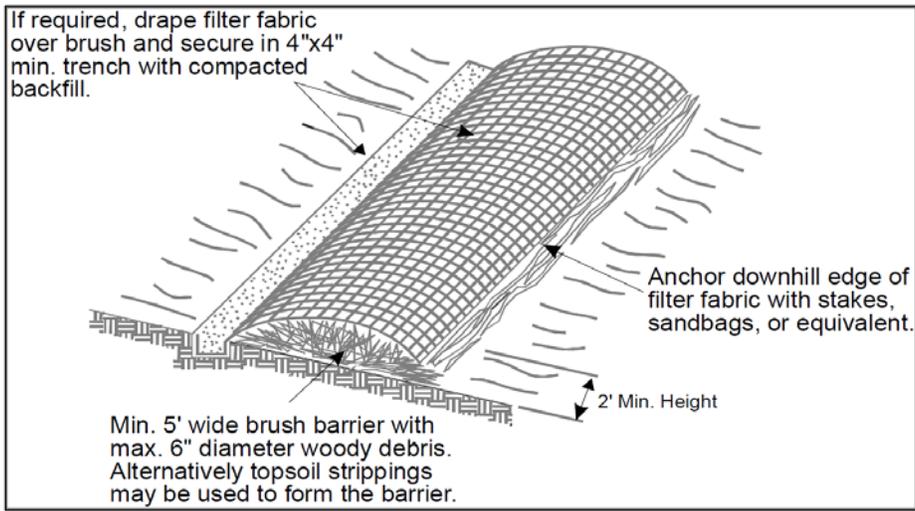
Figure 39: Brush Barrier (Source: WA State Dept. of Ecology)

A brush barrier is a perimeter sediment control constructed of material such as small tree branches, root mats, chipped vegetation, or other debris left over from site clearing and grubbing. Brush barriers can be covered with a filter cloth to stabilize the structure and improve barrier efficiency.

- Height 2 feet (minimum) to 5 feet (maximum).
- Width 5 feet at base (minimum) to 15 feet (maximum).
- Filter fabric (geotextile) may be anchored over the brush berm to enhance the filtration ability of the barrier. Ten-ounce burlap is an adequate alternative to filter fabric.
- Chipped site vegetation, composted mulch, or wood-based mulch (hog fuel) can be used to construct brush barriers.
- A 100 percent biodegradable installation can be constructed using 10-ounce burlap held in place by wooden stakes.
