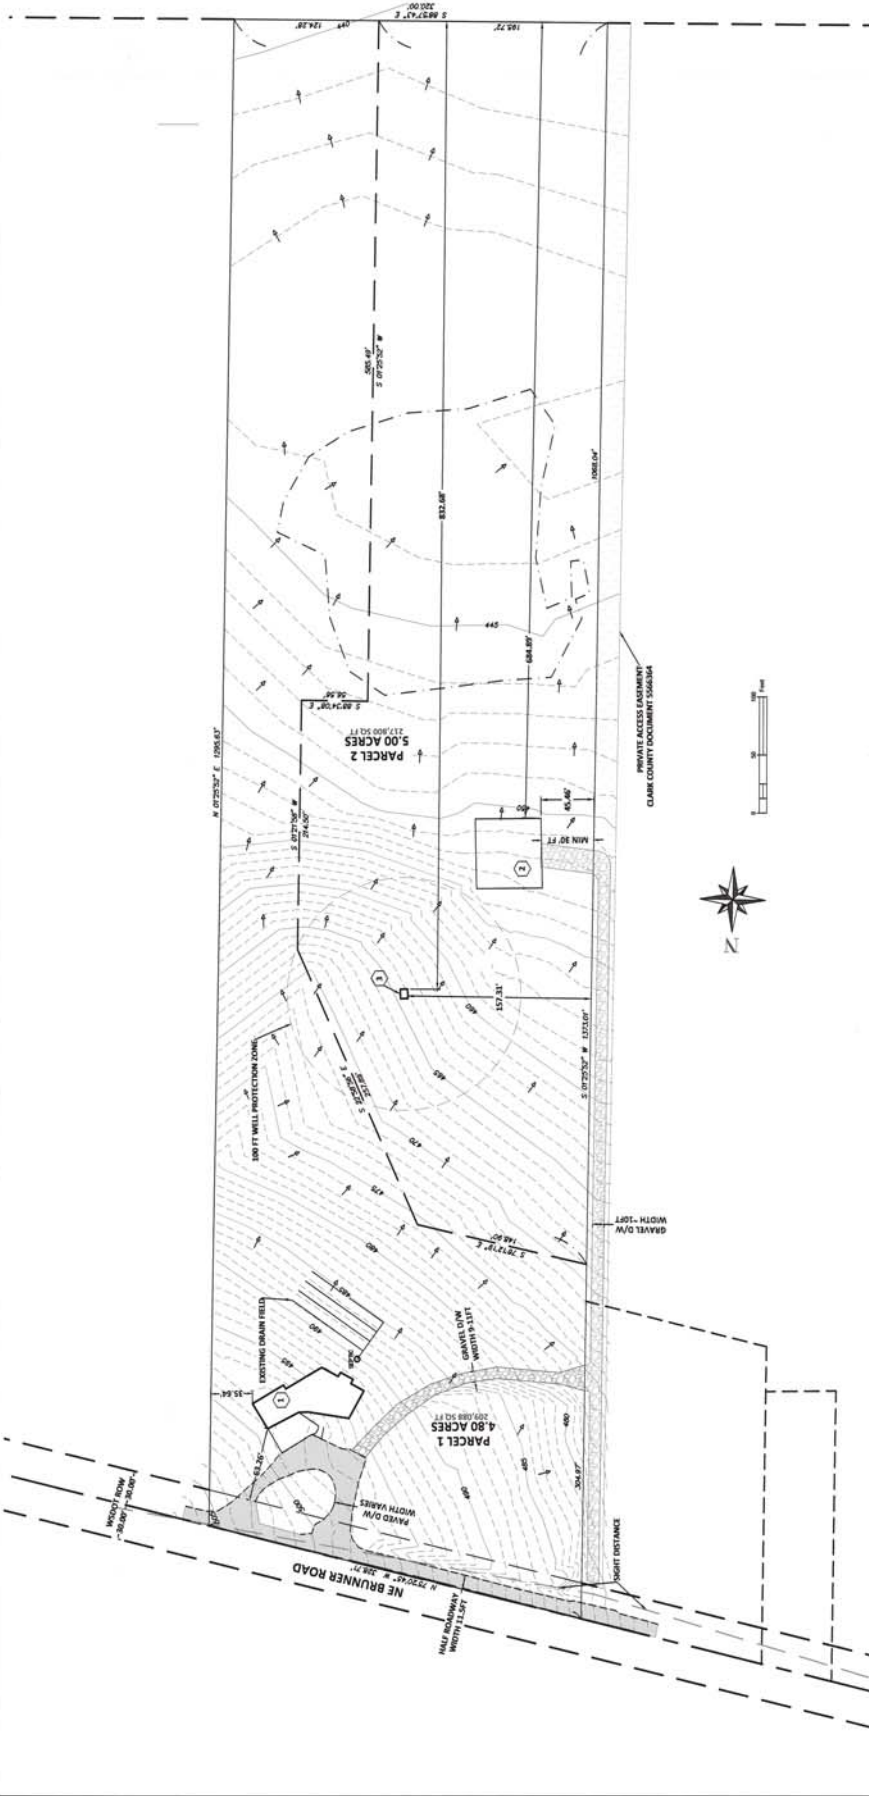
1. EXISTING HOME - ADDRESS 29515 NE BRUNNER ROAD CAMAS WA 98607
2. PROPOSED HOME LOCATION - APPROXIMATELY 1.500 SQ. FT. SINGLE FAMILY RESIDENCE WITH UNKNOWN HEIGHT. ASSUMED WOOD CONSTRUCTION. A CLASS "X" OR BETTER RATED ROOF AND NON-COMBUSTIBLE SIDING SHALL BE REQUIRED.
3. WELL HOUSE - 50 SQ. FT. WOODEN STRUCTURE, SINGLE STORY

SIGHT DISTANCE IS MEASURED IN THE FIELD AT THE EXISTING OBSTACLE'S 56 FEET HEIGHT AND 420 FEET TO THE EAST. LINE OF SIGHT IS IMPAIRED TO THE WEST DUE TO A UTILITY POLE WITHIN WOODS. HEIGHT OF WAY AND TO THE EAST DUE TO VERTICAL CURVE IN NE BRUNNER RD.
